Building Name Address	Use (as per FSA Annexed Table)	Date and Time of Incident	Structure and Stories Area	Extent of Damage (Damaged Area/ Total Area)	No. of Casualties
<b>Kaneyasu Department Store</b>	Department Store  (4)	Nov. 30, 1952	Fire Resistive 6 stories above ground and 1 below	<b>All</b> , Half, Partial, Small  4,096m <sup>2</sup>  (100%)	Fatalities 0  Injured 5 (5)
		Breakout at 05:15 (approx.) Detected at 05:57 Detected by fire watchtower Extinguished by 08:00	Building area 712m <sup>2</sup>  Total floor area 4,096m <sup>2</sup>		
Uomachi 4-Chome FUKUOKA

### I. Summary of Fire Incident

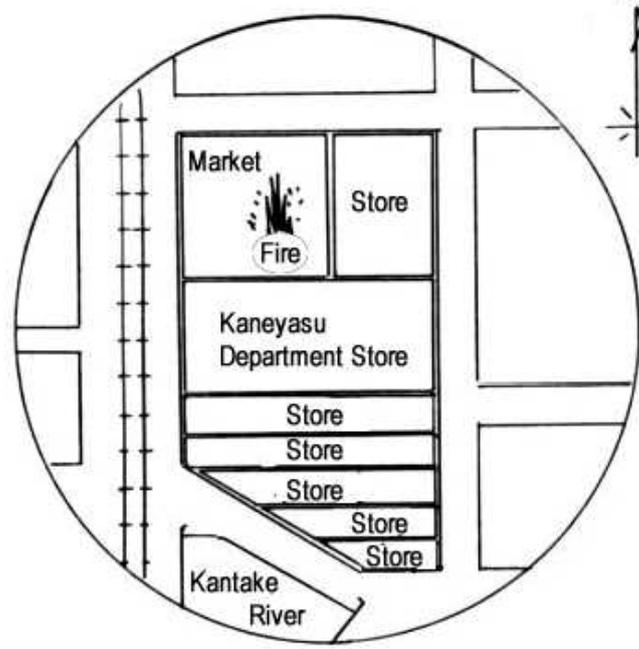
None		
<b>IV. Issues and Lessons Learned</b>		
<ol style="list-style-type: none"> <li>1. The old wooden building of the department store was connected to the new fire resistant building and sales floors were shared; however, there were no fire shutters or any fire safety equipment in the connecting portion.</li> <li>2. No fire patrol was carried out at night, which resulted in delay of fire discovery and communications, and led to such a large fire.</li> <li>3. The fire emerged in an area that was packed by the post-war wooden barrack stores, and the department store was tightly surrounded by hazardous structures.</li> </ol>

\*There were no fire shutters between the new and old buildings. Details such as the locations of stairwells are unknown.
