Building Name Address	Use (as per FSA Annexed Table 1)	Date and Time of Incident	Structure and Stories Area	Extent of Damage (Damaged Area/ Total Area)	No. of Casualties
Seibu Department Store, Ltd.	Department Store (4)	Aug. 22, 1963	Fire resistant 8 stories above ground and 2 below	All, Half, Partial , Small 10,250 m ² (15%)	Fatalities 7
		Breakout at 17:30 (approx.)	Building Area 7,250m ²		Injured 216 (204)
2-8 Higashi-Ikebukuro, Toshima-ku, TOKYO		Noticed at 13:11 Notified by emergency call	Total floor area 69,350 m ²		
		Extinguished by 20:35

I. Summary of Fire Incident

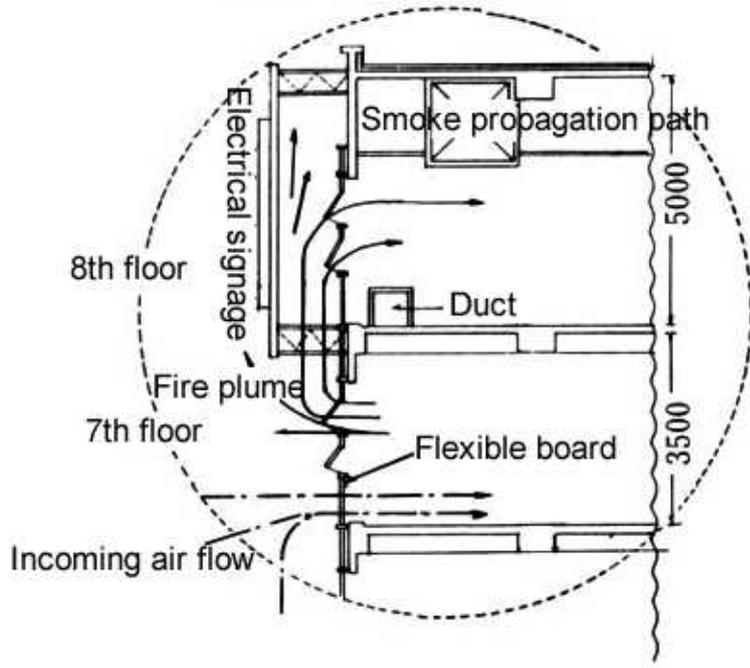
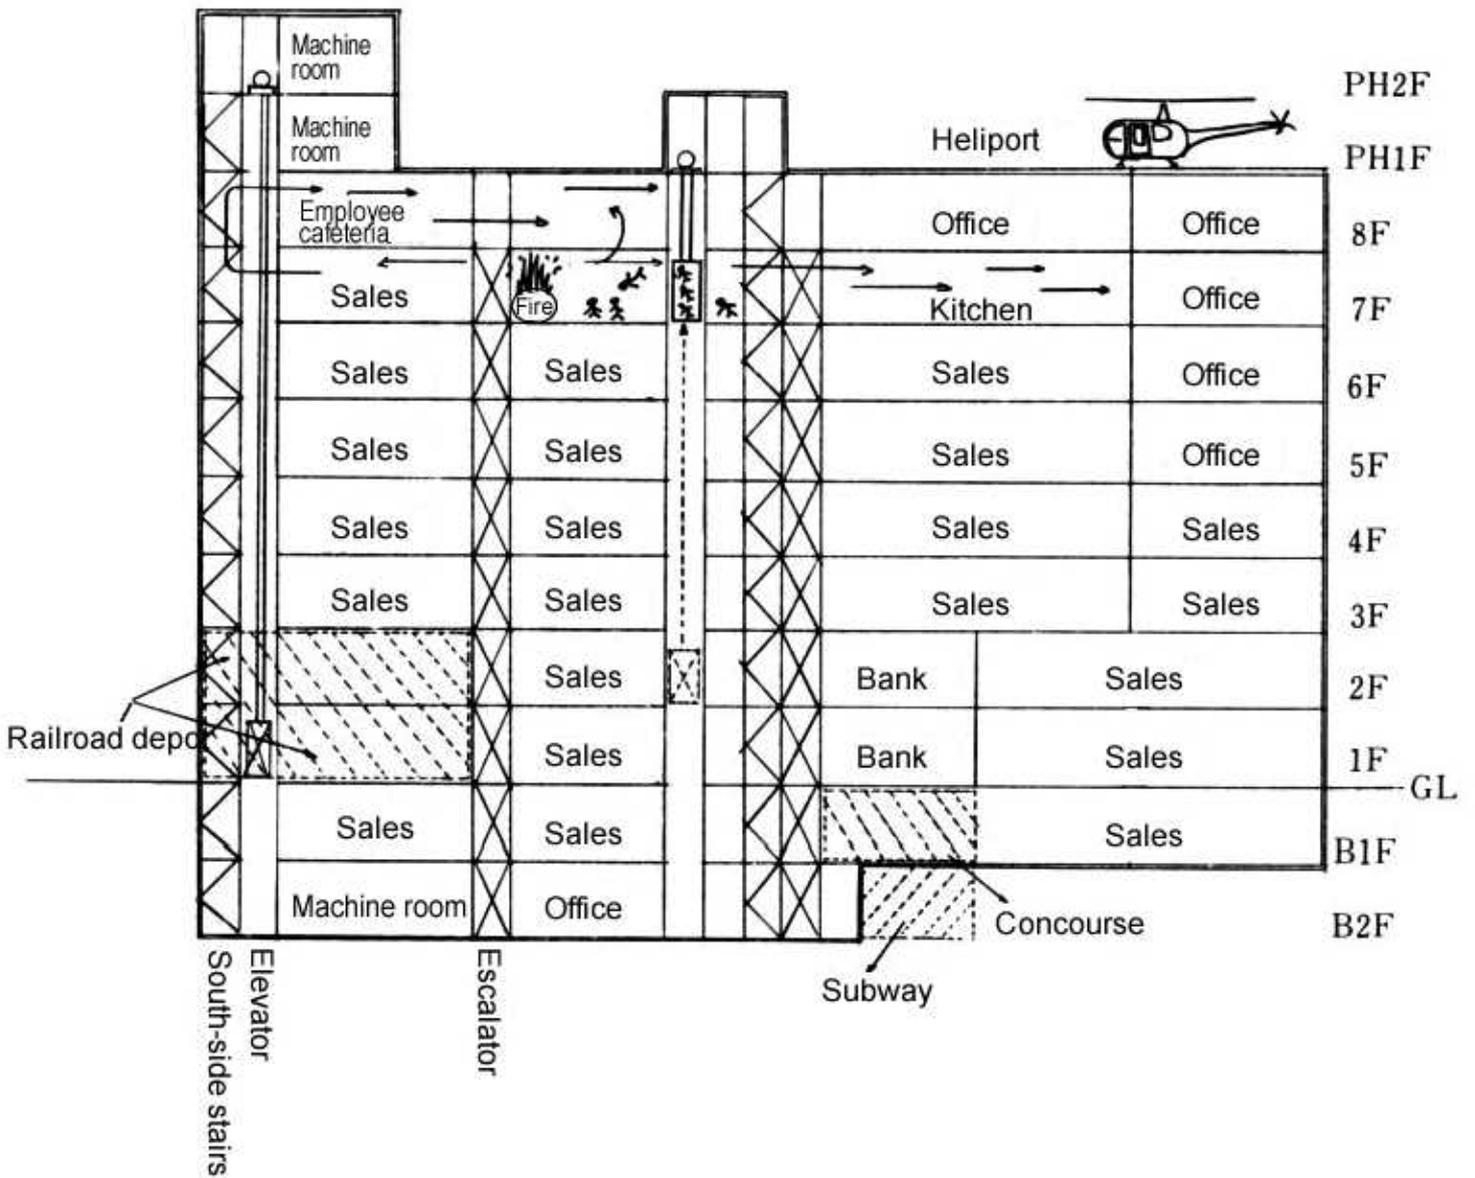
(5) Fire Propagation Path	(Location of Fire Source)	(Propagation from Source)	(Propagation to Other Floors)
	The hallway in front of the escalator shutter located in front of the restaurant on the 7th floor	Ignited the flammable pesticide and spread instantly to other sections of the floor through the fire shutters that were open for pesticide treatment	The flame that blasted out of the windows of the 7th floor ignited electrical signage outside the 7th floor, spreading fire spread to the 8th floor.
<p>Since the fire broke out in the hallway and ignited a highly flammable pesticide, flames spread rapidly to the ceiling and toward the restaurant, which resulted in the fire emerging from the west-side windows of the 7th floor at the early stage of the fire. The fire spread to the sports section and to the north side of the restaurant section through fire shutters that remained opened. The flames emerging from the west-side windows of the 7th floor reached the windows on the 8th floor via electrical signage. With the radiating heat, the flames spread from the upper side of the windows of the 8th floor to the ceiling of the office and then to the employee cafeteria and exhibition room through a fire shutter that remained open.</p>

<p>○ Main Reasons for the Propagation of the Fire</p> <ul style="list-style-type: none"> ○ The pesticide solution which ignited was highly flammable, instantly spreading the fire. ○ During the pesticide treatment and construction work, the workers opened some of the fire shutters, and these fire shutters became the path for the fire to spread. <p>○ Smoke Propagation Path</p> <p>At that time, the fire doors and shutters for the vertical shafts were all closed as the store was closed for the day and thus did not become propagation paths. The smoke propagated from the 7th to the 8th floor generally along the same path as the flames.</p>			
II. Summary of the Building

Probable path of the fire spread to the upper floor
