Building Name Address	Use (as per FSA Annexed Table 1)	Date and Time of Incident	Structure and Stories Area	Extent of Damage (Damaged Area/ Total Area)	No. of Casualties
Matsuya Ginza Department Store	Department Store (4)	Feb. 13, 1964	Fire resistive 8 stories above ground and 3 below	All · Half · Partial · Small 3,862 m ² (8%)	Fatalities 0
		Breakout at 15:33 (approx.)	Building Area 4,739 m ²		Injured 24 (22)
3-1 Ginza, Chuo-ku, TOKYO		Noticed at 15:27 Notified by emergency call	Gross Floor Area 45,659 m ²		
		Extinguished by 21:07

I. Summary of Fire Incident

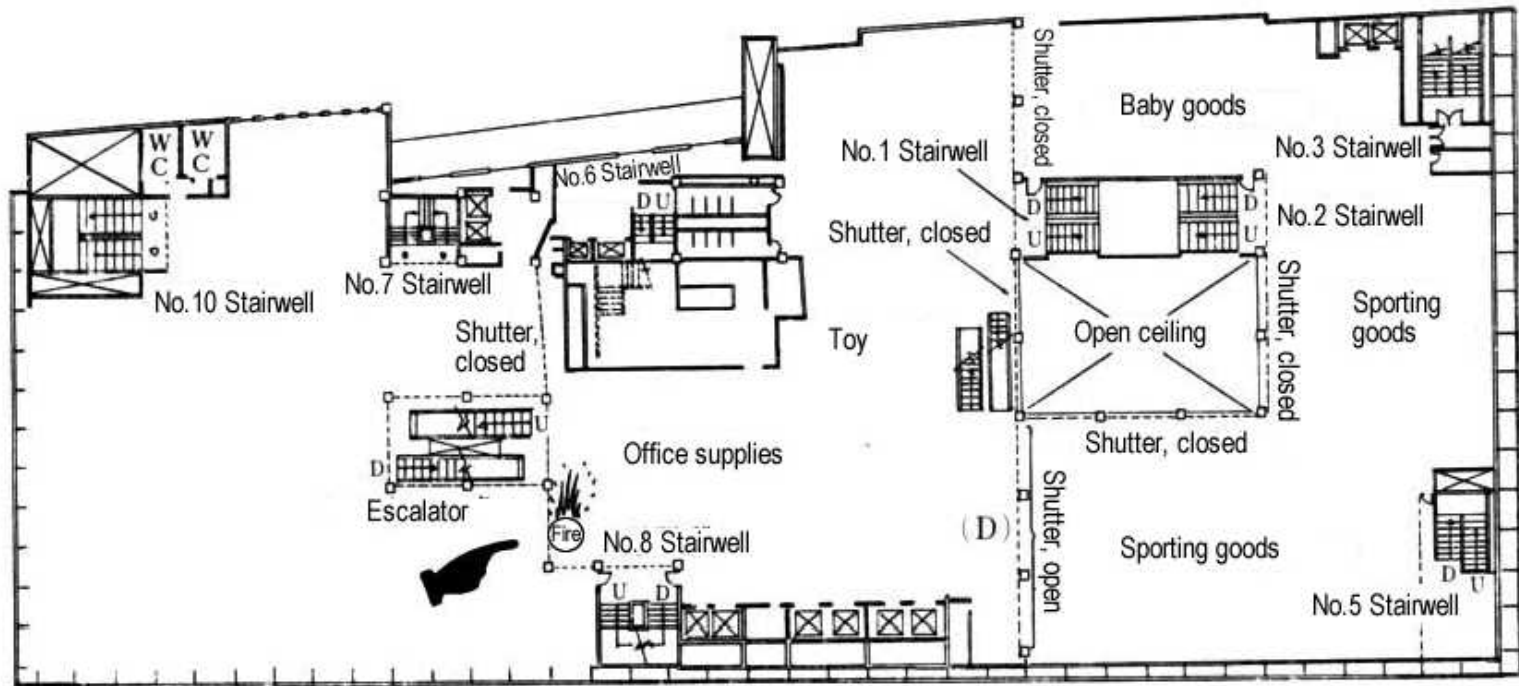
(3) Origin of Fire	(Floor, Room, Part, Combustibles, Habitable/Non-habitable Rooms, Present/Absent)				(4) Cause of Fire	<u>Unknown</u>		
	Near the office supplies section on the 5th floor that was located next to the construction site for the additional building.					The cause of fire could not be determined, but was believed to be from sparks scattered by ongoing oxygen welding work on the 6th floor for the construction project. From around 13:00, the contractors were cutting through existing steel pipes that were embedded on the floor, which was right above the office supplies section of the 5th floor, and sparks may have landed on the ceiling that was made of plywood and hardboard.

(5) Fire Propagation Path	(Location of Fire Source)	(Propagation from Source)	(Propagation to Adjacent Zones)	(Propagation to Upper Floors)
	Near the office supplies section	To the sales goods	Through the accidentally opened D-type fire shutter	Via the stairway of the 5th floor on the south-west side of the building
	To the sales goods near the stairwell shutters on the 6th and 7th floors			
	<p>The fire emerged near the office supplies section on the 5th floor. The partition walls in the construction site area prevented the flames from spreading, but instead, the flames moved toward the toy section where the fire shutters close in the direction of south to north. However, the other shutter on the west side opened by itself (about 3/4 open) and therefore the flames reached the sporting goods section and then spread across the open ceiling area. Meanwhile, the heat from the fire was transferred upward along stairwell No.5 (on the south-west side of the building) because the west-side wall had been wide open for construction and to let fresh air in. This heat made the shutters on the 6th and 7th floor hot enough to ignite nearby combustibles, and resulted in the fire spreading to the 6th and 7th floors.</p>
