Building Name Address	Use (as per FSA Annexed Table 1)	Date and Time of Incident	Structure and Stories Area	Extent of Damage (Damaged Area/ Total Area)	No. of Casualties
Ikenoboh Mangetsu-joh	Hotel (5) a	Nov. 2, 1968	Fire resistive Partially wooden 4 stories above ground and 2 below	All, Half, Partial, Small	Fatalities 30
		Breakout at 02:30 (approx) Detected at 03:06 Notified by ___ Extinguished by 05:45			
865 Arima-machi, Hyogo-ku, KOBE			Building Area 3,520 m ²	6,950 m ² (62%)	Injured 44 (3)
			Gross Floor Area 11,258 m ²

I. Summary of Fire Incident								
(1) Summary	The fatal fire originated on the 2nd floor of a wooden hotel and spread rapidly. The hotel was constructed on the hillside: this geographical feature was utilized to add more rooms over the years, which increased serious concerns for evacuation safety as well. The delayed detection and emergency call and inappropriate evacuation instructions exposed all occupants to danger from heavy smoke and resulted in 30 fatalities and 44 injuries.

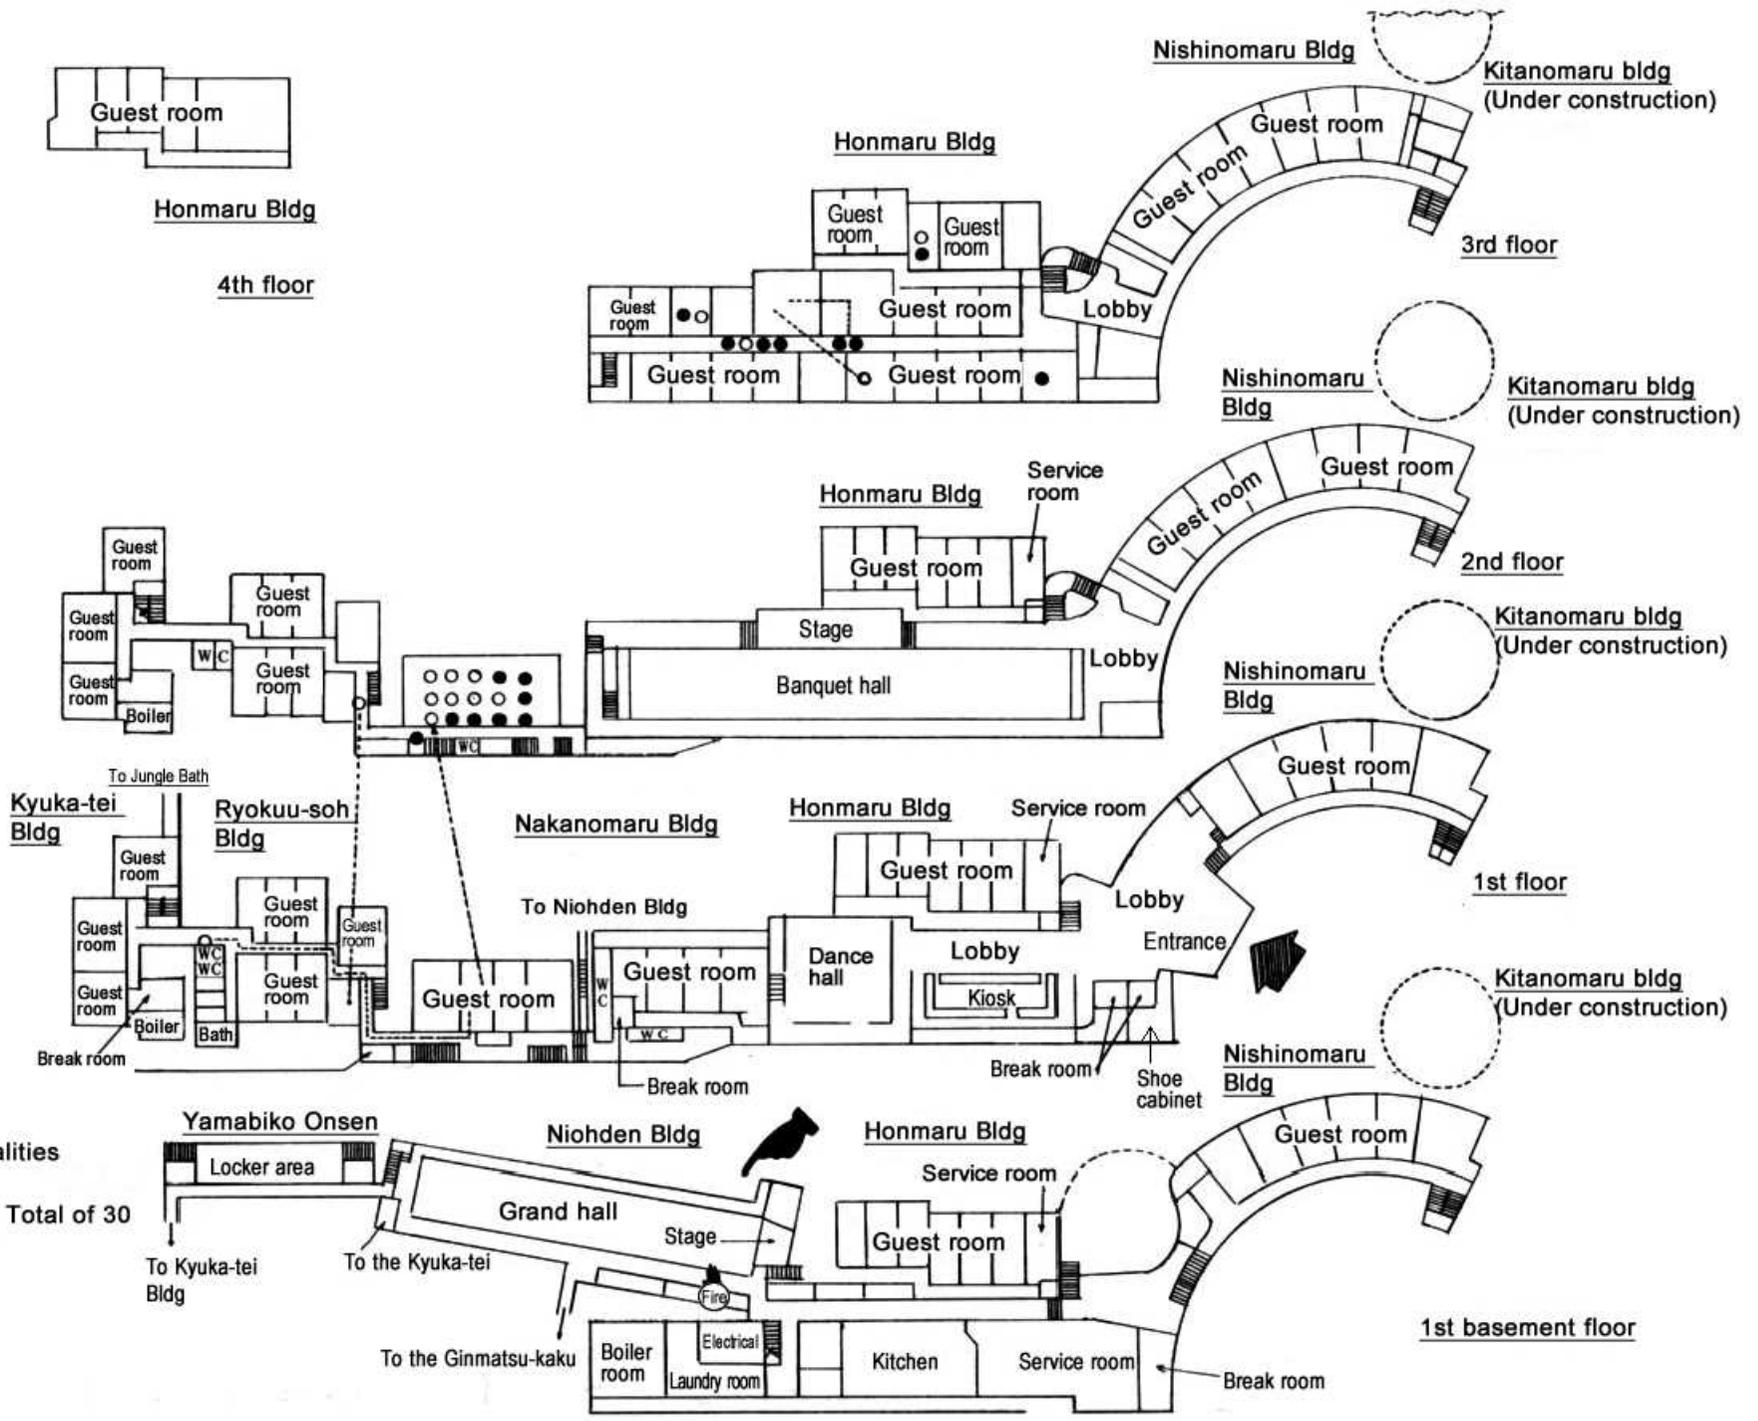
Layout

- ● Number of fatalities
 - Male 14
 - Female 16
- } Total of 30
