Building Name Address	Use (as per FSA Annexed Table 1)	Date and Time of Incident	Structure and Stories Area	Extent of Damage (Damaged Area/ Total Area)	No. of Casualties
Tsuruya Hotel 6-45 Higashikaigan-cho, Atami, SHIZUOKA	Hotel (5) a	Feb. 3, 1970	Fire resistive 10 stories above ground and 1 below Building area 3,208 m ² Total floor area 24,149 m ²	All, Half, Partial , Small 2,450 m ² (10%)	Fatalities 0
		Breakout at 02:00 (approx) Detected at 03:50 Notified by emergency call Extinguished by 6:00			Injured 2 (2)

I. Summary of Fire Incident

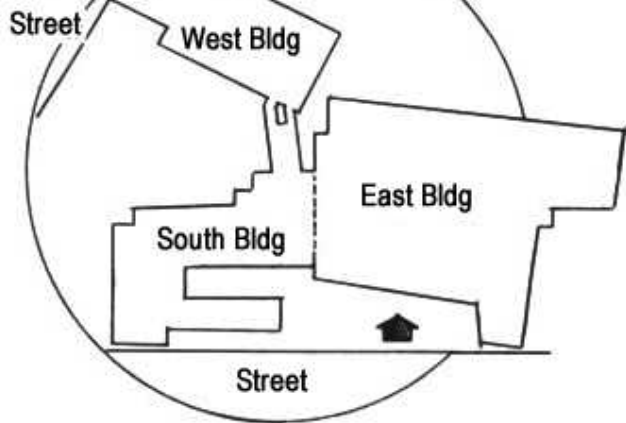
Layout

Note: Presumably, the fire spread to the upper floors through holes in the ceiling (faulty sealing) and to the lower floors through the collapsed floor (non-fire resistive).
