Building Name Address	Use (as per FSA Annexed Table 1)	Date and Time of Incident	Structure and Stories Area	Extent of Damage (Damaged Area/ Total Area)	No. of Casualties	
W''. C	Mito Central Building	Dec. 26, 1970	Fire resistive 8 stories			
		Breakout at 14:30 (approx)	above ground and 2 below	<u>All</u> , Half, Partial, Small	Fatalities 2	
2-3-2 Izumi-cho Mito,	Complex (16) a	Notified at 14:46 Noticed by fire watchtower	Building area 1,372 m ²	10,476 m ²	Injured	
IDANANI			Total floor	(86%)	18	
		Extinguished by 22:00	area 12,112 m ²	,	()

I. Summary of Fire Incident

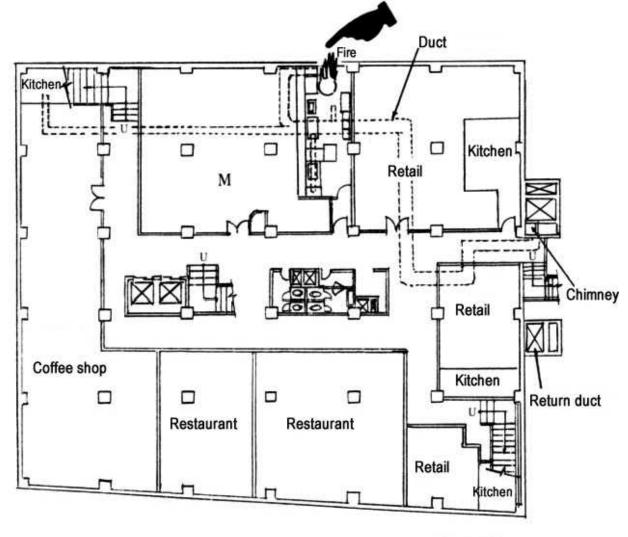
(3) Origin of Fire		(Floor, Room, Part, Combustibles, Habitable/Non-habitable				(4)	Unknown		
	Room	Rooms, Present/Absent)) Cause	CHRIOWII		
rigii	_								
0	From the exhaust air duct of the restaurant kitchen on the 1st					e o			
Ę;	basement floor					of Fire			
ė.	5				ē

(Location of Fire Source) (Propagation from Source) (Propagation to Other Floors) (Propagation to Adjacent Bldg) (5) Fire Propagation Path From the duct Spread to the 1st floor through The exhaust air duct From the windows of to the ceiling the stairwell with no fire of the restaurant the fire building to the compartment, and to the upper kitchen on the 1st adjacent building floors from the open ceiling, through a ventilation basement floor stairwell and vertical shaft The fire emerged from the exhaust air duct of the restaurant kitchen on the 1st basement floor and spread to the ceiling. The nearby stairs leading to the 1st floor were not fireproofed and the fire spread via these stairs to the sales floor of the 1st floor, before spreading higher to the 3rd floor through the open ceiling area. In addition, via the stairwells and clearances around the duct and pipe shafts, which were not properly fireproofed, the fire spread to the top floor. Notably, the bank on the 1st floor was perfectly fireproofed and therefore, the fire did not penetrate into the bank. O Main Reasons for Propagation of the Fire ° The employees tried to extinguish the fire but the fire was beyond their control because it had reached the backside of the ceiling and therefore the fire propagated further. There was no fire compartment (horizontally and vertically) and fire doors were left open for the evacuation. O Smoke Propagation Path The smoke that was produced in the kitchen spread in all directions and rapidly ascended the stairwells and elevator shaft that acted as a chimney. In addition, the smoke traveled continuously to each floor through the duct and clearances of the electrical/bathroom piping systems. II. Summary of the Building (1) Built Construction, Completion, and Major Renovations (Completion) September 1964 (2) Vertical Shafts Fire Prevention Management (3) Fire Prevention Stairs **Duct Spaces** [X][X] No fire-prevention manager. Elevators [X] Pipe Shafts [X] No fire defense plan. Escalator Other (garbage chute) O No cooperative fire safety management. O No fire drill. o The clearances of the electrical wires and the No voluntary inspection. ducts that were running directly from the 2nd O Security patrol by 2 guards in the daytime and 4 guards at basement to the 7th floor were not sealed off. nighttime. On the stairwell, the fire doors were left open (for evacuation), and above the fire doors, the backside of the ceiling was not compartmentalized. (4) Fire Compartments (5) Firefighting Equipment The open ceiling running from the 1st to 3rd floors O The alarm sound was turned off on the control panel of the on the department store floor had no fire automatic fire detection system; therefore, no one heard any compartment for the 1,500 m² area. alarm when the fire broke out. • The guiding lights and the emergency alarm system were not installed in their proper places. O During the fire, the fire escape equipment on the 5th and 7th floors was not utilized.

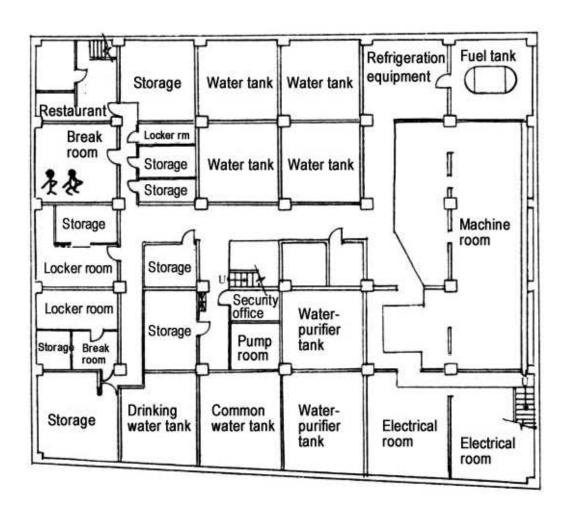
The 2 fatalities in this fire were a male employee Y and a female employee S. Y (age 32) went to the 2nd basement floor to turn off the power in the electrical room and at the door, somebody told him that the power was already turned off, but he went inside to confirm. On the way back to the 1st floor, he met S (age 18) in the dark and they tried to escape together. However, they were trapped because the upper floor was already in flames. Y helped S to go to the break room and called for help through the internal telephone. The firefighters went to look for them according to the information given to them in the telephone call, but they could not find them. S was a student and part-time worker who just started working there that day. How she ended up in the basement before meeting Y is unknown.
