Building Name Address	Use (asper FSA Annexed Table 1)	Date and Time of Incident	Structure and Stories Area	Extent of Damage (Damaged Area/ Total Area)	No. of Casualties
Takatsuki		Sept 25, 1973	Fire resistive 6 stories		Catalitica
Shopping Center	' \ \ '/	Breakout at 06:00 (approx.) Detected at 06:27 Notified by	above ground and 1 below Building area	All, <u>Half</u> , Partial, Small	Fatalities 6
150-3 Hakubaicho, Takatsuki, OSAKA			10,477.7 m ²	34,647.2 m ²	Injured 13 (10)
		Extinguished at 02:00 next day	Total floor area 59,145.7 m ²	(59%)

I. Summary of Fire Incident

This great fire emerged from the 1st basement floor of a 6-story shopping mall. The mall was being built under a busy construction schedule for the grand opening in 4 days' time. The fire burned 60% of the total floor area of 6000 m² and caused 6 fatalities and 14 injuries. Since this steel-frame fire-resistive building was engulfed in flames for hours, the concrete floor collapsed and damage was extensive.

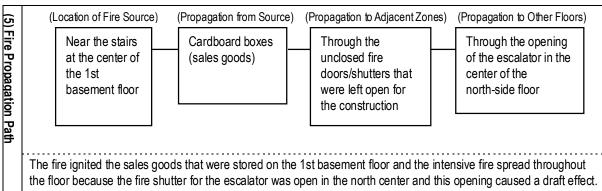
On the 1st floor, the fire shutter for this escalator was closed, but that of the other escalator was open, so the fire spread to the 1st floor through that opening.

After that, the fire propagated to upper floors as some other shutters also remained open.

- O Main Reasons for Propagation of the Fire
 - The fire floor contained a large number of cardboard boxes (sales goods).
 - O Due to the draft effect through the vertical opening of the escalator near the origin of the fire, the fire quickly spread to the upper floors.
 - O Delayed 119 call
- O Smoke Propagation Path

The smoke ascended rapidly to the upper floor through the escalator openings located in the north center of the floor. In addition, the smoke that was concentrated in the basement floor ascended through the openings of the other escalators and stairwells.
