Building Name Address	Use (as per FSA Annexed Table 1)	Date and Time of Incident	Structure and Stories and Area	Extent of Damage (Damaged Area/ Total Area)	No. of Casualties
Ikebukuro Asahi Building	Complex (16) a	Mar 1, 1975	Fire-resistive structure, 7 stories above ground and 2 below	All, [Half] , Partial, Small 811 m ² (50%)	Fatalities 5
		Breakout at 02:28 (approx.) Detected at 02:45 Notified by emergency call Extinguished by 07:14	Semi-resistive structure, 2 stories above ground and 0 below Partially fire preventive		
1-12-11 Higashi-ikebukuro, Toshima-ku, TOKYO			Building area 350 m ² Total floor area 1,618 m ²		Injured 17 (2)

I. Summary of Fire Incident

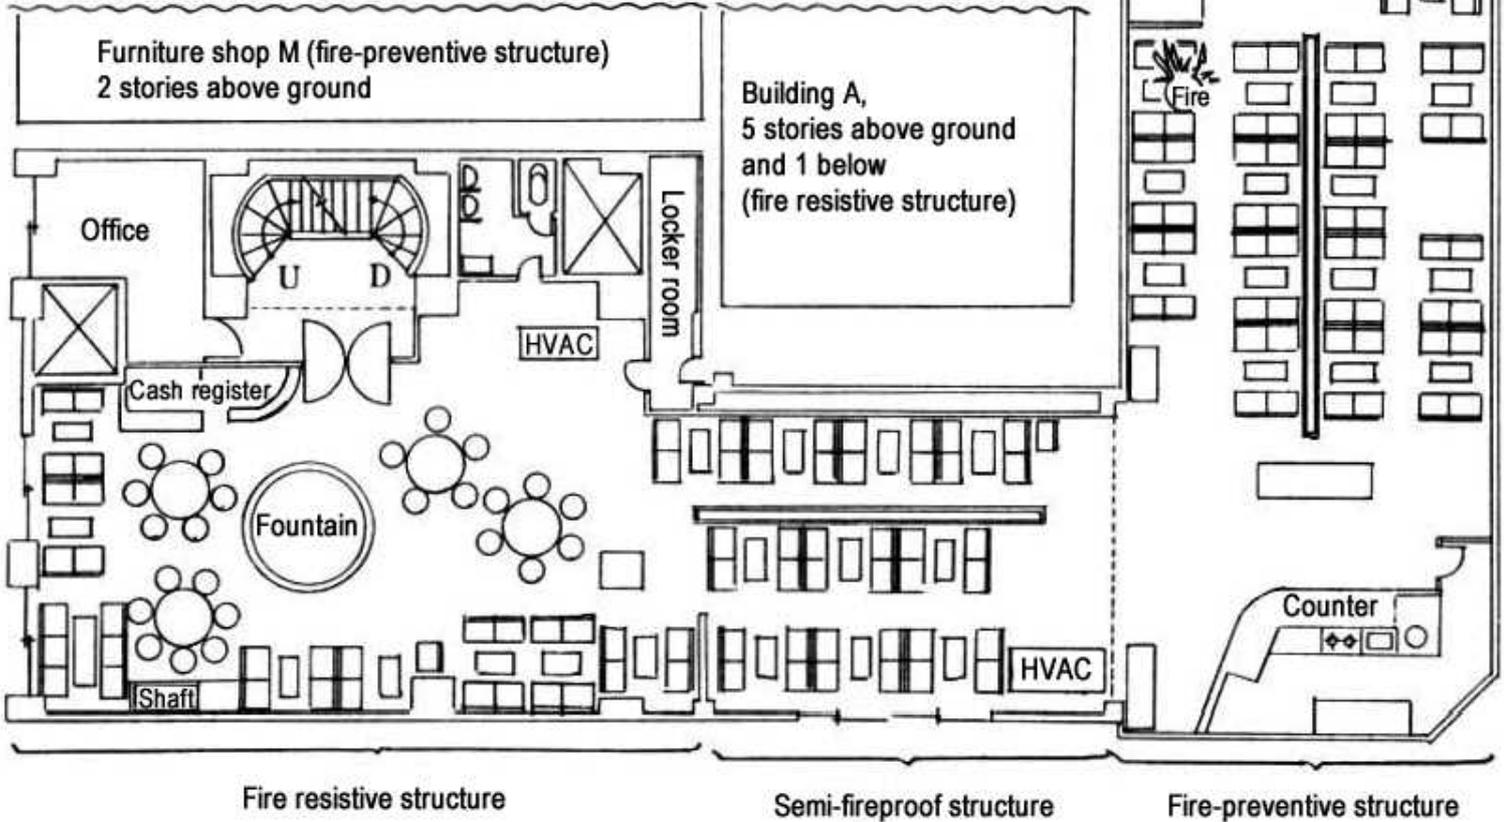
(3) Origin of Fire	(Floor, Room, Part, Combustibles, Habitable /Non-Habitable rooms, Present /Absent) <u>From the customer seating area of the coffee shop on the 2nd floor of the fire-preventive structure.</u>					(A) Cause of Fire	Presumably 1 of the employees had too much alcohol in the coffee shop after he closed the shop for the night. He decided to sleep on the chairs and was too intoxicated to go home. While he was asleep, his jacket that he was using as a blanket fell on an electrical heater that he did not turn off and caused the fire.	
	<ul style="list-style-type: none"> o The coffee shop was a part of the wood-frame structure, and the interior was made of wallpapered plasterboard wall and wallpapered plywood ceiling. o When the fire broke out, 1 employee was sleeping on customer seating inside the coffee shop.
