Building Name Address	Use (as per FSA Annexed Table 1)	Date and Time of Incident	Structure and Stories Area	Extent of Damage (Damaged Area/ Total Area)	No. of Casualties
		March 10, 1975	Semi-fire resistive,		
Sennari Hostel	Hostel (5) a	Breakout at 06:16 (approx) Detected at 06:20 Notified by fire	7 stories above ground and 0 below Building	[All] , Half, Partial. Small 1,501 m ²	Fatalities 4
1-8-20 Oginochaya, Nishinari-ku, Osaka City, OSAKA		emergency dedicated telephone line Extinguished by 12:58	area 251 m² Total floor area 1,501 m²	(100%)	Injured 61 ()

I. Summary of Fire Incident

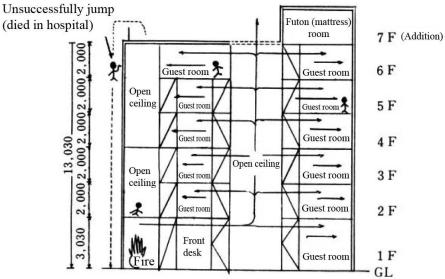
Note: The odd-number floors were made of steel plate (deck plate). Therefore, each hallway had some open ceilings (approx. size of 0.5 m x 1.3 m), total of 7 to 10 sections throughout the building and none of them had fire compartments. (Odd-number floors) The fatality locations are estimate.
