Golden Shopping Center in Front of Shizuoka Station in Shizuoka City,
Shizuoka Prefecture
(Accident Involving Underground Explosion of Gas)

1. Characteristics of the fire

This is an explosion incident at the Golden Shopping Center in front of Shizuoka Station. The primary explosion occurred when combustible gas which had accumulated underground ignited. In addition, the primary explosion ruptured a gas pipe, igniting the gas which leaked out of the pipe, causing a secondary explosion. As a result of the secondary explosion and the subsequent fire which emerged in the underground shopping center, 15 people died, including 5 fire fighters who were attempting to extinguish the fire, and 223 were injured.

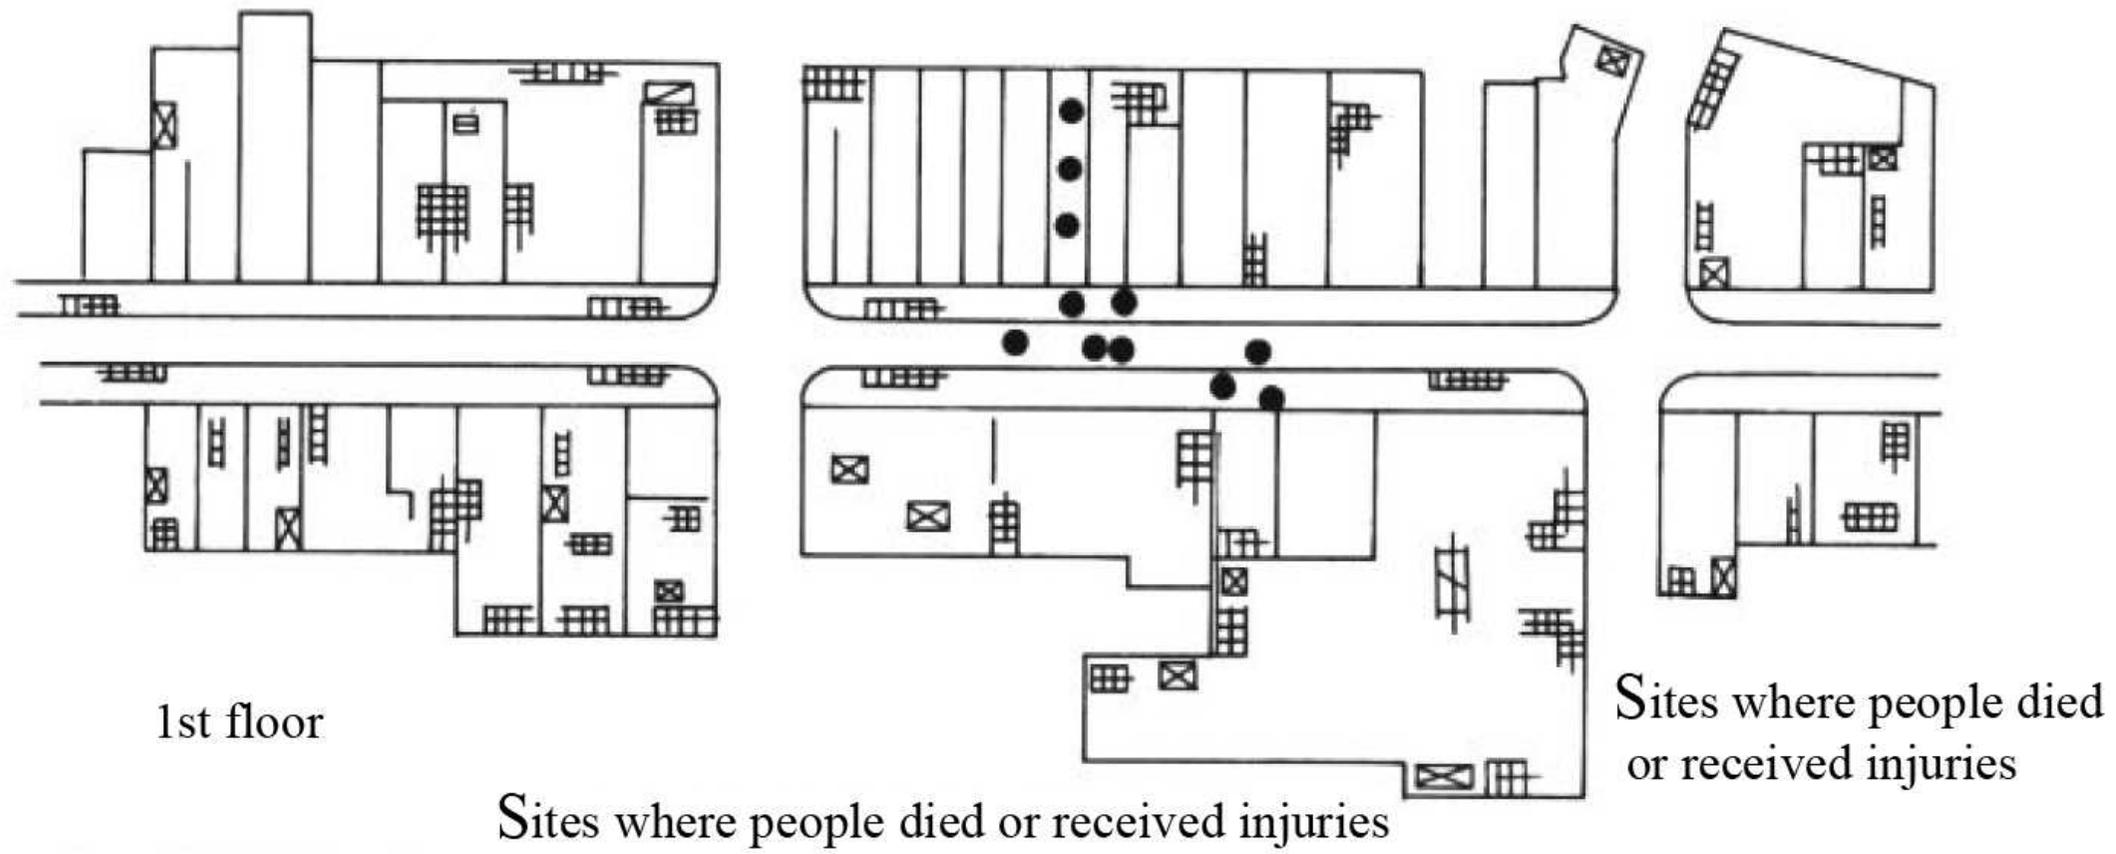
Fig. 2 Floor plan of 1st floor

Sites where people died or received injuries

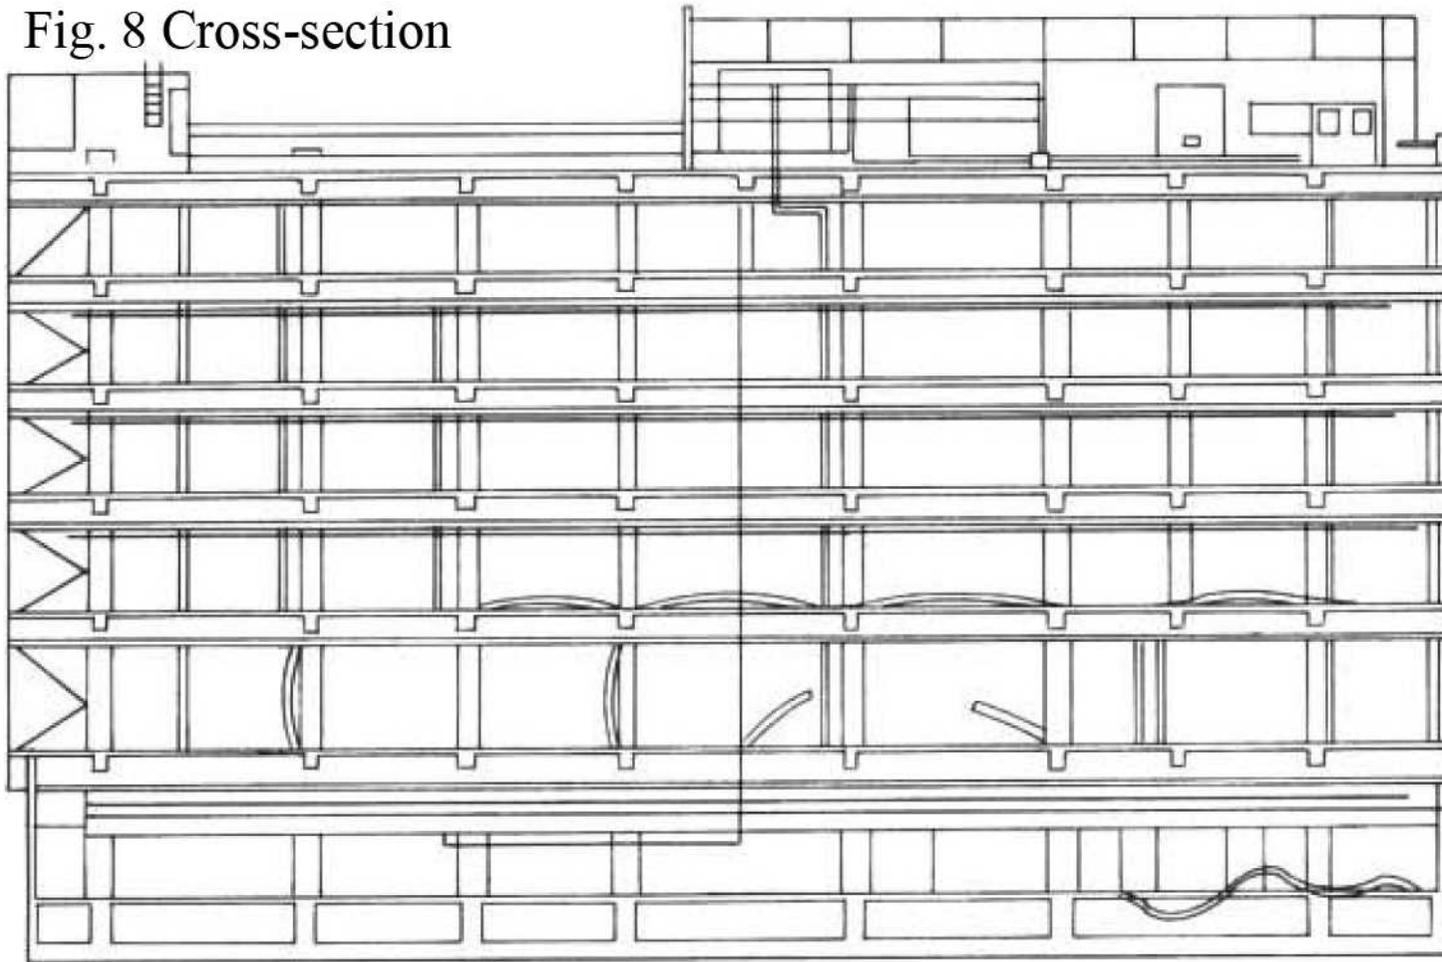
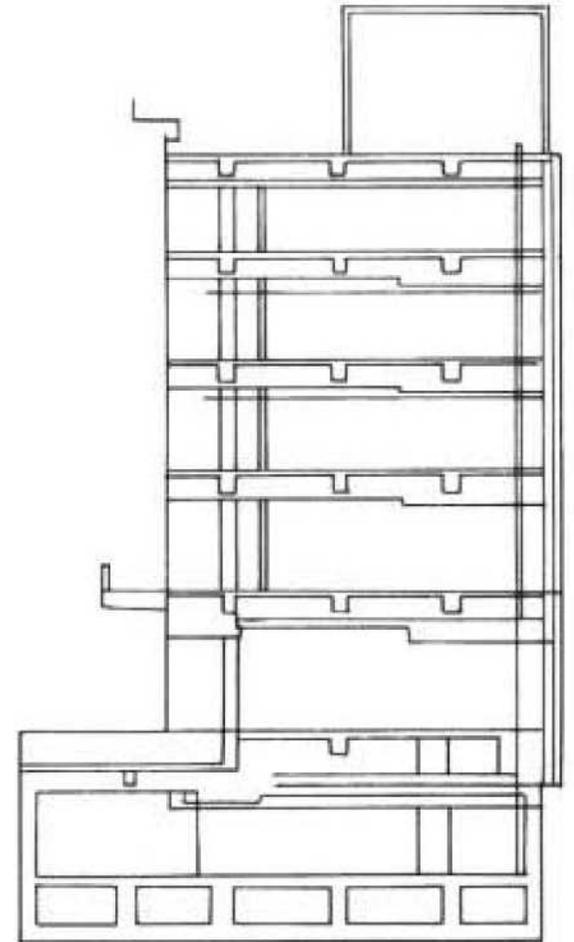
Fig. 8 Cross-section

Since town gas is lighter than air, it accumulates in spaces with poor ventilation, such as overhead storage spaces and air conditioning ducts, and it is considered that the gas travelled upwards from underground via the elevator shaft and filled the building. In addition, since a gas pipe was ruptured by the first explosion, the second explosion affected both the underground shopping area and the 1st floor simultaneously. Although it seems that there were several explosions after the outbreak of fire, it is assumed that this was due to the time needed to close the pipe completely.
