## Hotel New Japan, Chiyoda ward, Tokyo

### **1. Characteristics of the fire**

### **2. Overview of fire outbreak**

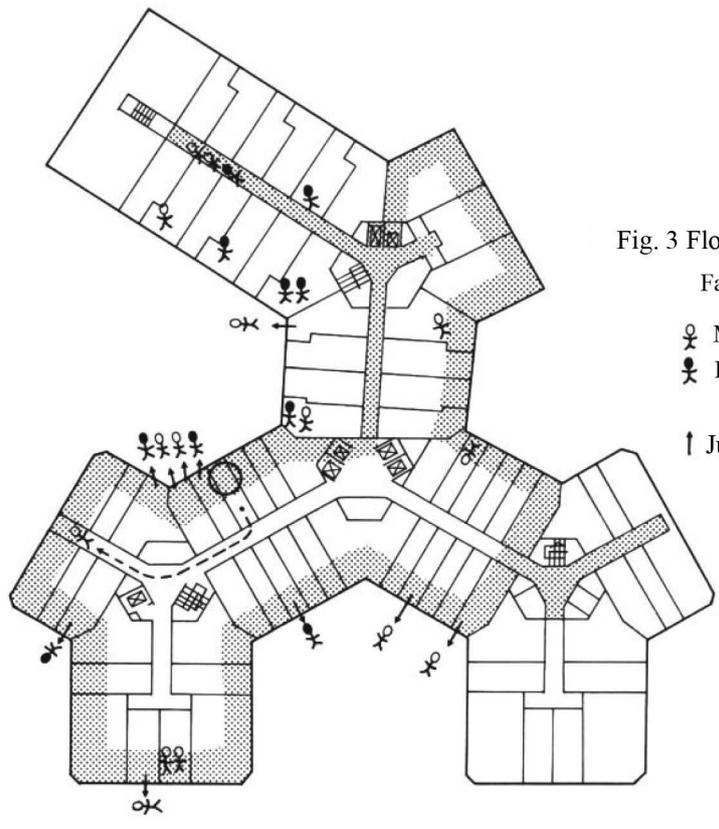
Fig. 3 Floor plan of 9th floor

Room 938 on the 9th floor (a guest from the UK)

It is considered that the fire emerged in the vicinity of the bed in room 938 due to an unattended lit cigarette

At the time when the fire emerged, there were 27 persons on the 10th floor, 76 on the 9th floor and 249 on the 8th floor. Regarding the evacuation guidance for guests on the 9th floor, Staff A instructed several of the guests who had gathered in the corridor around the room with the fire to evacuate themselves via the elevator. Also, a guard who then arrived at the site guided several guests who had gathered in front of the service area to the evacuation staircase. On the 10th floor, another guard instructed several guests to evacuate via the stairs, and staff members working at the front desk guided 2 people to the stairs.

When the fire department arrived, the 9th floor was engulfed in flames. Several guests from the 9th floor were rescued via the windows, etc.

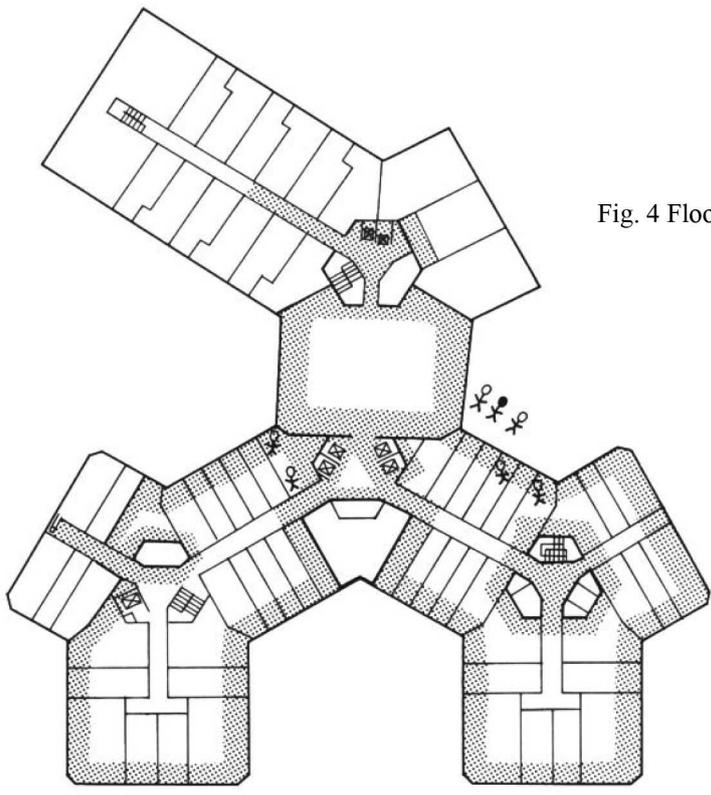
Fig. 4 Floor plan of 10th floor

▪ 7th floor	21 m <sup>2</sup>
▪ 9th floor	1,870 m <sup>2</sup>
▪ 10th floor	2,201 m <sup>2</sup>
▪ Rooftop structures	94 m <sup>2</sup>
Total	4,186 m <sup>2</sup>

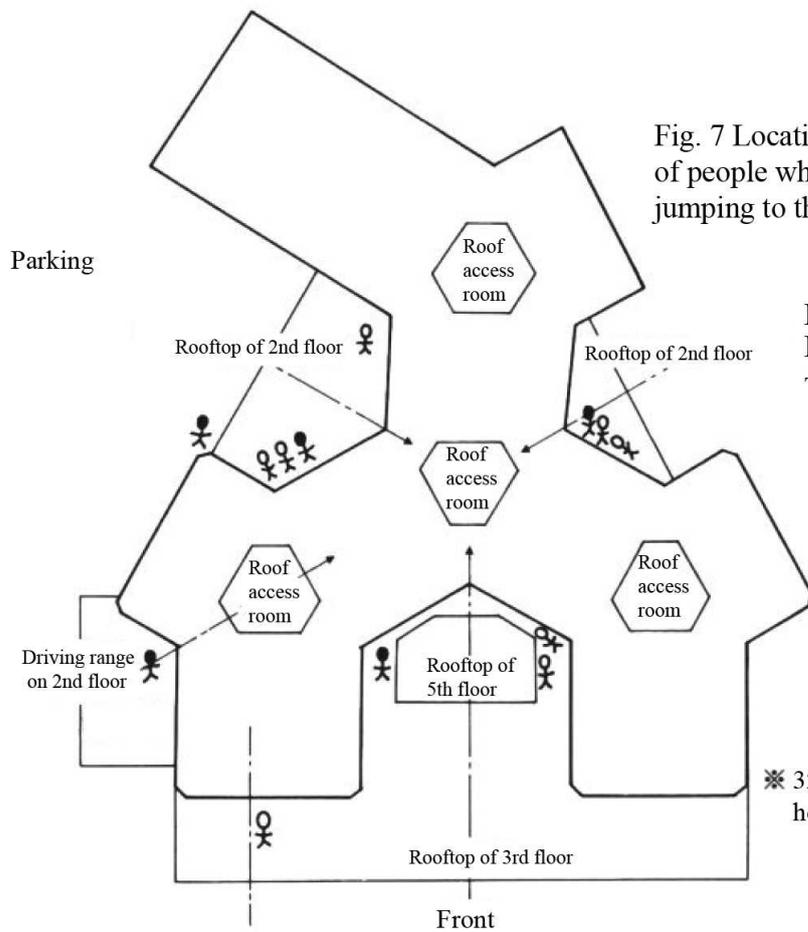
Fig. 7 Locations of bodies of people who died after jumping to the ground

Male	8
Female	5
Total	13

※ 32 people died after hospitalization
