Hotel Zao, Yamagata city, Yamagata prefecture

### **1. Characteristics of the fire**

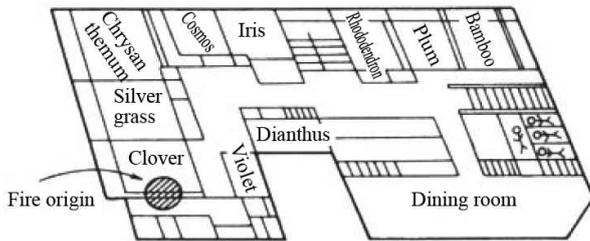
Fig. 3 2nd floor of the main building

- (1) Ignition source  
It is assumed that the fire was produced by an electric heater used in the lavatory of "Clover Room" on the 2nd floor.
- (2) Ignited substances  
The wall and other combustible materials inside the lavatory (assumed)

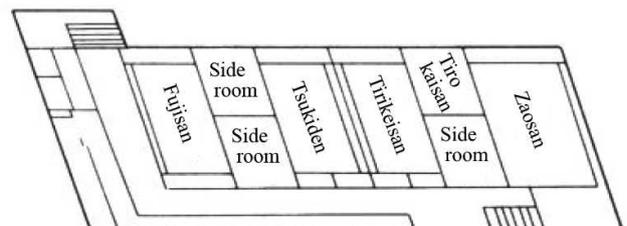
Fig. 5 4th floor of the main building

Locations dead bodies were found
