Manza Onsen Hotel, Tsumagoi town, Gunma prefecture

1. Characteristics of the fire

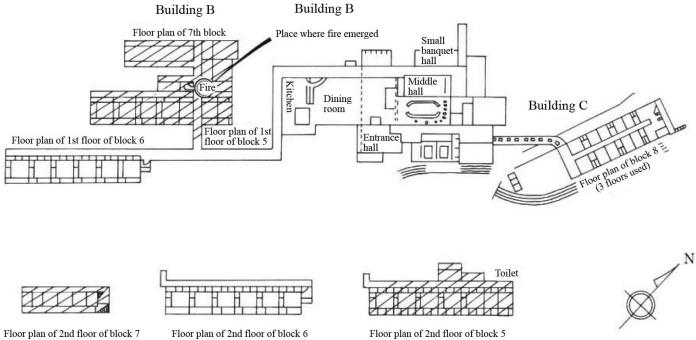
Fig. 2 Floor plans (the floor where the fire emerged; damaged floors; 1st floor; others)

In the vicinity of the toilet roof on the 1st floor of Building B (assumed)

Although the installed automatic fire alarm system covered a part of the building which included the burned area, it did not sound. The fire was discovered by hotel guests who were passing the place where the fire emerged.

Due to snow coverage of more than 2 m, all 6 emergency exits in the old building were closed. For this reason, many guests broke the windows in their own rooms and in the corridors with their hands and feet and subsequently jumped outside.
