Transportation Authority Electric Transformer Substation in Sakae, Nagoya city, Aichi prefecture

1. Characteristics of the fire

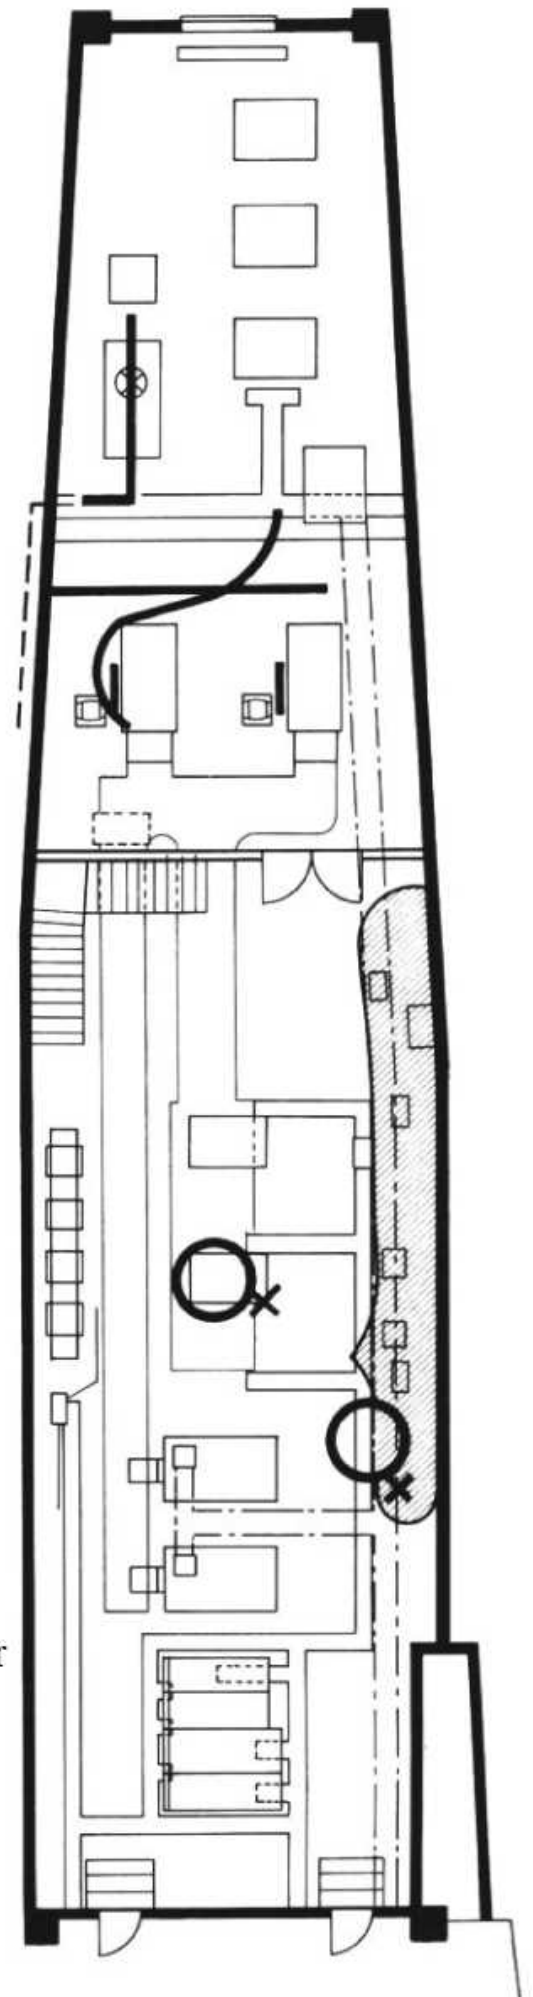
Fig. 2 Layout of the 2nd underground floor

- (1) Ignition source
The source of the fire was a deteriorated over-voltage protection condenser in the transformer room on the 2nd underground floor.
- (2) Route
A ground fault event induced ground-fault current in the primary side of the rectifier, and as a result a spark was produced between it and the steel angle block of the power distribution duct on the ceiling, which caused the fire.
- (3) Ignited substances
The coating of electric wires and the FRP duct cover.
