Higashi Izu, Shizuoka Prefecture: Hotel Daitokan

1. Characteristics of the fire

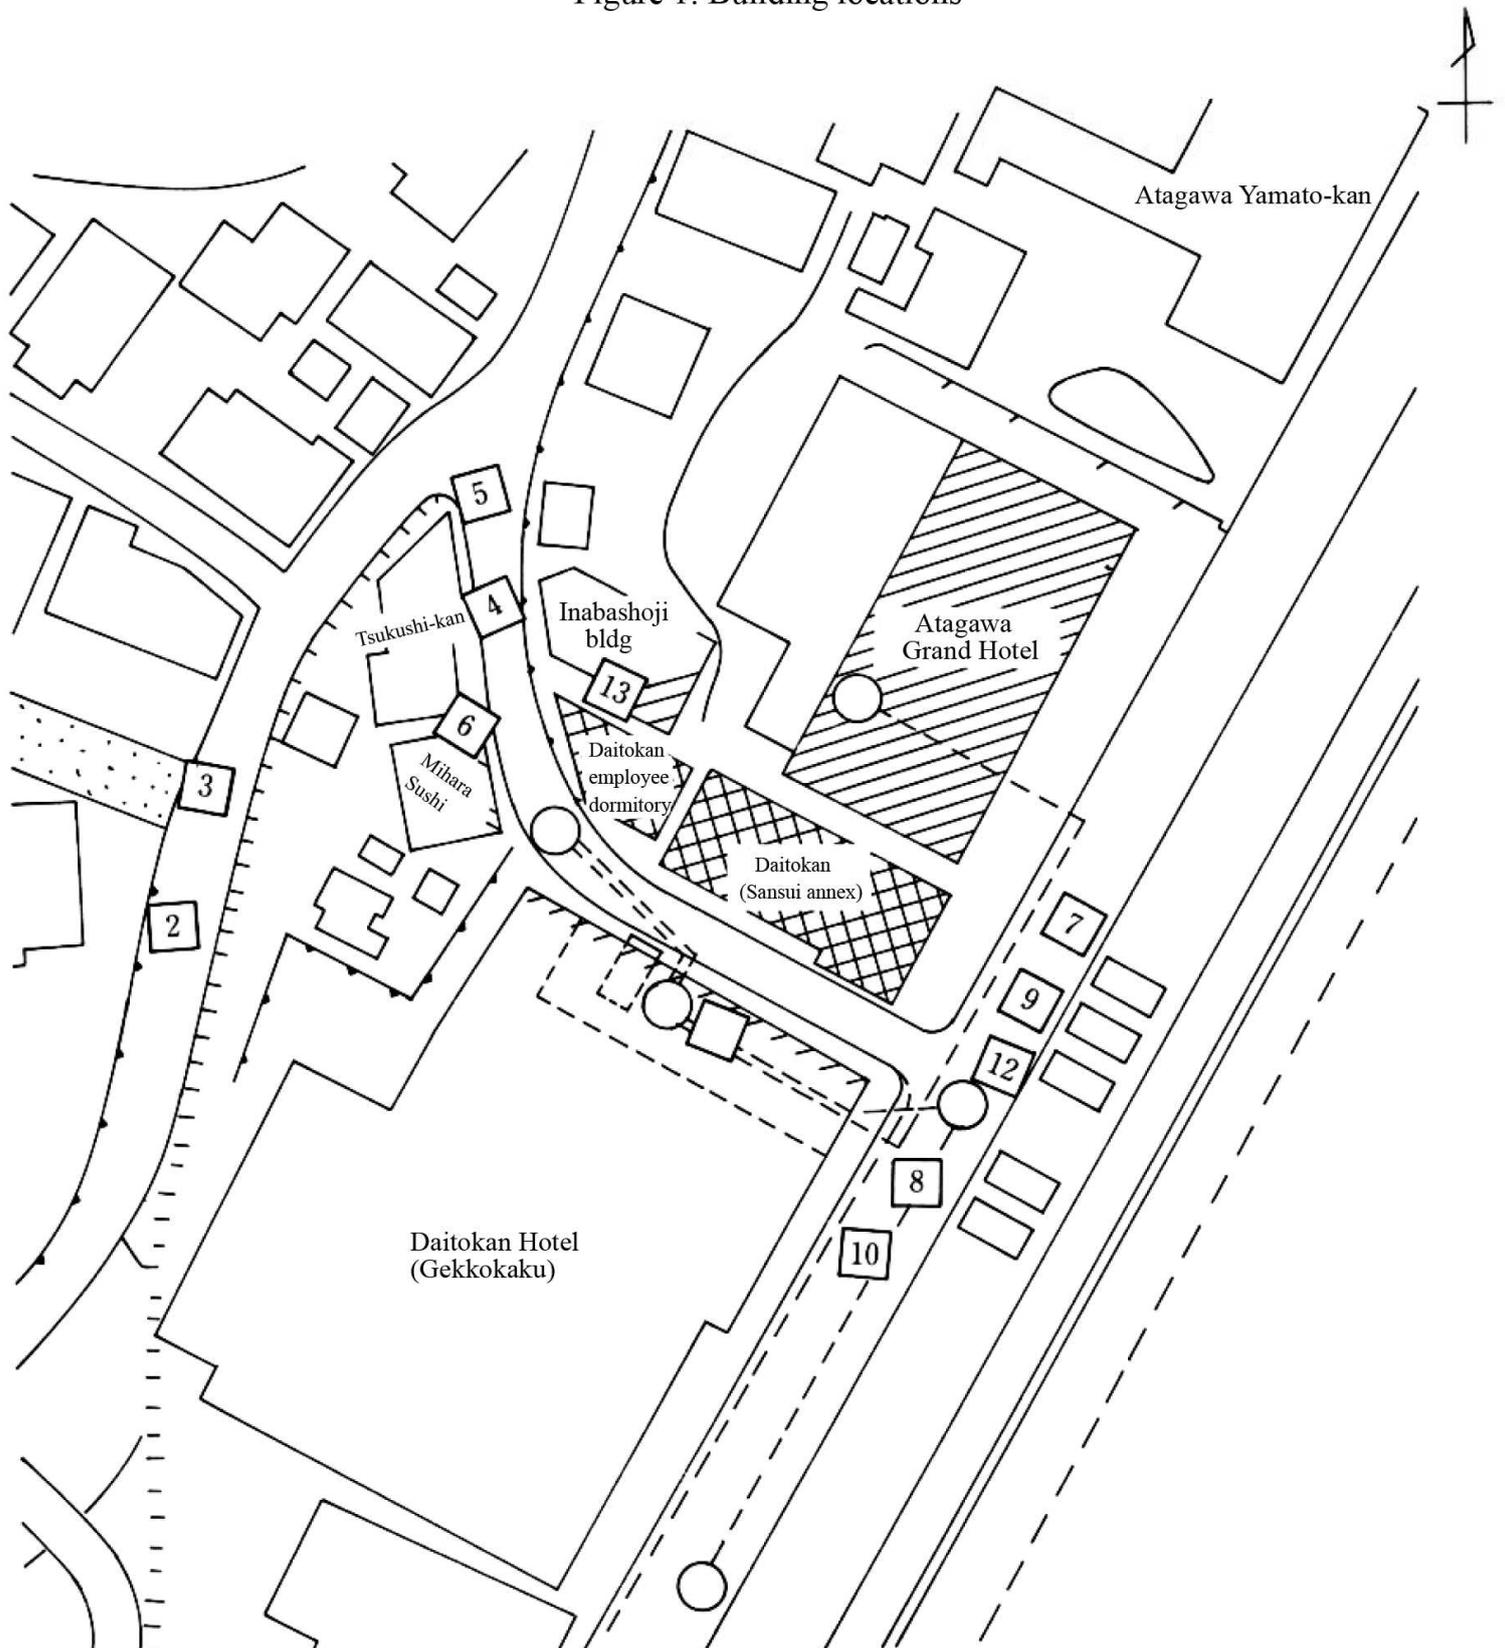
Figure 2: Floorplan, 1st floor

The fire broke out in the vicinity of a pantry with a gas cooking range. The gas range was used for roughly 30 minutes a day when guests were in the annex. It was used the previous day (the fire occurred very early the next morning).

The Sansui annex was made of wood. The fire grew from the first-floor pantry and, spreading through windows and other routes, rapidly reached the upper floors.
