Kobe, Hyogo Prefecture: Youki Dormitory of the Youkikai (social welfare foundation)

1. Characteristics of the fire

Eight seriously disabled residents died in a fire that broke out after bedtime in a facility for the intellectually disabled. There were no particular problems with the facility in terms of hard, physical aspects; and, even in terms of soft, service aspects, the staff displayed a higher degree of fire prevention awareness than staff members at most facilities. Despite that, however, the tragedy occurred, calling into question the adequacy of measures for facilities for people who may not be able to adequately respond to disasters themselves.

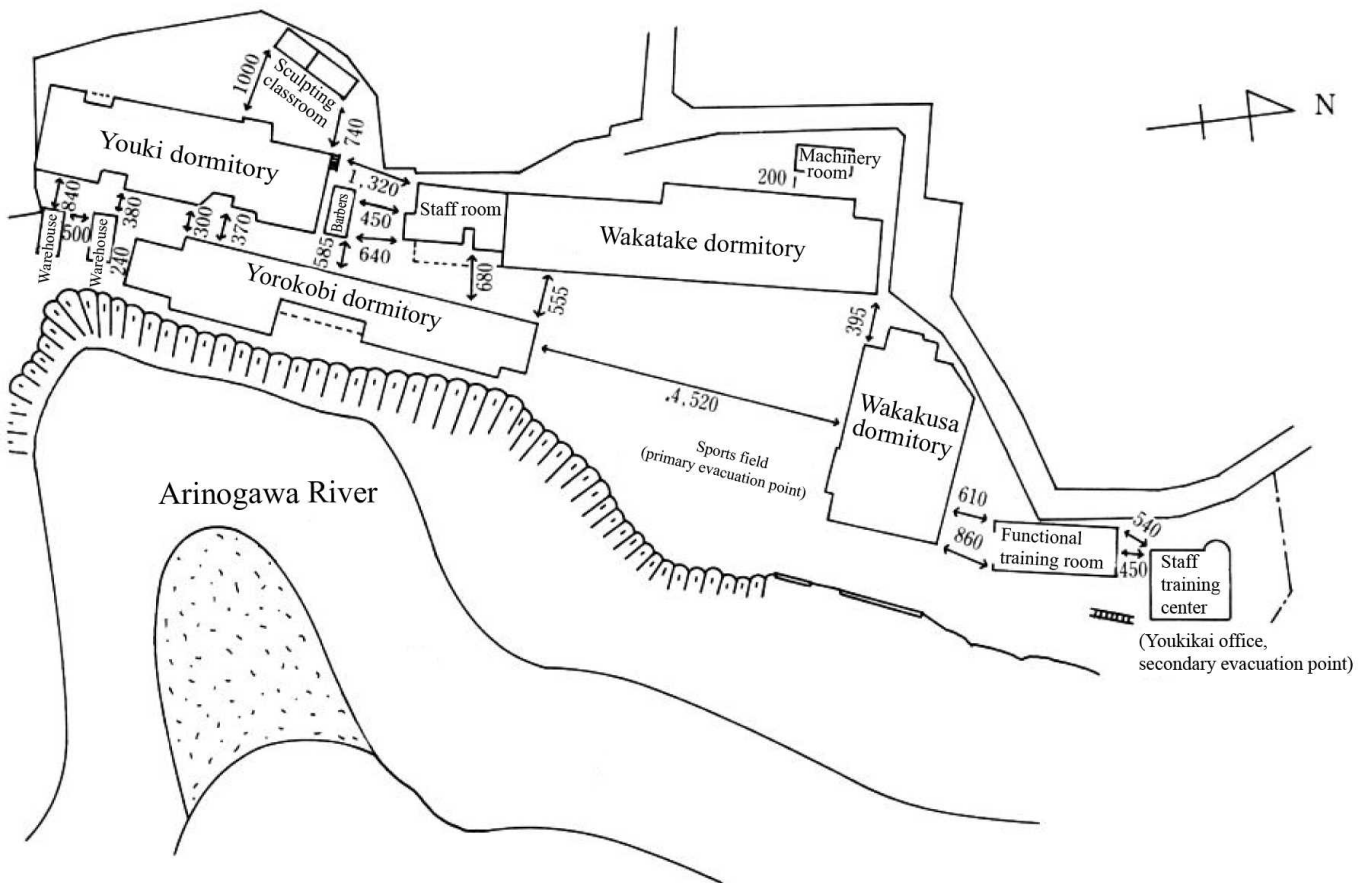
Figure 1: Youkikai facility overview

(5) The Youkikai facility is comprised of several buildings over a plot of land, including the Youki dormitory and 3 other dormitories, a training center, and the manager's residence. The Youki dormitory, the site of the fire, did not have an outside telephone that could be used to directly call the fire department. It did have a dedicated (internal) telephone for use in contacting the training center and/or manager's residence in an emergency, with the call to the fire department to be placed from such a location. Here, it is necessary to establish a rapid communication system for use in

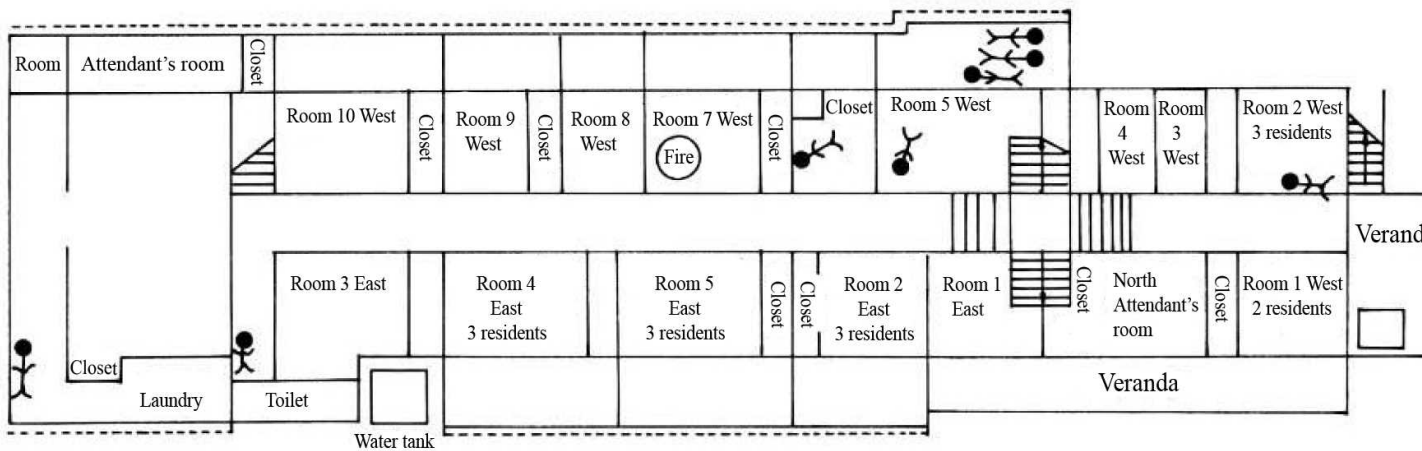
Figure 3: Floorplan, second floor

Bottom of built-in closet in Room 7 West, second floor.

The ignition source and ignited substance remain unclear. It is inferred, however, that the fire spread from the area of vinyl flush door of a built-in closet and rose to the ceiling, whereupon it began to proceed laterally along a print-paneled wall and partitions made of (flammable) acrylic sheet.

(2) The second-floor veranda had been modified into dormitory rooms by partitioning it with aluminum-framed acrylic panels. These acrylic panels not only hindered escape but also acted to spread the fire.
