Koto-ku, Tokyo: Skycity Minamisuna

1. Characteristics of the fire

A fire broke out within a residential unit on the 24th floor of a 28-floor high-rise condominium building in Tokyo, damaging the unit and a portion of a common area. This incident attracted much attention in fire prevention/fighting circles in that it occurred on the highest floor of any fire in a multi-family dwelling in Japan.

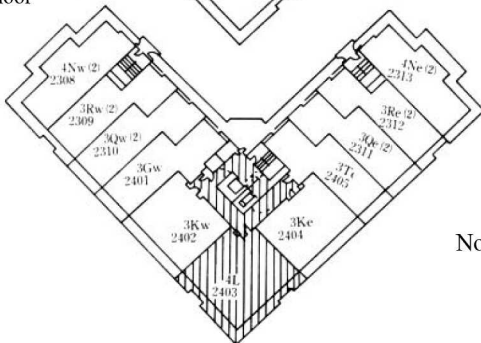
24th Floor

183.9 m² (24th floor — room 2403: 108.0 m²; balcony: 24.9 m²; common area: 51.0 m² — plus portion of 25th floor)

The area of the residential unit was 108 m², yet interior fire zones are limited to 100 m² or less. Because a partition was left open, the entire residential unit was lost. The fire also extended out from the front door onto the common area, of which approximately 50 m² was lost.

Note: Shading indicates fire loss

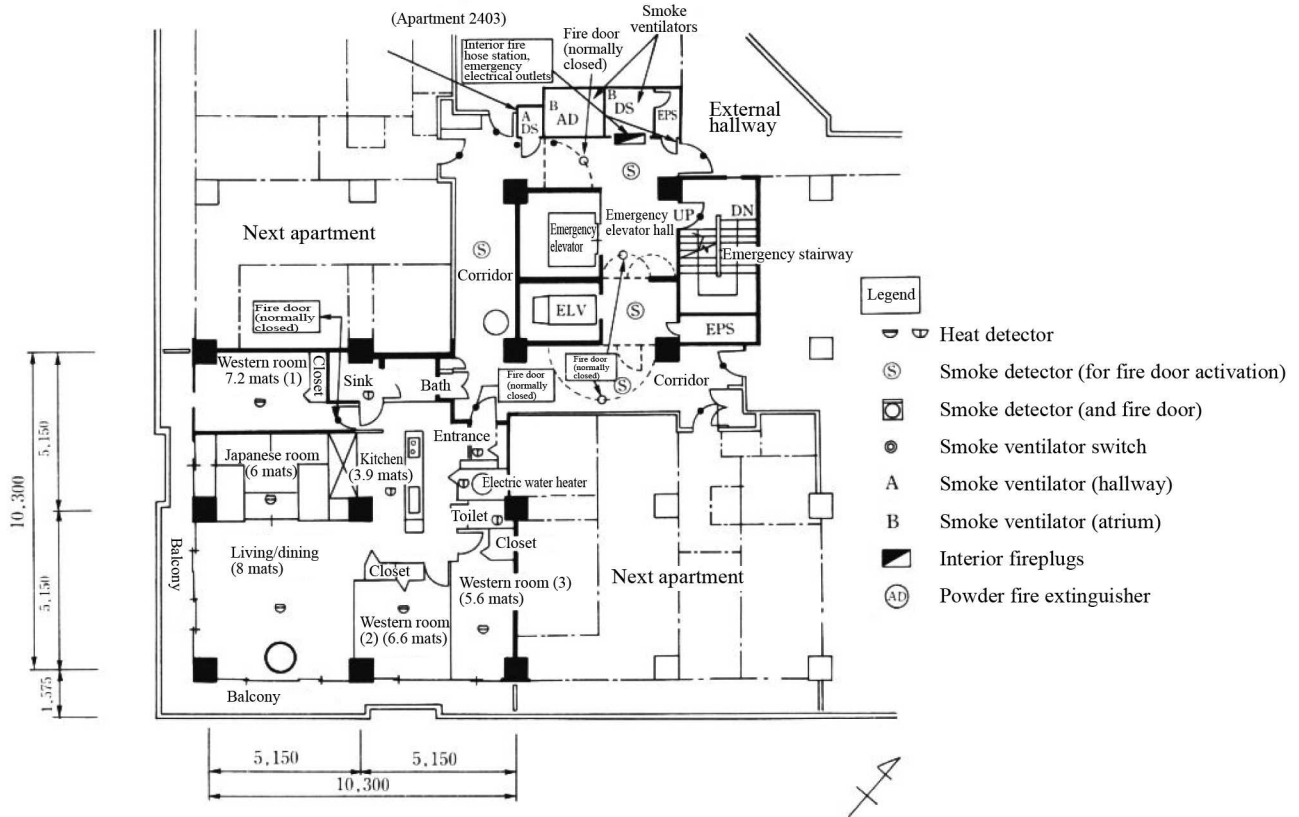
Figure 3: Floorplan of area around fire

The fire broke out toward the south side of the living room of room 2403 (4LDK) on the 24th floor. It came from the around and audio set. A small (3-year old) girl was in the room at the time, noticed the fire, and tried to tell somebody. She fell from her chair, however, and lost consciousness.

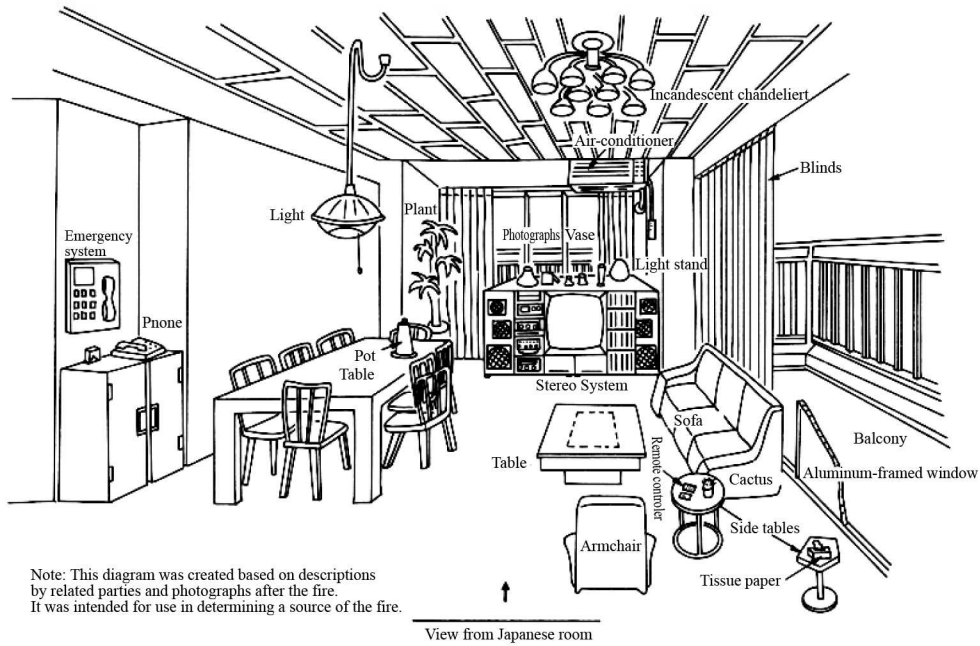
Figure 4: View of room before fire

The fire broke out in the vicinity of an interior audio set. The cause, however, is unclear.

Note: This diagram was created based on descriptions by related parties and photographs after the fire. It was intended for use in determining a source of the fire.
