Fire Investigation Report of Club “Santika” in Bangkok

Kyoichi Kobayashi

*Center for Fire Science & Technology, Research Institute for Science & Technology,
Tokyo University of Science, Japan*

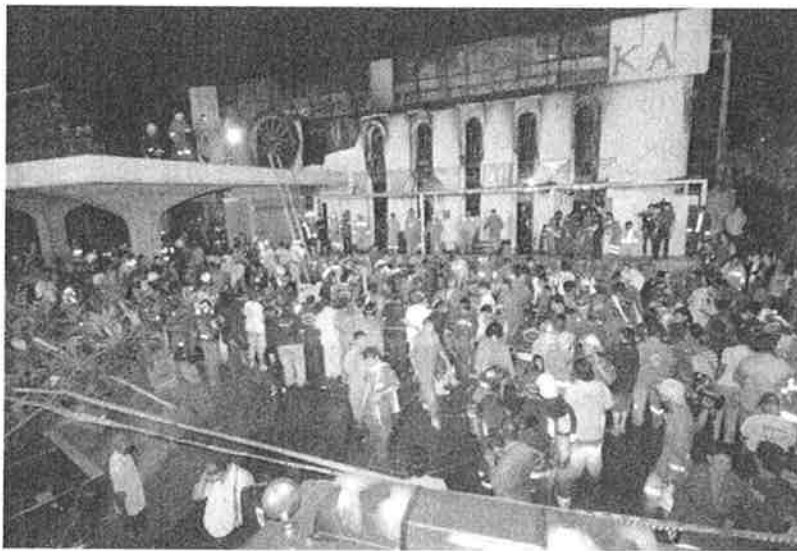
Before dawn on January 1, 2009, a fire broke out and killed 66 people at Club “Santika” in Bangkok, Thailand (*Image 1*).

Image 1 The scene of the fire in Club "Santika"

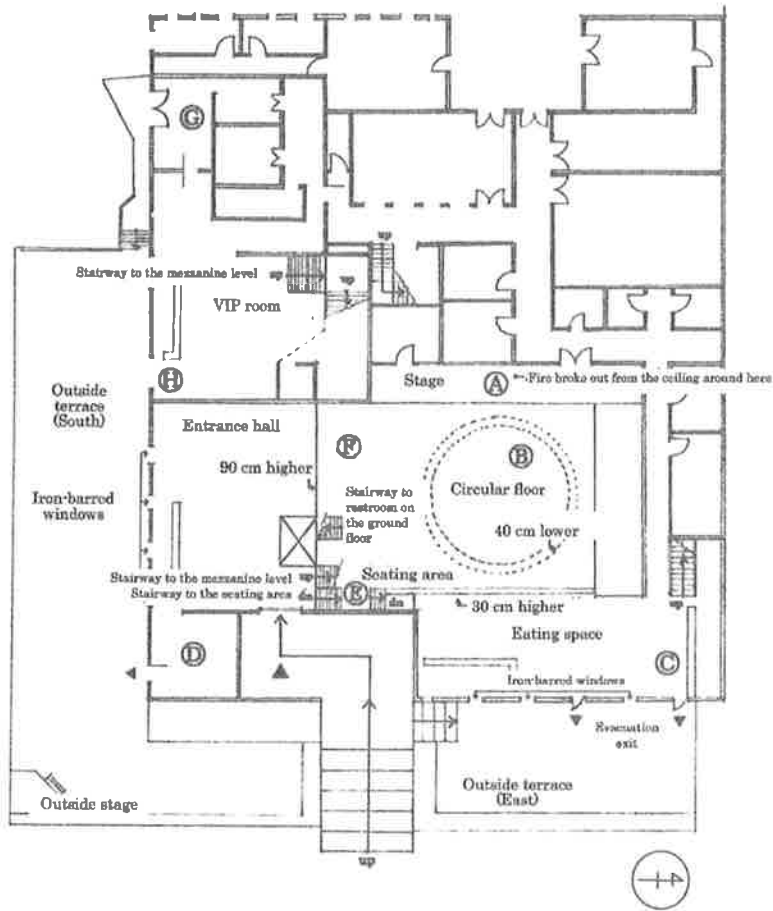
Figure 1 Floor plan of 1F in Club "Santika"

It was at midnight of New Year’s Eve and the guest area (*Figure 1* ㉔) was packed full with about 400 people of pairs and groups who were excited about celebrating the New Year together. The club also had a stage and seating area in the terrace on the south side. Thus the club was crowded with almost 1,000 people both indoor and outdoor. In such a fully-packed condition, countdown to the New Year started. Firework display began on the stage and guests were also given sparklers. The movie posted on YouTube shows people swinging around sparkles together just before the fire broke out.

Reportedly, the cause of the fire is that fireworks displayed on the stage ignited combustible material near the ceiling (*Figure 1* ㉓).

Except for the main entrance, there were two major evacuation routes from the guest area that had exits of 70 cm wide each leading to the terrace on the east side (Figure 1 ©).

Also there was a lobby by the front door next to the entrance hall that led to the terrace on the south side (Figure 1 ①). Some escaped through this way and it also worked for rescue efforts.

One of them was VIP room at the back of the stage. There is a wall between VIP room and the entrance hall or the seating area on the plan, but actually the wall between VIP room and the seating area was left open (Figure 1 (F)).

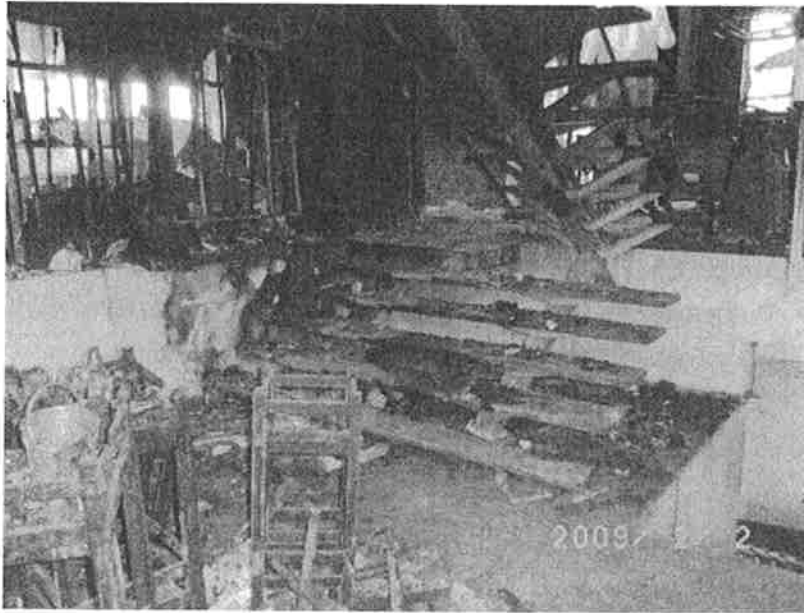
(iii) The passage from the seating area to the entrance hall was limited and narrow because it was blocked by stairway to the mezzanine level. It had enough space for ordinary use but must have been a bottleneck in the case of a mass evacuation.

Because of the above mentioned reasons, evacuees fell over one on top of another at the space going up into the entrance hall and the largest number of victims died here.

Image 2 Stairway from the seating area to the entrance hall (Figure 1 (E))
