Building Name Address	Use (as per FSA Annexed Table 1)	Date and Time of Incident	Structure and Stories Area	Extent of Damage (Damaged Area/ Total Area)	No. of Casualties
Yurakucho Building	Complex (16) a	March 13, 1968	Fire resistive 12 stories above ground and 5 below	All, Half, Partial, Small 34 m ² (%)	Fatalities 3
		Breakout at 12:41 (approx.) Notified at 12:46 Notified by emergency call Extinguished by 13:33			
1-5 Yurakucho, Chiyoda-ku, TOKYO		Total floor area 41,936 m ²

I. Summary of Fire Incident								
(1) Summary (2) Conditions per Floor	The fire originated from a sauna house, a facility which became very popular in Japan following the Tokyo Olympics. Although the fire itself was relatively small, it resulted in 3 fatalities because of the unique structure of the sauna room and the heavy smoke that obscured the evacuation route.							
	FL	Total area	Damaged area	Use (Purpose)	No. of persons	No. of fatalities	Fire escape equipment	Firefighting equipment
PH	m ²	m ²						
12	361.0						Inside stairs 5 sets of 4 sets of fire escape equipment (on each floor from 2nd to 5th floors) 5 sets of escape chutes (on each floor from 6th to 10th floors)	48 sets of indoor fire hydrant

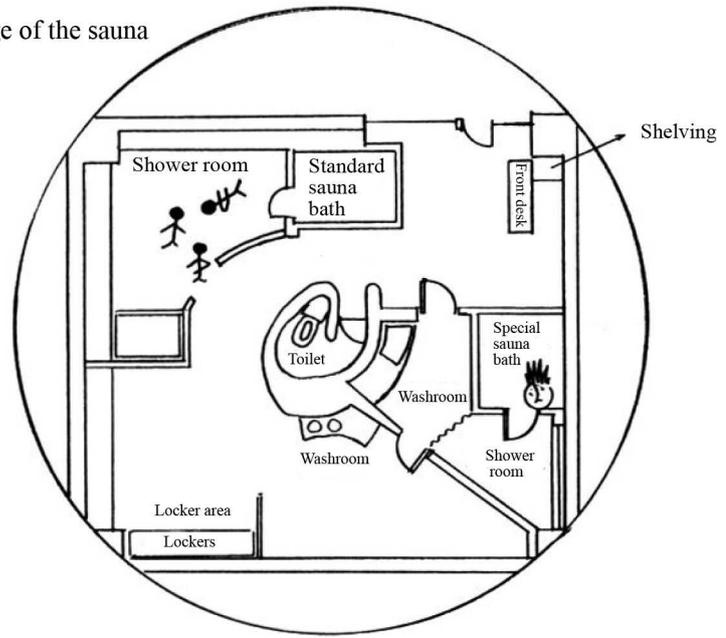
Enlarged image of the sauna

(3) Origin of Fire	<p>(Floor, Room, Part, Combustibles, Habitable/Non-habitable Rooms, Present/Absent)</p> <p><u>The fire emerged from the sauna house on the 2nd floor (Yurakacho Sauna)</u></p> <ul style="list-style-type: none"> ○ The sauna room was made of combustible materials such as spruce lumber and phenolic foam material. There was a sauna heater (200 V, 4 kW) placed under the seating bed. ○ When the fire emerged, there were 3 guests in the locker area of the sauna house. 	(4) Cause of Fire	<p>The cause of the fire is believed to be smokeless ignition that started from the wooden seating bed that was placed too close to the sauna heater. The wooden materials became very dry because the sauna heater was turned on for a long time at a temperature of 120 °C while there were only a few people using the sauna.</p>
---------------------------	---	--------------------------	--

(5) Fire Propagation Path	<table border="1" style="width: 100%; border-collapse: collapse;"> <tr> <td style="width: 33%; text-align: center;">(Location of Fire Source)</td> <td style="width: 33%; text-align: center;">(Propagation from Source)</td> <td style="width: 33%; text-align: center;">(Propagation to Adjacent Rooms)</td> </tr> <tr> <td style="text-align: center;"> <div style="border: 1px solid black; padding: 5px; width: 90%; margin: auto;"> Wooden portion above the heater in the sauna room on the 2nd floor </div> </td> <td style="text-align: center;"> <div style="border: 1px solid black; padding: 5px; width: 90%; margin: auto;"> Spread to the interior materials, walls and ceiling of the sauna room </div> </td> <td style="text-align: center;"> <div style="border: 1px solid black; padding: 5px; width: 90%; margin: auto;"> Through the vent of the sauna room and the combustible walls, the fire spread to the ceilings of the washstands and the front desk of the sauna house </div> </td> </tr> </table>		(Location of Fire Source)	(Propagation from Source)	(Propagation to Adjacent Rooms)	<div style="border: 1px solid black; padding: 5px; width: 90%; margin: auto;"> Wooden portion above the heater in the sauna room on the 2nd floor </div>	<div style="border: 1px solid black; padding: 5px; width: 90%; margin: auto;"> Spread to the interior materials, walls and ceiling of the sauna room </div>	<div style="border: 1px solid black; padding: 5px; width: 90%; margin: auto;"> Through the vent of the sauna room and the combustible walls, the fire spread to the ceilings of the washstands and the front desk of the sauna house </div>

<ul style="list-style-type: none"> ○ Main Reasons for Propagation of the Fire <ul style="list-style-type: none"> ○ The interior materials were combustible and dry, which accelerated the spread of the fire. ○ There was no fire compartment in the sauna room. ○ Smoke Propagation Path <ul style="list-style-type: none"> ○ The sauna room was filled with noxious fumes produced by from the phenolic resin of the spruce lumber and foam material, and the fumes propagated through the vent throughout the sauna house. 														
II. Summary of the Building

IV. Issues and Lessons Learned		
<ol style="list-style-type: none"> 1. Saunas should be partitioned by a smoke- and fire-preventive compartment. 2. The nature of a sauna requires insulation, and as such, the sauna was made of many combustible materials such as spruce, plywood, and phenolic foam in places where no metal cannot be used, and the inside of the sauna was kept at high temperature and low humidity. In such conditions, placing a sauna heater under the seating bed was careless from the aspect of fire safety. 3. The size of the sauna house was relatively small and only 2 female employees were handling the business, which inevitably affected their attention to fire safety matters. Therefore, each tenant needs to review the purpose of fire prevention and the necessary measures according to business type. 4. Individuals who had evacuated returned to the fire room in order to salvage their belongings and died because of this action. It is necessary to remind people that such action is highly dangerous. 5. To be able to detect a fire at an early stage, all kinds of sauna rooms should have a fire detector installed.

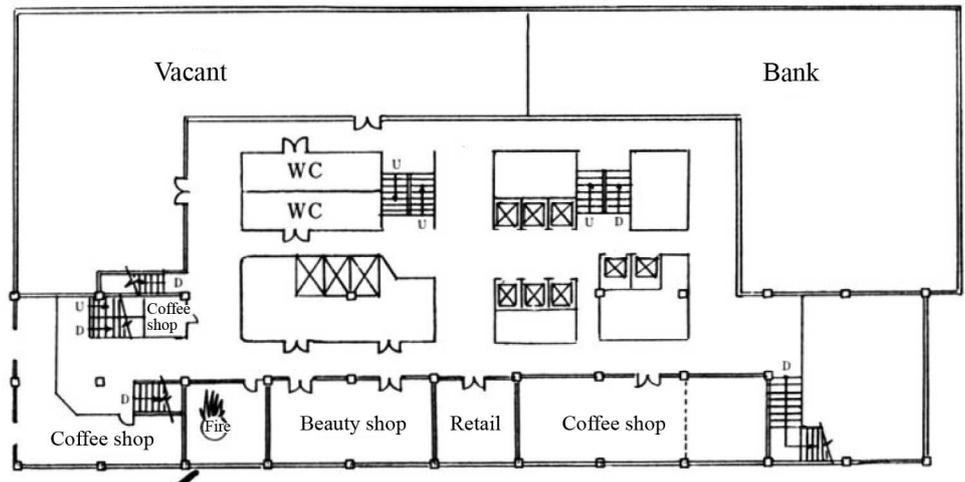
Yurakucho Sauna

(Location of Fire Source)	(Propagation from Source)	(Propagation to Adjacent Rooms)											
	<div style="border: 1px solid black; padding: 5px; width: 90%; margin: auto;"> Wooden portion above the heater in the sauna room on the 2nd floor </div>	<div style="border: 1px solid black; padding: 5px; width: 90%; margin: auto;"> Spread to the interior materials, walls and ceiling of the sauna room </div>	<div style="border: 1px solid black; padding: 5px; width: 90%; margin: auto;"> Through the vent of the sauna room and the combustible walls, the fire spread to the ceilings of the washstands and the front desk of the sauna house </div>											
<p>In the special sauna room, the fire emerged from the upper part of the heater and spread to the combustible interior materials (walls and ceiling). The spread of the fire was facilitated by the wooden rafters, plywood walls, and ventilation openings and reached the ceiling of the washstands and front desk.</p>
