Building Name Address	Use (as per FSA Annexed Table 1)	Date and Time of Incident	Structure and Stories Area	Extent of Damage (Damaged Area/ Total Area)	No. of Casualties
Kobe Department Store	Department store	Feb. 17, 1974	Fireproof structure,	All, [Half] , Partial, Small	Fatalities 1
		Breakout at 23:52 (approx.)	7 stories above ground and 1 below		
5-5-12 Udezuka, Nagata, Kobe, HYOGO		Detected at 03:59	Building area 1,861.6m ²	7,090 m ²	Injured 40 (40)
		Notified by Extinguished by 19:32	Total floor area 16,113 m ²	(44%)

I. Summary of Fire Incident

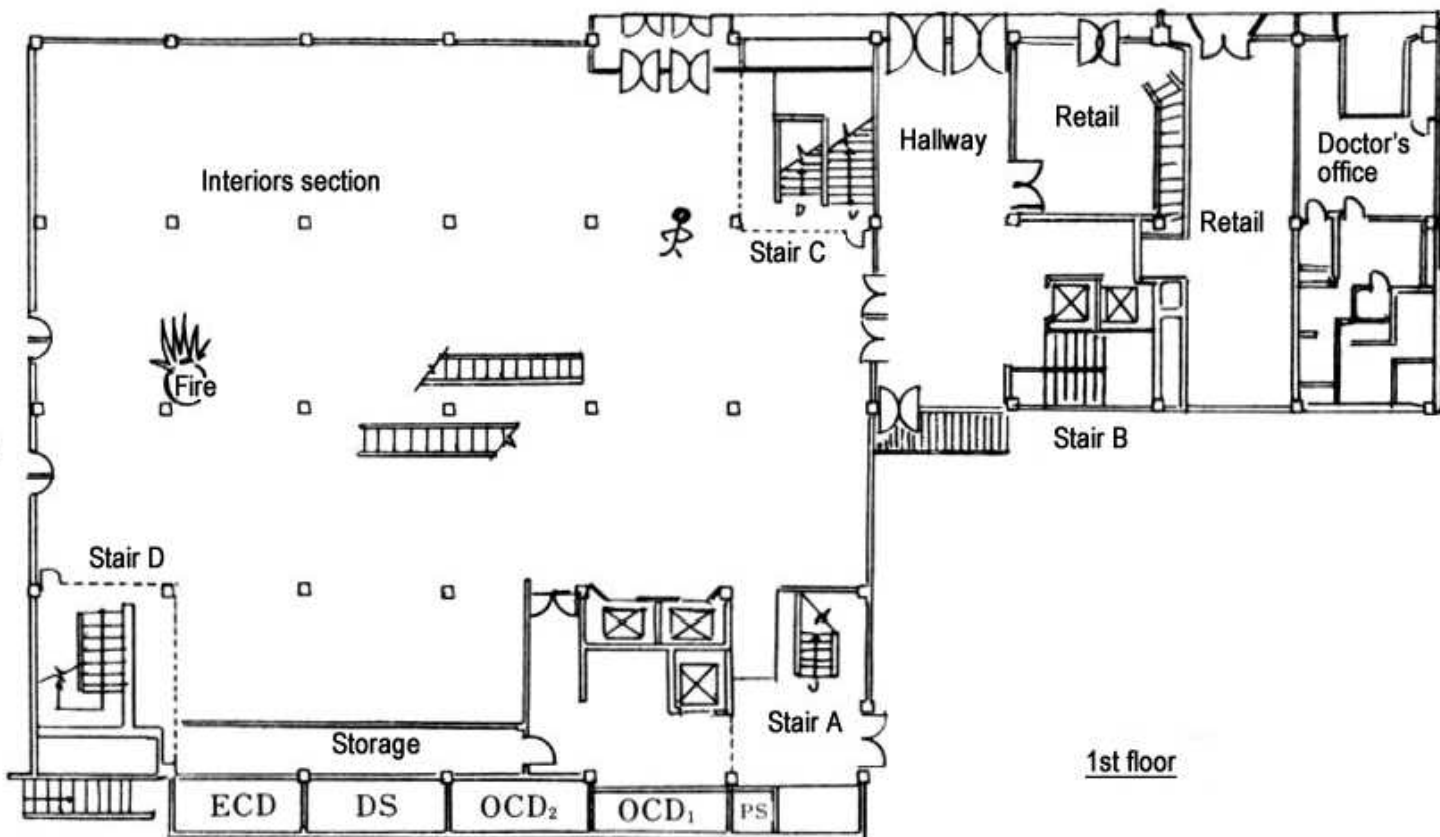
(1)		1,861.6	1,402		6	1		
B1	2,581.9			2				
Total	16,113.0	7,090		8	1			
(3) Origin of Fire	(Floor, Room, Part, Combustibles, Habitable/Non-habitable Rooms, Present/Absent)				(4) Cause of Fire	Believed to be arson or an accidental fire started by a boy (age 17) who was arrested for robbery.		
	From the interior goods section in the west-central area of the 1st floor

(5) Fire Propagation Path	<div style="display: flex; justify-content: space-around; align-items: center;"> <div style="border: 1px solid black; padding: 5px; text-align: center;"> <small>(Location of Fire Source)</small> In the west-central area of the sales floor </div> <div style="border: 1px solid black; padding: 5px; text-align: center;"> <small>(Propagation from Source)</small> Large amounts of combustible materials </div> <div style="border: 1px solid black; padding: 5px; text-align: center;"> <small>(Propagation to Upper Floors)</small> Through a faulty fire compartment around the escalator Through a faulty partition-wall construction around the duct </div> </div>	
	<p>The fire that emerged from the west-central area of the sales floor on the 1st floor ignited large amounts of combustible materials in the vicinity and then spread to the ceiling and the sales goods. From the 1st to the 2nd floor, the fire mainly propagated through a faulty fire compartment around the escalator and then spread to the 3rd and 4th floors in a similar manner. In addition, through a faulty duct space (where the unsealed opening was facing the sales floor), the fire spread directly from the 1st to the 4th and 5th floors. The fire that burned on the 3rd floor also eventually spread to these floors.</p> <p>○ Main Reasons for Propagation of the Fire The fire spread to the upper floors through faulty or incomplete structures around the escalator, horizontal shutter, and duct space. Large amounts of combustible materials including the ceiling were present.</p> <p>○ Smoke Propagation Path Through the unsealed opening of the partition wall in the duct space, heavy smoke was drawn into the duct running to the 5th floor without any exhaust connection, and therefore the smoke drifted through the louver doors and filled the 5th and 6th floors. The smoke also propagated from the open escalator where the fire compartment was incomplete.</p>
