Building Name Address	Use (as per FSA Annexed Table 1)	Date and Time of Incident	Structure and Stories Area	Extent of Damage (Damaged Area/ Total Area)	No. of Casualties
<b>Aichi Cancer Center</b>	Hospital (6) a	Feb 8, 1975	Fireproof structure	All, Half, Partial, <b>[Small]</b>	Fatalities 0
		Breakout at 22:20 (approx) Noticed at 22:24 Notified by Extinguished at 00:06 of next day	8 stories above ground and 1 below		
81-1159 Kanokaden, Chikusa-ku, Nagoya, AICHI			Building area 3,392 m <sup>2</sup>	81 m <sup>2</sup>	Injured 0 (0)
			Total floor area 16,744 m <sup>2</sup>	(0.48%)

### I. Summary of Fire Incident

The fire emerged from the machine room (81 m<sup>2</sup>) on the 1st basement floor of the hospital. The fire damaged only one room; however, the evacuation was slow and chaotic, and firefighters rescued most of the people inside. This hospital fire served to provide an opportunity to revise the evacuation plans of hospitals so that any number of physically-disabled individuals can evacuate safely.

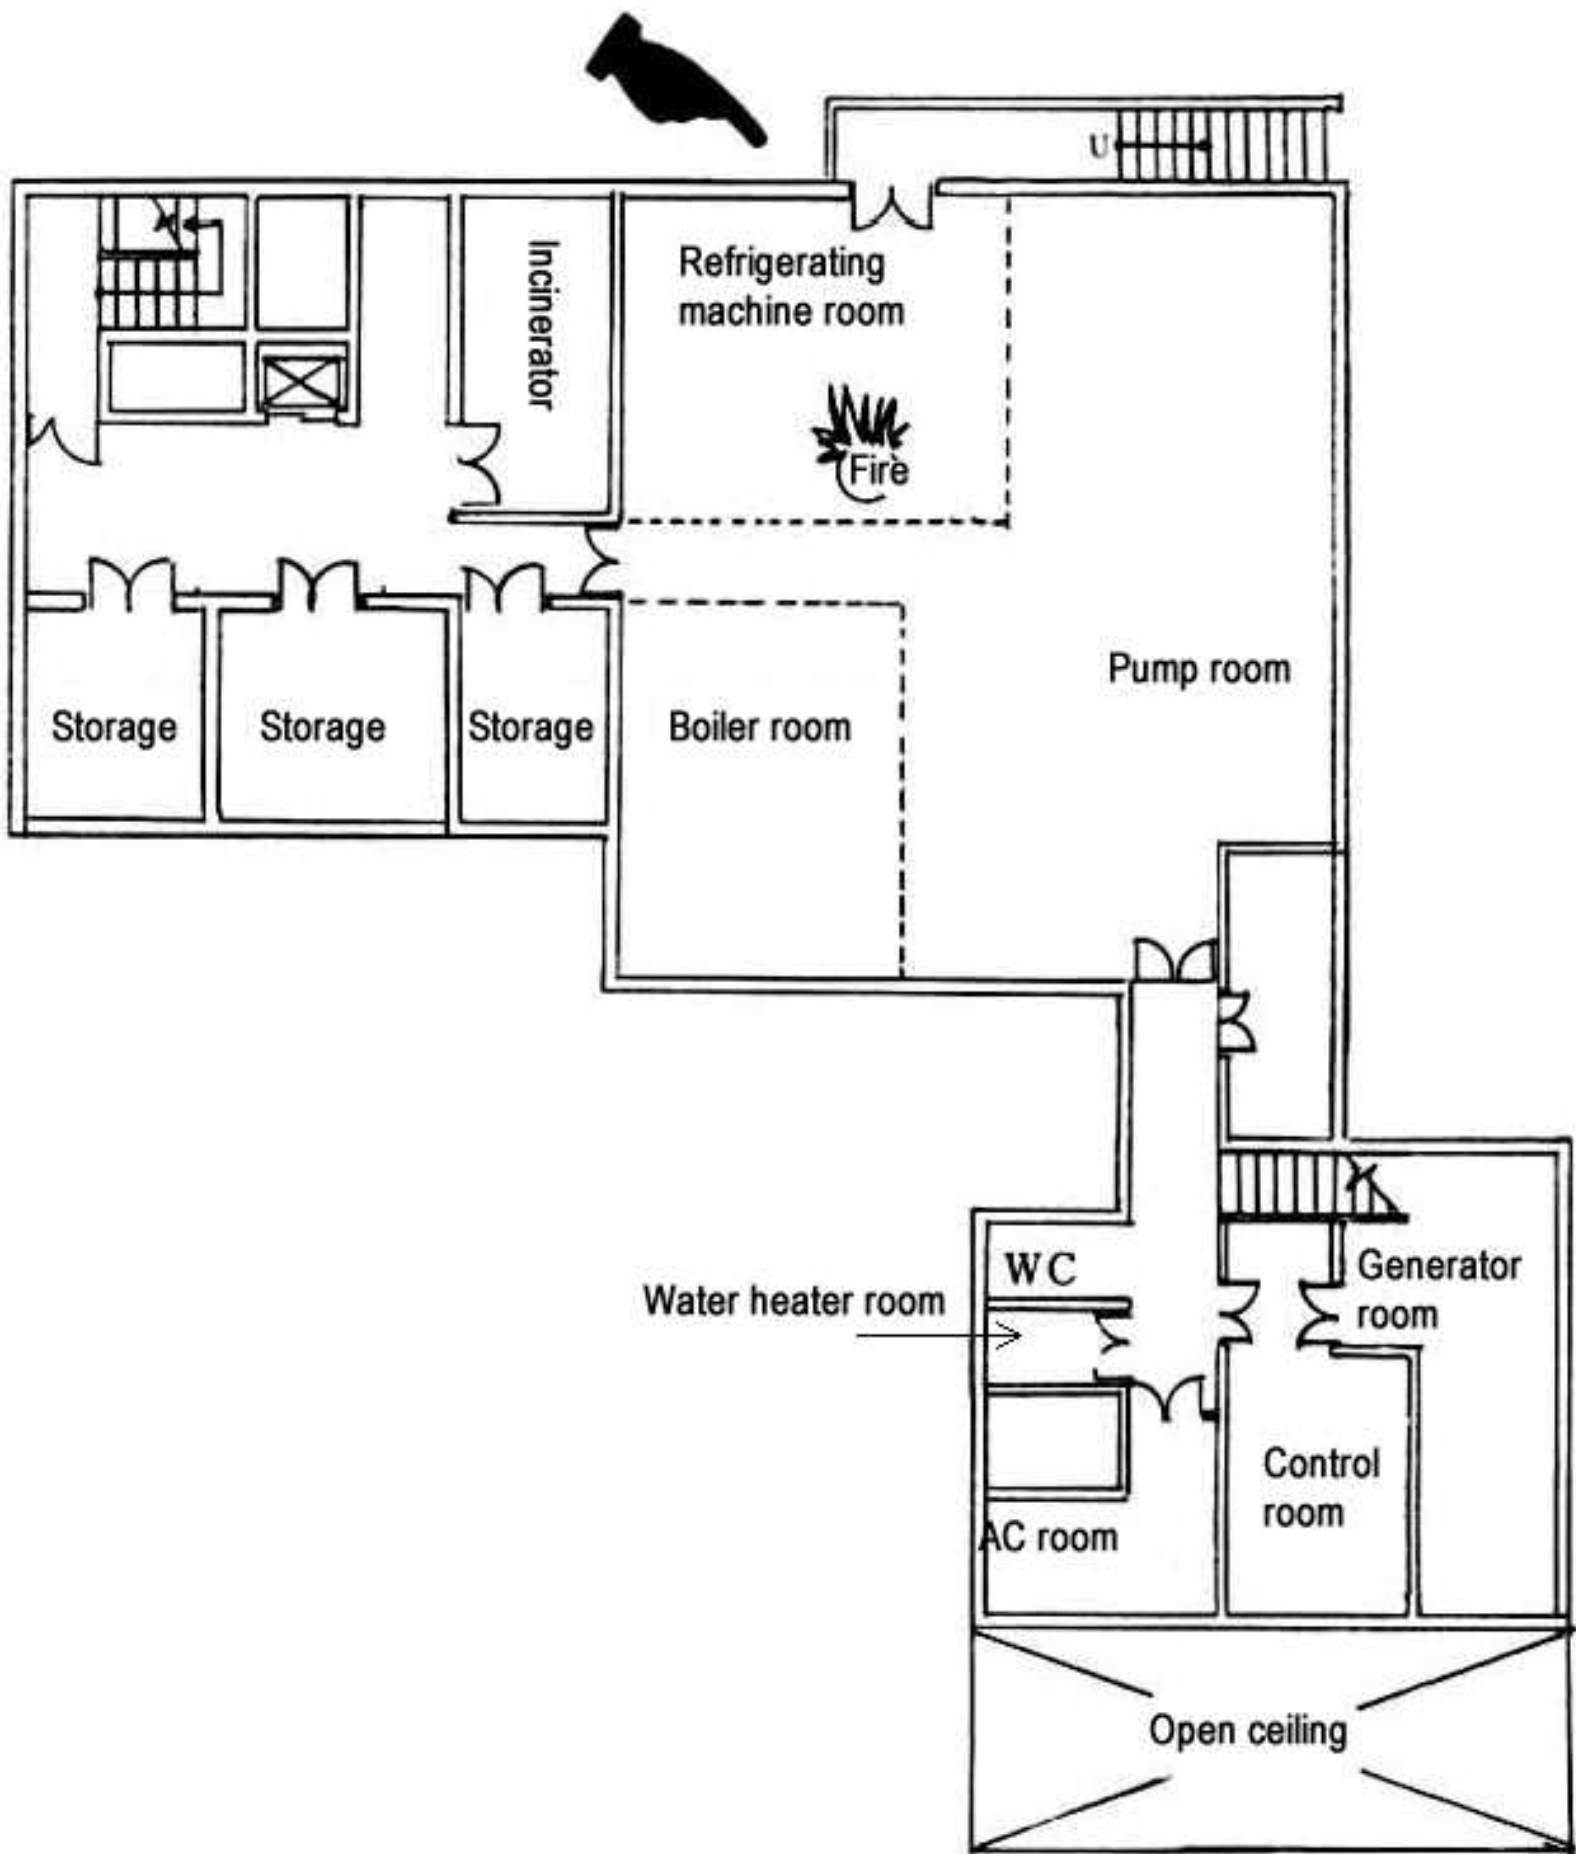
Basement floor

From the center of the machine room on the 1st basement floor	Coverings of the HVAC piping inside the room	Central stairs and east stairs											
<p>The fire burned the coverings of the HVAC piping inside the machine room on the 1st basement floor.</p>														
<p>○ Main Reasons for Propagation of the Fire</p> <p>○ Smoke Propagation Path When the fire broke out, smoke and heated air ascended the stairwell and drifted into the 5th and 7th floors where the fire doors of the central stair were open. The smoke also drifted to the east stairs through the fire door clearance. Although the condition there was not as bad as in the central stairs, the smoke made the evacuation difficult.</p>														
<b>II. Summary of the Building</b>														
<b>(1) Built</b>	Construction, Completion, and Major Renovations													
<b>Fire Prevention Management</b>	<b>(2) Vertical Shafts</b>	<b>(3) Fire Prevention</b>
