lding Name Address	Use (as per FSA Annexed Table 1)	Date and Time of Incident			Structure and Stories Area		Extent of Damage (Damaged Area/ Total Area)		No. of Casualties	
					Dec. 4, 1976		Fi re	Fire resistive					
		Kunim	atsu Building	Complex (16) a	Breakout at 00:33 (approx) Detected at 00:36 Notified by emergency call Extinguished by 02:35		3 al gi 6 1	4 stories above ground and 1 below Building area 105 m ² Total floor		All, Half, <u>Partial</u> , Small 75 m² (15%)	Fatalities 6		
			-7 Kotobashi, la-ku, TOKYO	E			Тс				Injured 3

02.35		a	area 513 m ²				(1)	
1. 9	Summa	ry of Fire In	cident										
(1) Summarv	The fire emerged from the 2nd floor of a small but typical multi-tenant building. The extent of the damage was contained within a certain portion of the 3rd floor, but the only escape route was filled with noxious smoke and the 3rd floor was an enclosed area where all the windows and exits were closed off. As a result, this fire resulted in 6 fatalitie						and the 3rd

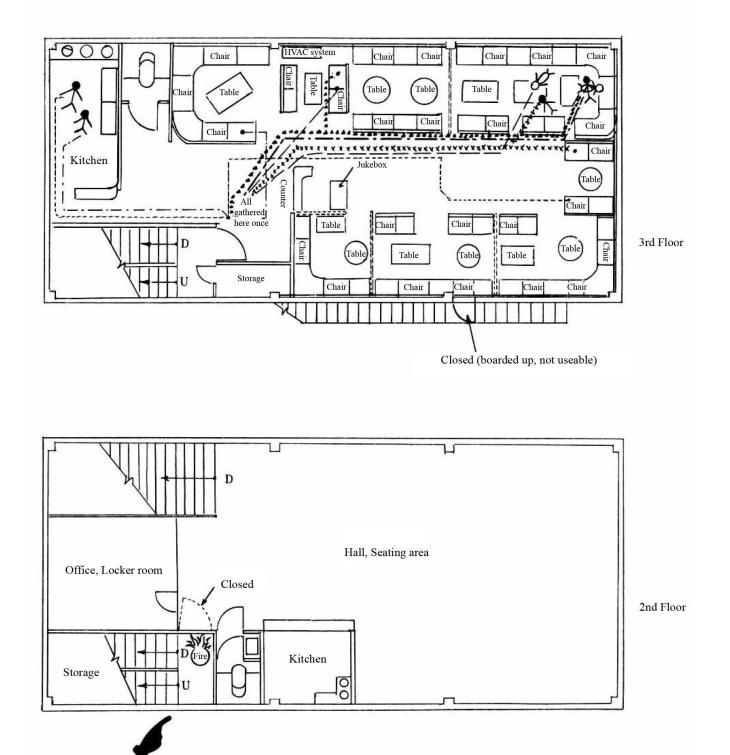
1.	The 3rd floor was windowless because all the windows on the 3rd floor were covered by mirrors, plywood, and wallpaper, including the exit to the outside stairs. Therefore, the only way to evacuate was via the stairs that were filled with flames and smoke and 6 people died.

2.	The chemical fibers used on the stairwell walls were not flame retardant and caused the fire to propagate inside the stairwell.						
3.	The wooden door to the 3rd floor was not protected by an adequate fire compartment system and therefore it became the spread path to the 3rd floor.

4.	Fire detection was delayed because there was no automatic fire detection system in the west stairwell.						
5.	<i>Utamaro</i> (hostess bar) on the 3rd floor failed to comply with the requirements for a fire-prevention manager, fire defense plan. and fire drill.
