## Fukoku Seimei Building, Chiyoda ward, Tokyo

### 1. Characteristics of the fire

The fire emerged from the electric pipe space (EPS) for cable wirings on the 3rd floor of an ultrahigh-rise building (height 120 m, 29 stories above-ground and 5 below ground).

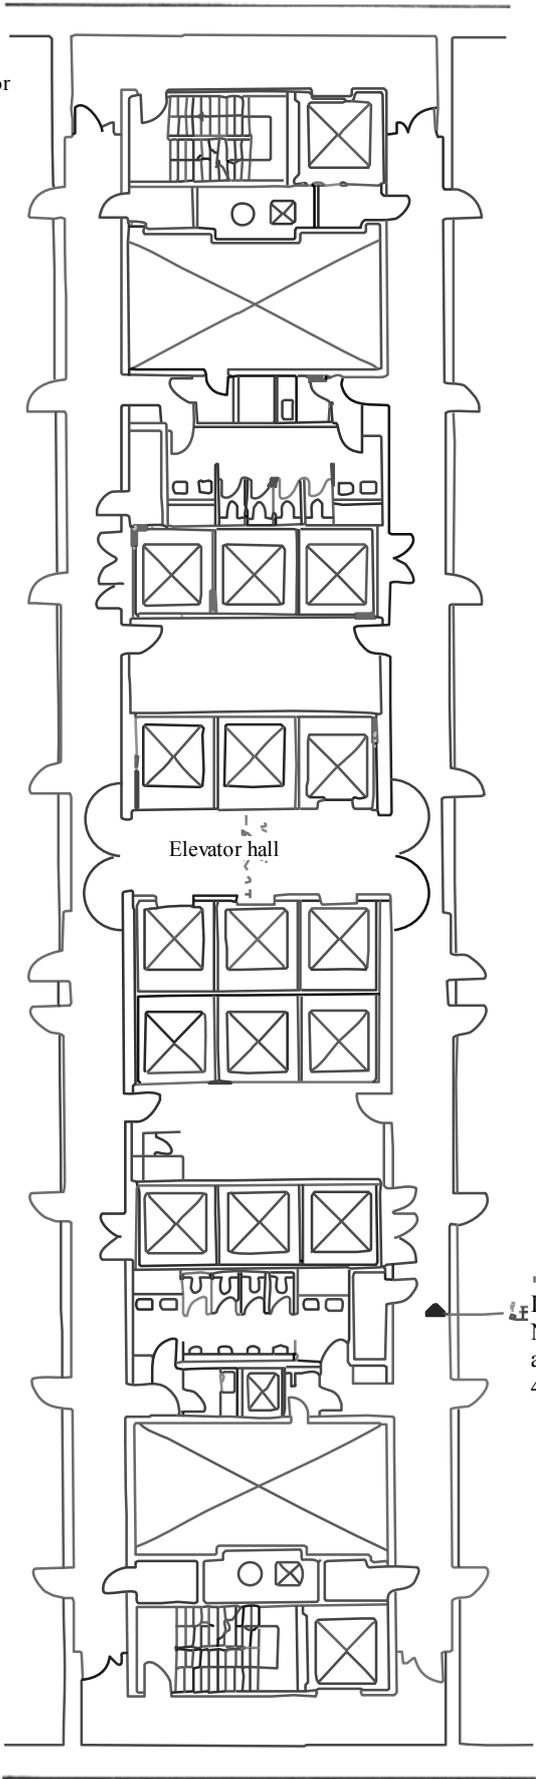
Fig. 2 Layout of the 3rd floor

A phone line shaft located in the western part of the 3rd floor of the building extended to the ceiling of the 5th floor (passing through the EPS). This shaft contained groups of cables (electric line bundles), mostly 100-volt utility F cables.

Location where the fire emerged  
Note: Since this area extends to the 5th floor and the burning was similar, the layout of the 4th and the 5th floors is omitted.

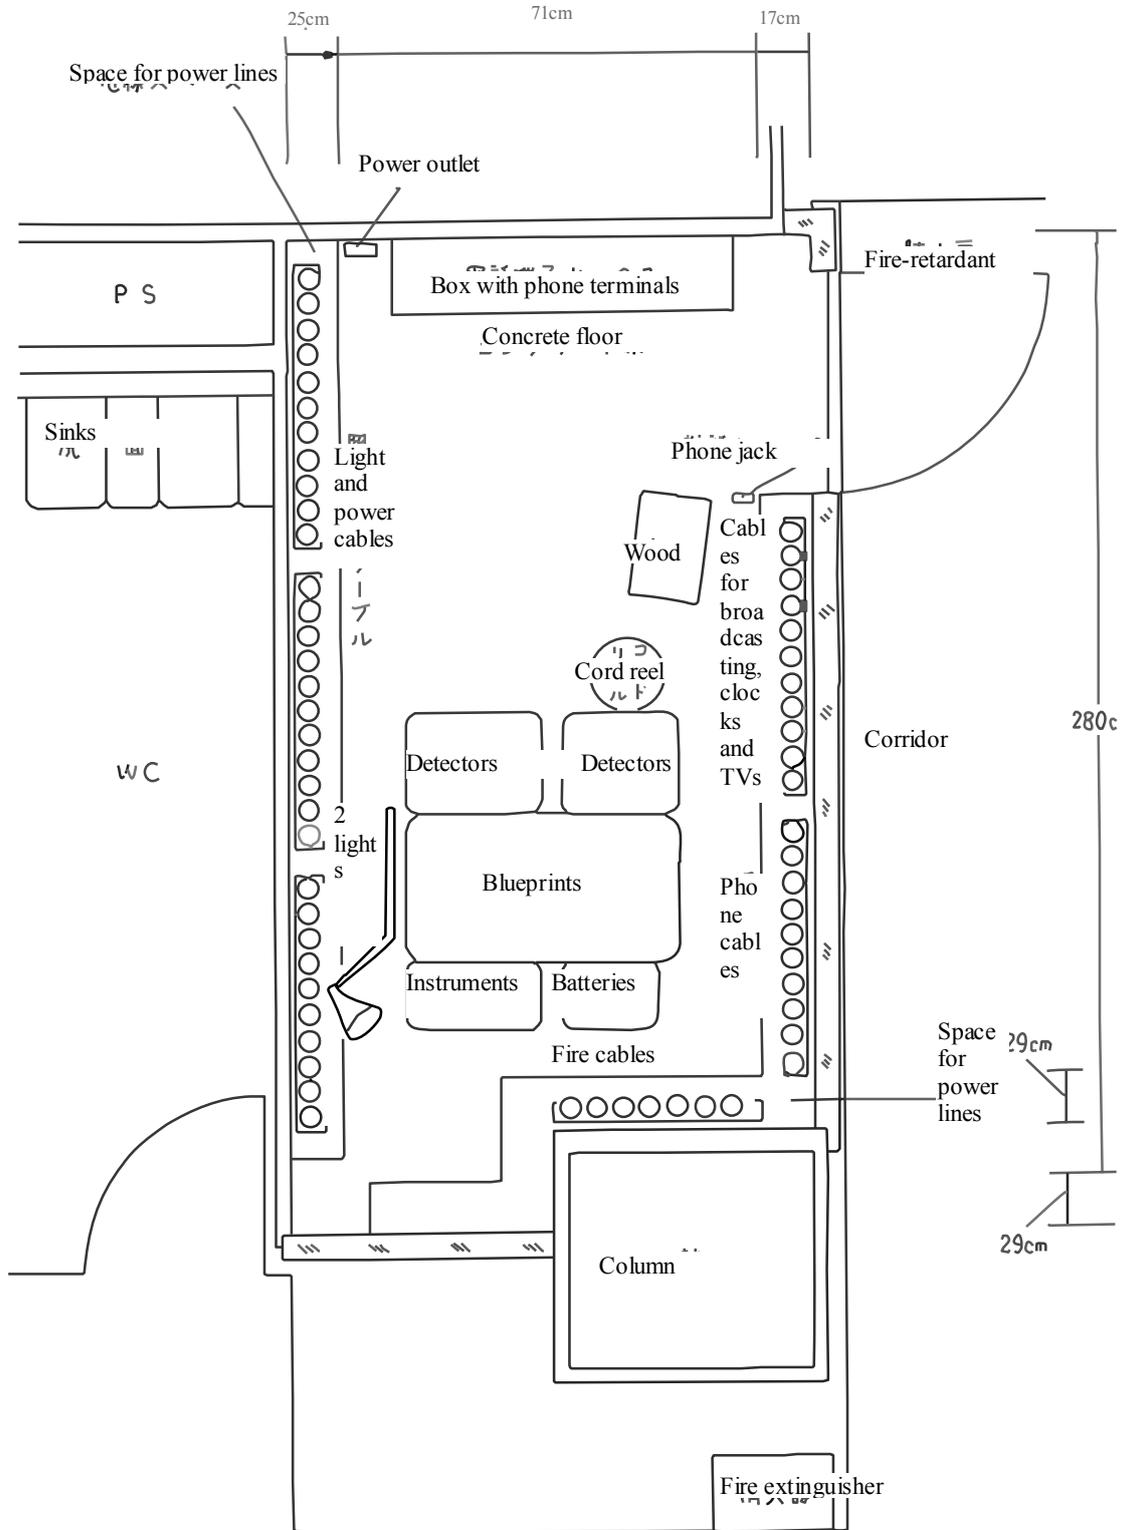
Fig. 3 Layout of the site where the fire emerged (EPS on the 3rd floor (B))

Also, workers had left smoke detectors (in cardboard boxes), wooden cleats, phone terminals, construction blueprints and Z lights in the same room.

As the shaft containing the phone cables (EPS) extended from the 3rd to the 5th floor, all cables in this space burned.

(2) Although the EPS comprised a partitioned shaft with horizontal partitioning every 6 floors, it is desirable to implement horizontal partitioning on each floor.

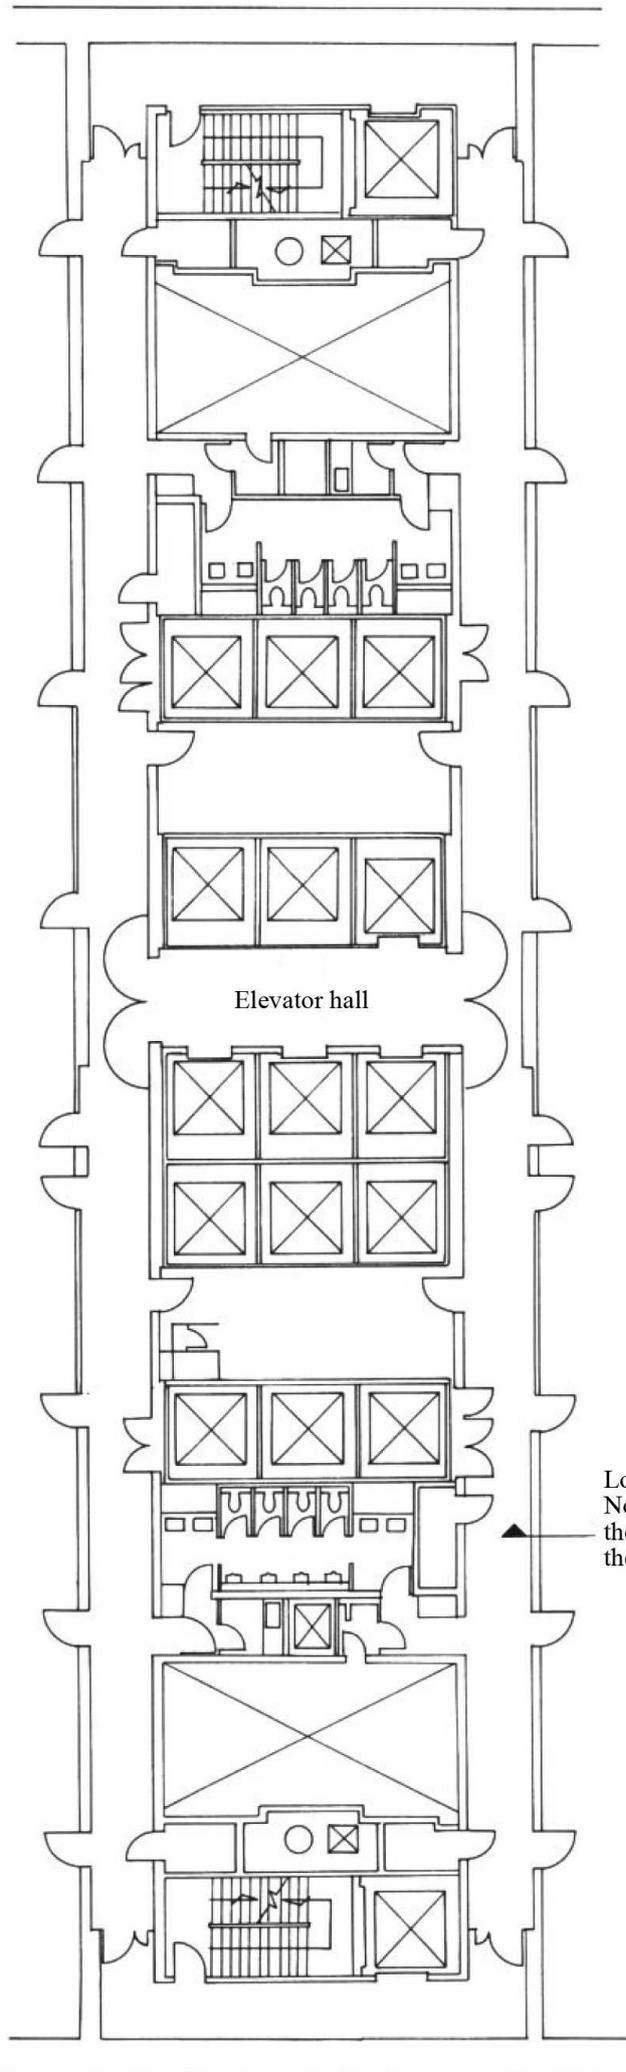
Fig. 2 Layout of the 3rd

Location where the fire emerged  
Note: Since this area extends to the 5th floor and the burning was similar, the layout of the 4th and the 5th floors is omitted.
