Kawazu-cho, Shizuoka Prefecture: Kikusui-kan

1. Characteristics of the fire

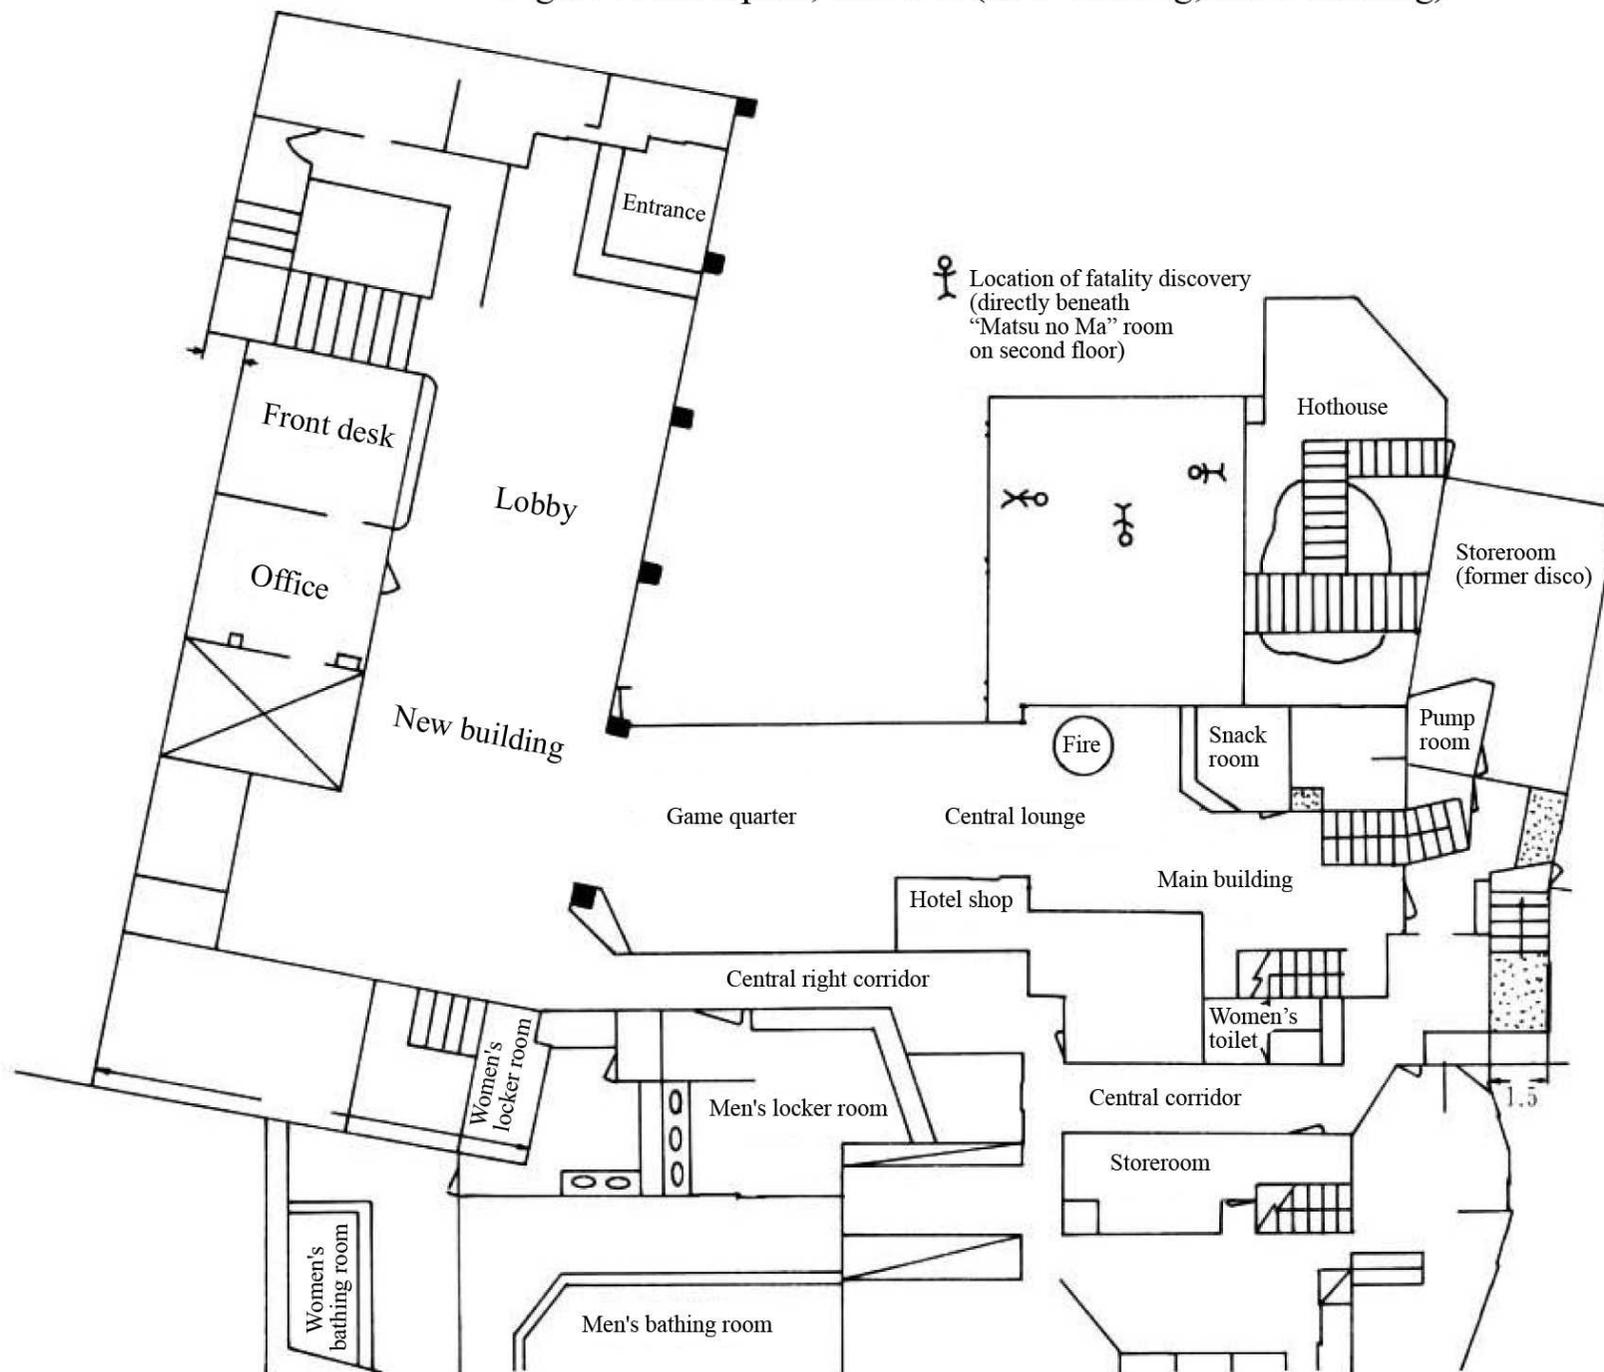
Figure 2: Floorplan, 1st floor (new building, main building)

The fire is thought to have broken out in a 1st-floor lounge, which is situated to the south of a game corner off the 1st-floor lobby. There was one gas cooking range placed on a counter within an adjacent snack room. At closing time (22:00), 2 female attendants checked the range and confirmed that it was off. Also, a security guard checked the area at around 01:00 while on his rounds and noticed nothing unusual.
