Fuji, Shizuoka Prefecture: Fussho-in

1. Characteristics of the fire

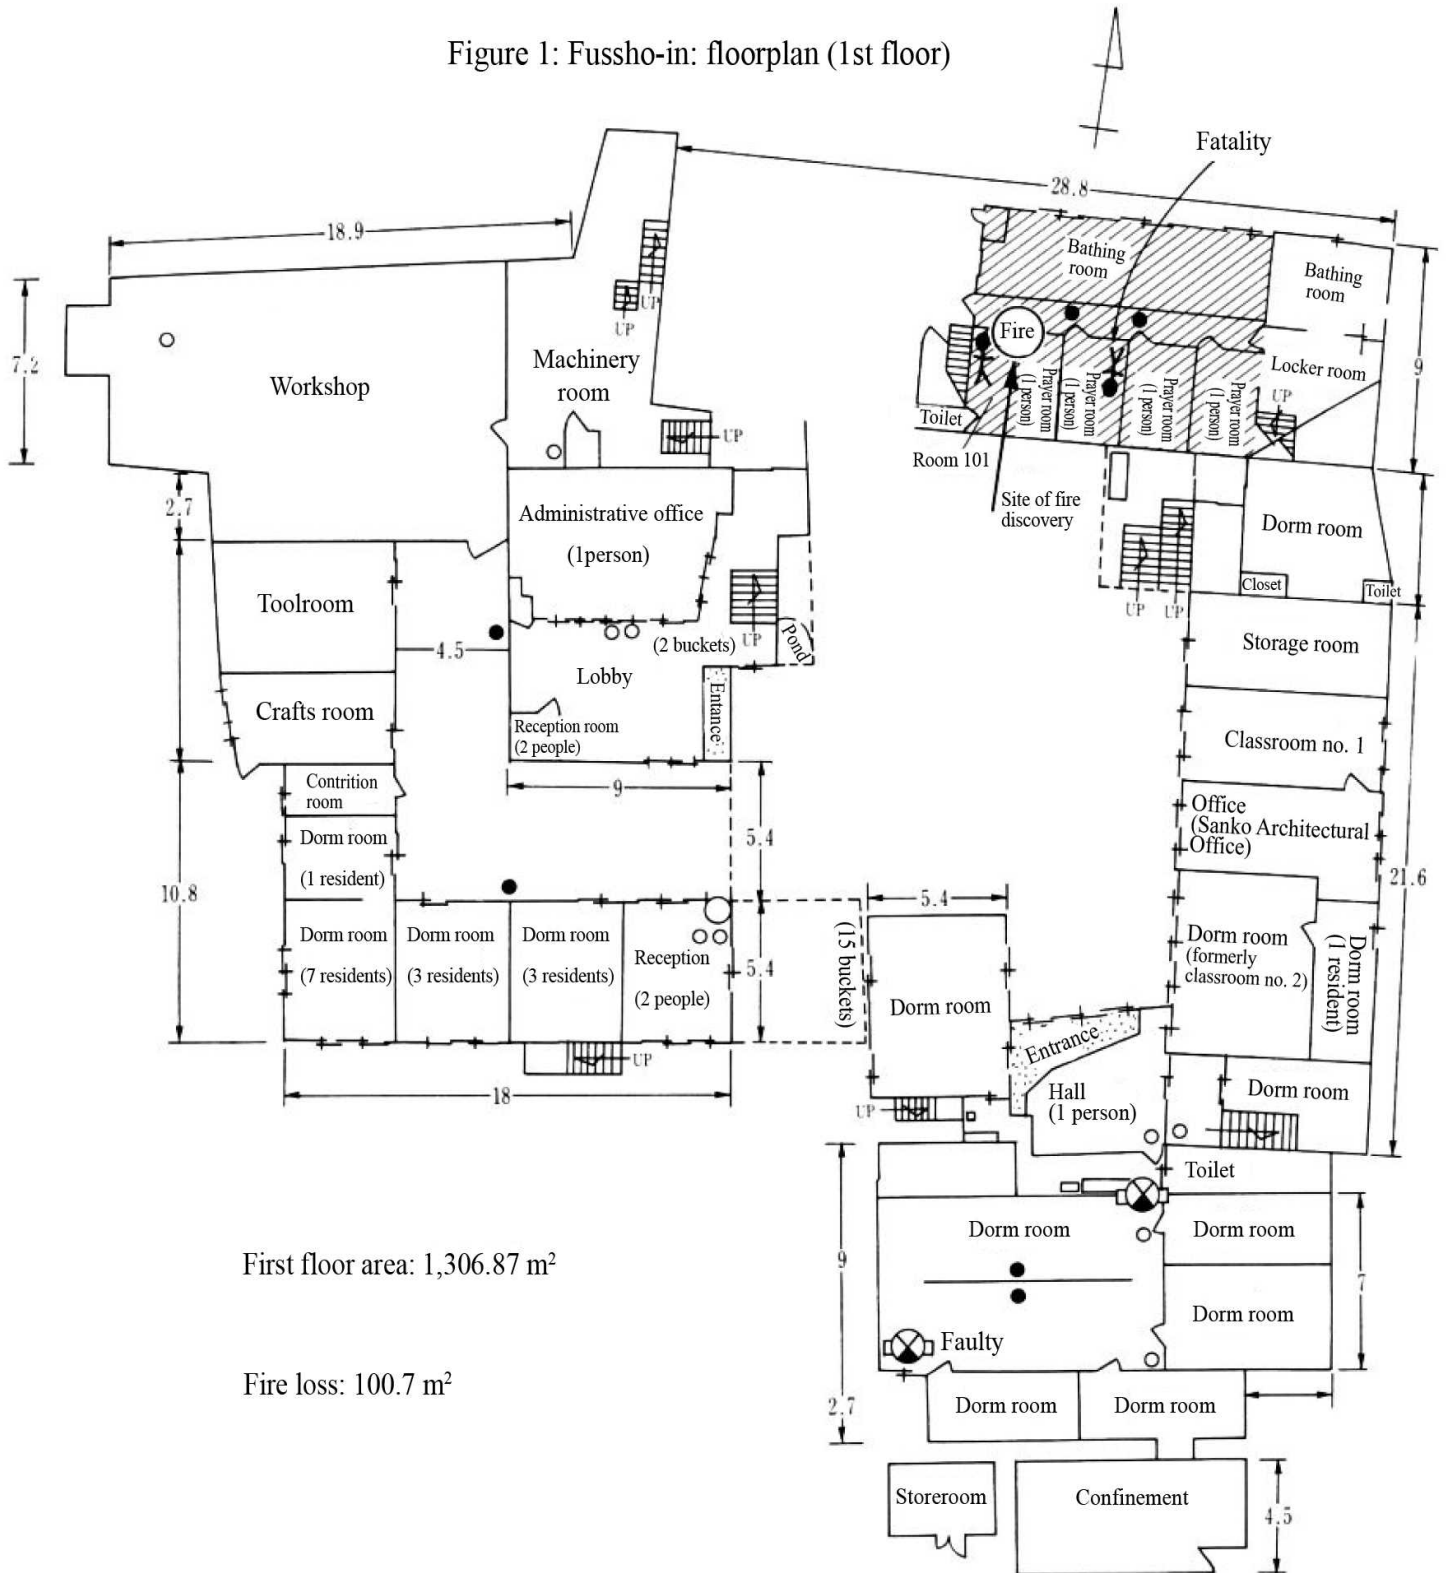
Figure 1: Fussho-in: floorplan (1st floor)

There were 4 small rooms (called “prayer rooms”) on the north side of the 1st floor. The fire broke out in the most westerly of them. Each of the rooms had only 1 door, kept locked from the outside. Each room also had a window, although it was covered with iron grating and thus prevented the occupant from going outside.

First floor area: 1,306.87 m²

Fire loss: 100.7 m²

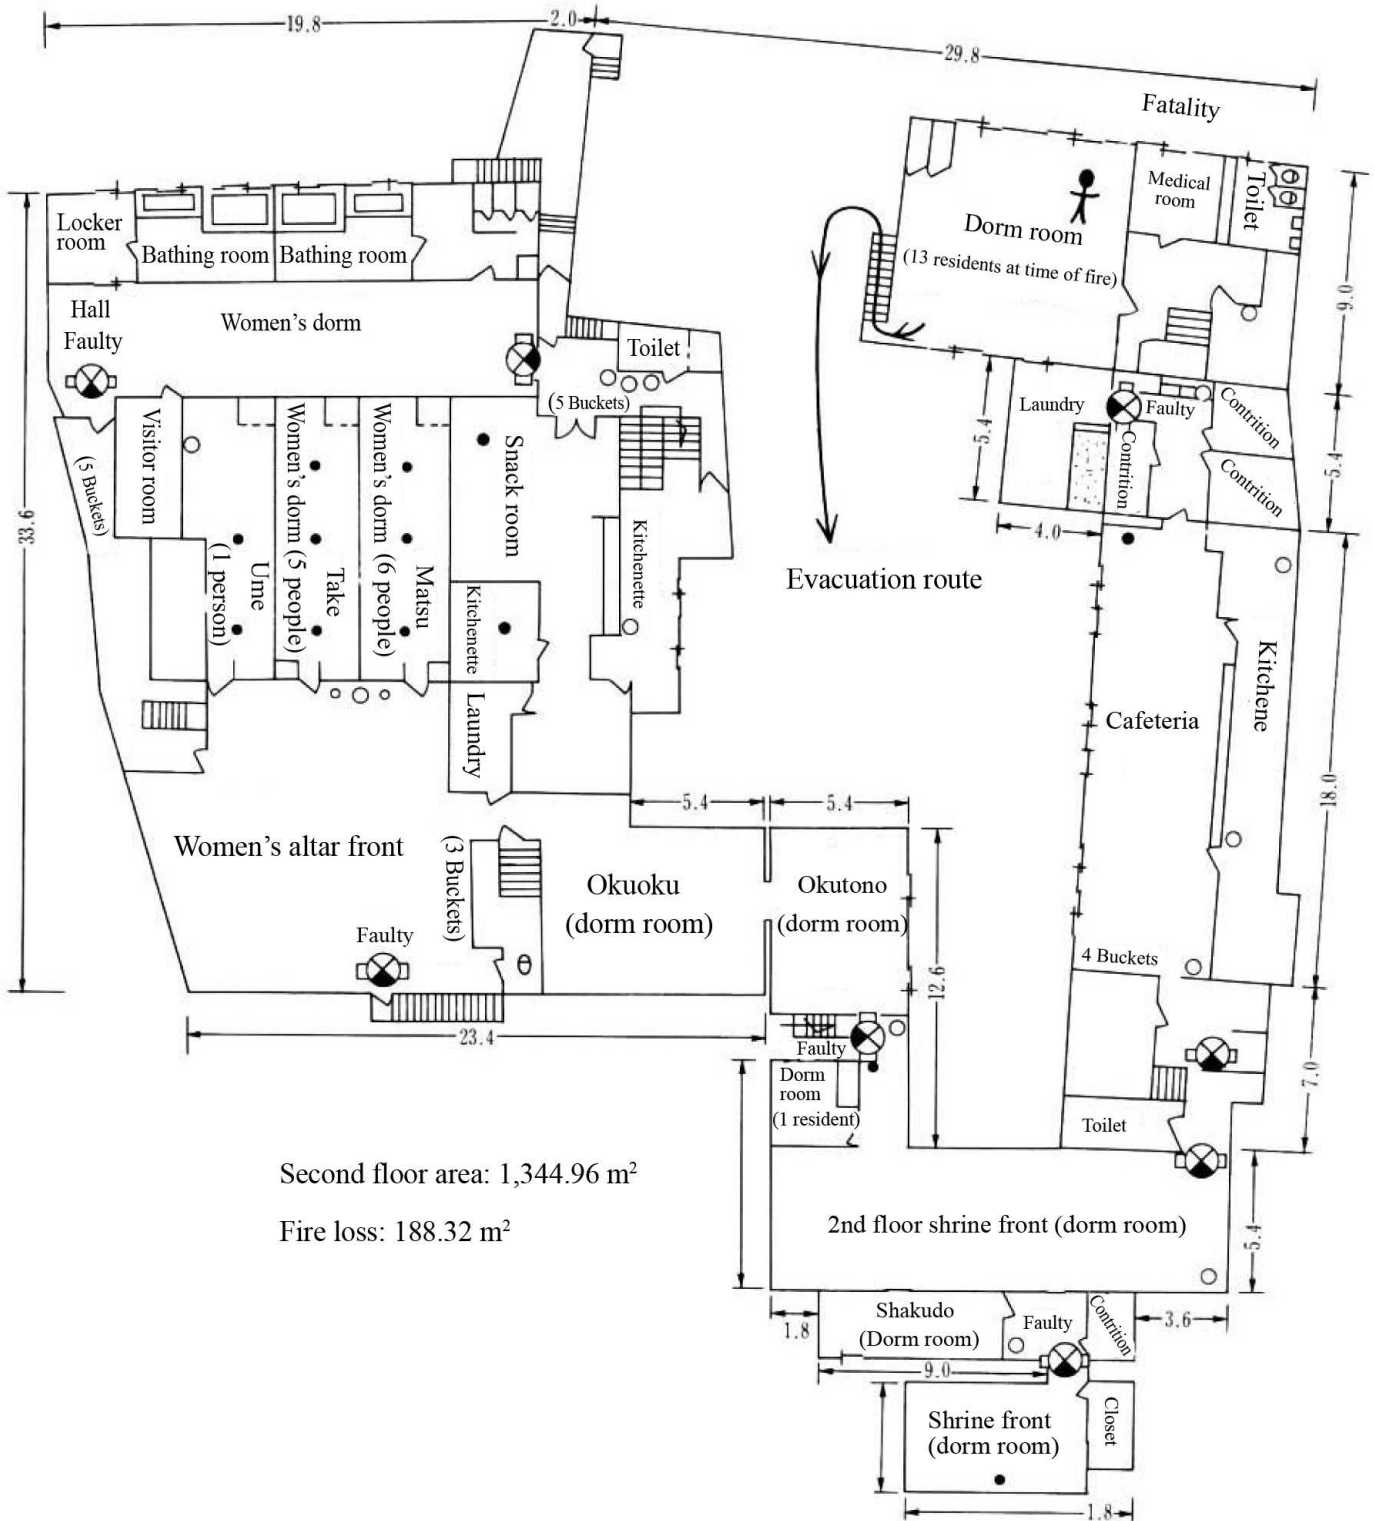
Figure 2: Fussho-in: floorplan (2nd floor)

Second floor area: 1,344.96 m²

Fire loss: 188.32 m²
