Toyonaka, Osaka Prefecture: School of Engineering Science, Osaka University

1. Characteristics of the fire

Silane gas, used as a material in the fabrication of integrated circuits (ICs), spontaneously combusted during IC fabrication experiments within a laboratory within the School of Engineering Science, Osaka University. Two students died and 5 were injured in the conflagration that followed. This incident called into question safety measures for university research facilities.

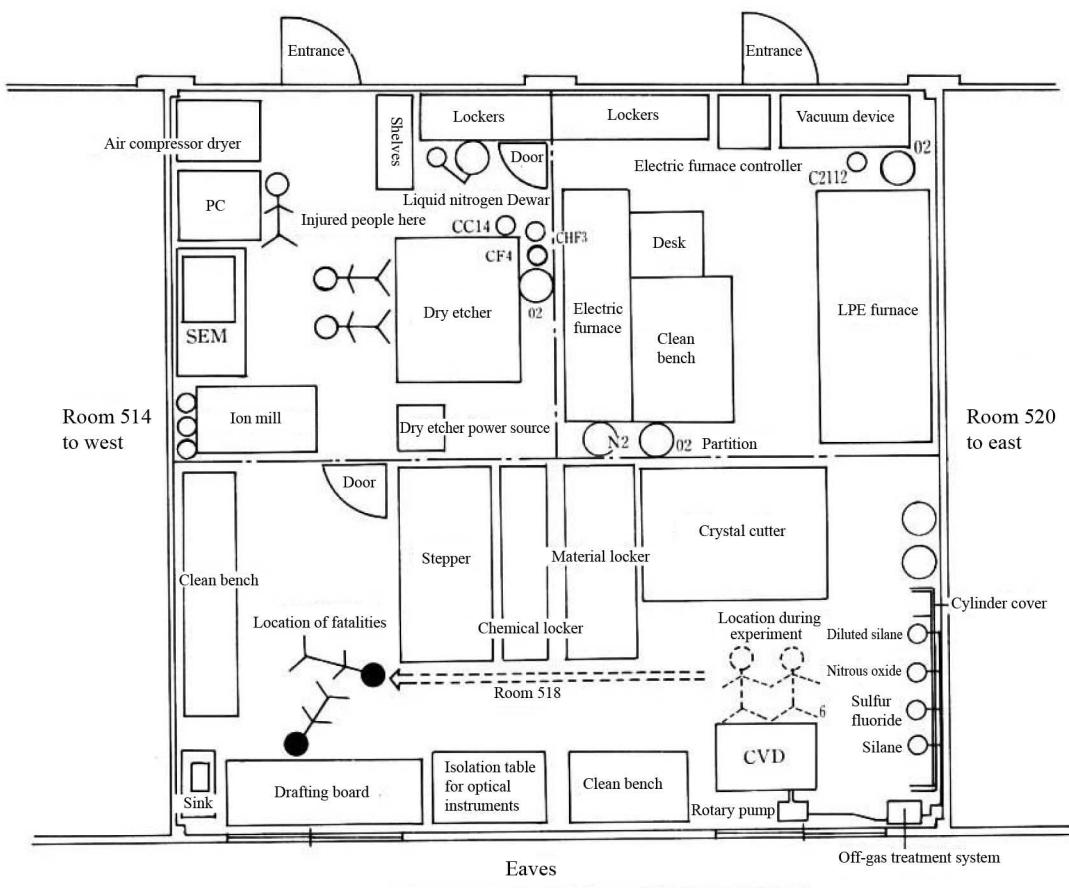
Figure 2: Laboratory floorplan

The fire occurred in Room 518, a room in Wing D partitioned into 3 laboratories (sections). Within

the room, 5 researchersassistants/students were conducting experiments, etc. Two were within the section of the explosion. Three were within another section of the room.

Five people were in room 518 when the fire broke out. As mentioned earlier, that room had been partitioned into 3 sections. Two people were in the section of the explosion, and, unable to escape, they died, presumably of burns.
