Tokyo University of Science “Research Center for Fire Safety Science”

■研究成果概要報告書/ Report for Outline of Research Results

研究課題 Research Topic		Structural Fire Performance of Earthquake-Damaged Light-wood and Light-gauge cold-formed Steel Frames	実施年度 2017
研究代表者 Research Leader	所属 Affiliation	Worcester Polytechnic Institute	
	氏名 Name	Praveen Kamath & Brian Meacham	
	e-mail	pkamath@wpi.edu	
受入担当責任者	氏名 Name	Yoshifumi Ohmiya

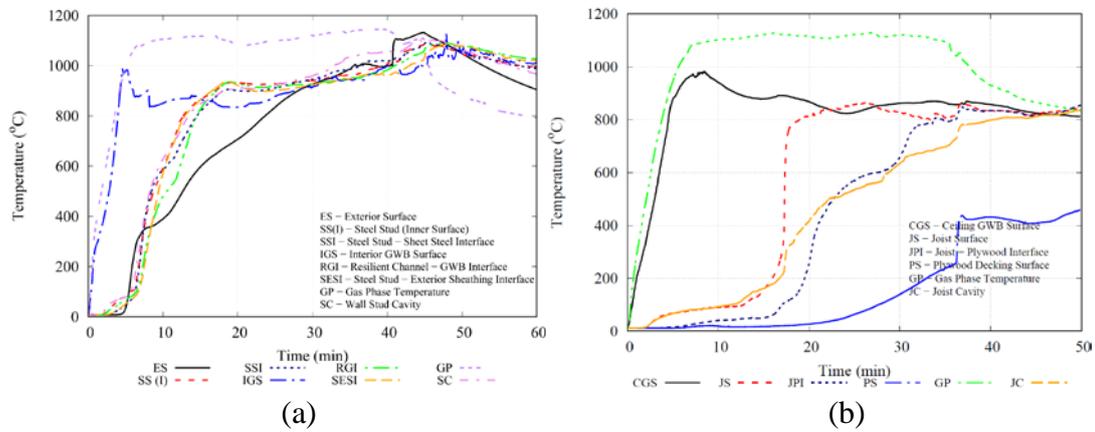
Figure 8. Thermal profiles (a) Wall B - CFS01 (b) Diaphragm - WOOD01

Figure 8 (a) shows the thermal profiles for Wall B of the test specimen CFS01. Wall B was designed as an interior shear wall, where the exposed face of the steel frame was protected by a one-hour fire rated gypsum board whereas the outer face was protected by a composite steel sheathed gypsum panel for additional shear strength. The thermal profiles on the Wall B followed a partially similar trend as compared to Wall A. The thermocouple on the gypsum surface followed the furnace temperature curve up to 1000°C and decreased thereafter, which is attributed to gypsum board releasing chemically combined water. Similar to Wall A, within two minutes from ignition, the temperature in the stud cavity started rising steadily up to around five minutes. Unlike in the Wall A, the temperature increased steeply thereafter and surpassed 800°C within 15 minutes. It is observed that the temperature in the stud cavity and the inner face of the steel stud (stud-resilient channel interface) followed a similar trend together throughout the test. The temperature at the steel-stud and sheet steel interface on the exterior of the wall also increased. The temperatures inside the wall intercepted the temperature on the gypsum surface around fifteen minutes, which shows the gypsum board is no more acting as a thermal barrier protecting the underlying steel frame. The heat on the exterior layer, which was insulated started rising as early as seven minutes and showed a gradual increase. Around 30 minutes, the different thermal profiles converged indicating a potential thermal equilibrium, that triggered the softening of steel frame and triggered the collapse. Figure 8 shows the thermal profiles obtained in the diaphragm of the dimensional lumber test specimen WOOD01. Similar to all the other panels, Figure 8 includes the furnace T-t curve. The temperature on the ceiling gypsum board followed the trends of the furnace T-t curve for the initial phase of temperature rise within the furnace. The temperature on the exposed face of the ceiling gypsum board decreases after reaching a peak temperature of over

900°C, which is attributed to the release of chemically combined water

. It may also be observed that the thermal profiles on the diaphragm resemble the thermal profiles on Wall B. The temperatures on the exposed bottom face of the joist remained under 200°C for at least 15 minutes, which shows that no charring initiated in the joist for the initial 15 minutes. Thereafter, the temperature on the bottom face of the joist showed a steep rise, which indicates a potential fall-off of the gypsum board from the ceiling. Fall-off of the ceiling gypsum board is further evident from the rise of the temperature in the joist cavity. Furthermore, the temperature at the interface of the joist and the decking plywood starts rising steadily around 20 minutes. The temperature on the surface of the decking plywood does not show any increment for the first 20 minutes from the start of the test. Thereafter, the temperature increases slowly. The temperature reaches around 250°C at around 35 minutes, and shows an abrupt rise at around 36 minutes, which also corroborates with the failure of the test specimen.

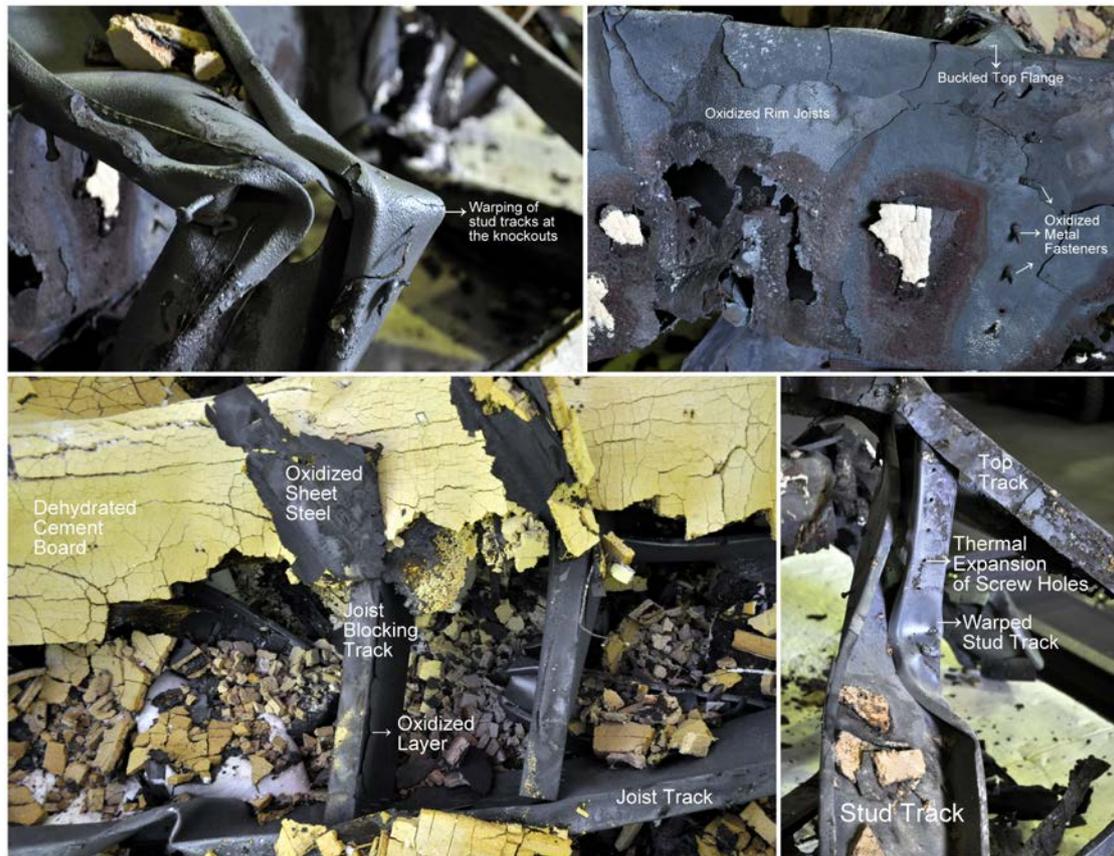
Figure 9. Failure patterns in the test specimen CFS01

Figure 9 shows the commonly observed damage patterns from the failed test specimen CFS01. It was apparent that the gypsum board disintegrated before the collapse of fire tests. The cement board deck was severely dehydrated. However, the collapse showed that the cement board did not disintegrate unlike the gypsum board into smaller fragments. This is because the cement board was adhered to the sheet steel underside and was protected on the top by the loading block and hence it came into contact with high temperature just before the collapse. However the sheet steel backing the gypsum board on the Wall B as well as cement board underwent high temperature oxidation as shown in Figure 9. High temperature oxidation was largely observed in all the structural members such as studs, joist tracks, rim tracks and blocking tracks as shown in the figure. Although high temperature oxidation of the self-

drilling self-tapping screws was also observed, the position of the screws suggest that the failure did not happen due to shearing of the fasteners. The screws holes on the receiving end of the members showed that they underwent thermal expansion, due to which the separation of panels occurred.
