Building Name Address	Use (as per FSA Annexed Table 1)	Date and Time of Incident	Structure and Stories Area	Extent of Damage (Damaged Area/ Total Area)	No. of Casualties
<b>Turkish Bathhouse, Sono</b>	Bathhouses with private rooms (9) a	Mar. 29, 1969	Fire preventive 2 stories above ground and 0 below	<b>All</b> , Half, Partial, Small  358 m <sup>2</sup>  (100 %)	Fatalities 5
		Breakout at 17:05 (approx) Noticed at 17:08 Notified by emergency call Extinguished by 19:51			
1-442 Nishi-okubo, Shinjuku, TOKYO			Total floor area 358 m <sup>2</sup>

I. Summary of Fire Incident									
(1) Summary	This fire originated in anon-fire resistive boiler room where overfilled boiler fuel ignited and several defects facilitated the fire to spread. The boarded window trapped the evacuees and resulted in 5 fatalities (employees) on the 2nd floor.

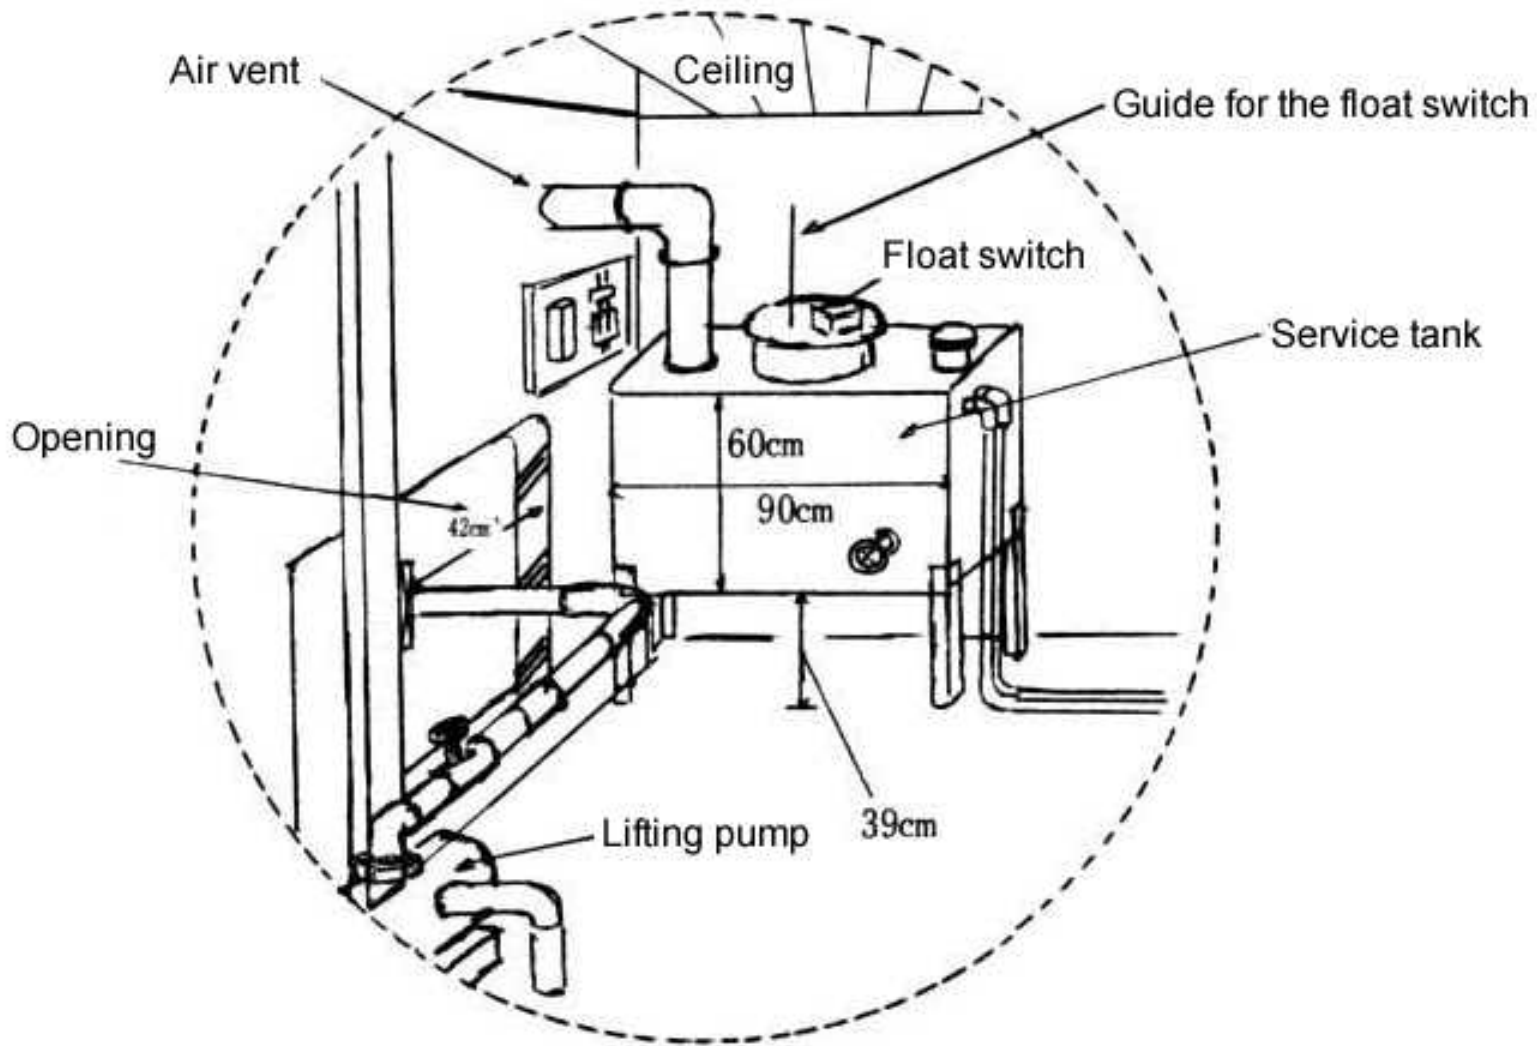
Layout of the service tank

(3) Origin of Fire	(Floor, Room, Part, Combustible, Habitable/ <u>Non-habitable</u> , Present/ <u>Absent</u> )				(4) Cause of Fire	A fuel track overfilled the heavy oil by 1000 liters in the indoor fuel tank for the boiler, and the excessive fuel spilled over the service tank, covering the boiler room. It was ignited by the flame for the active boiler.			
	<u>Flames emerged from the boiler room on the 1st floor</u> <ul style="list-style-type: none"> <li>o The boiler room was constructed with fire-preventive materials, and the entrance door was made of wood.</li> </ul>
