Building Name Address	Use (as per FSA Annexed Table 1)	Date and Time of Incident	Structure and Stories Area	Extent of Damage (Damaged Area/ Total Area)	No. of Casualties
Sennichi Building 3-1 Mannba-shinchi, Minami-ku, Osaka City, OSAKA	Complex (16) a	May 13, 1972	Fire resistive	All, [Half] , Partial, Small 8,763 m ² (34%)	Fatalities 118
		Breakout at 22:27 (approx) Noticed at 22:40 Notified by emergency call Extinguished at 17:30 on May 15th	7 stories above ground and 1 below Building area 3,770 m ² Total floor area 25,923 m ²

I. Summary of Fire Incident

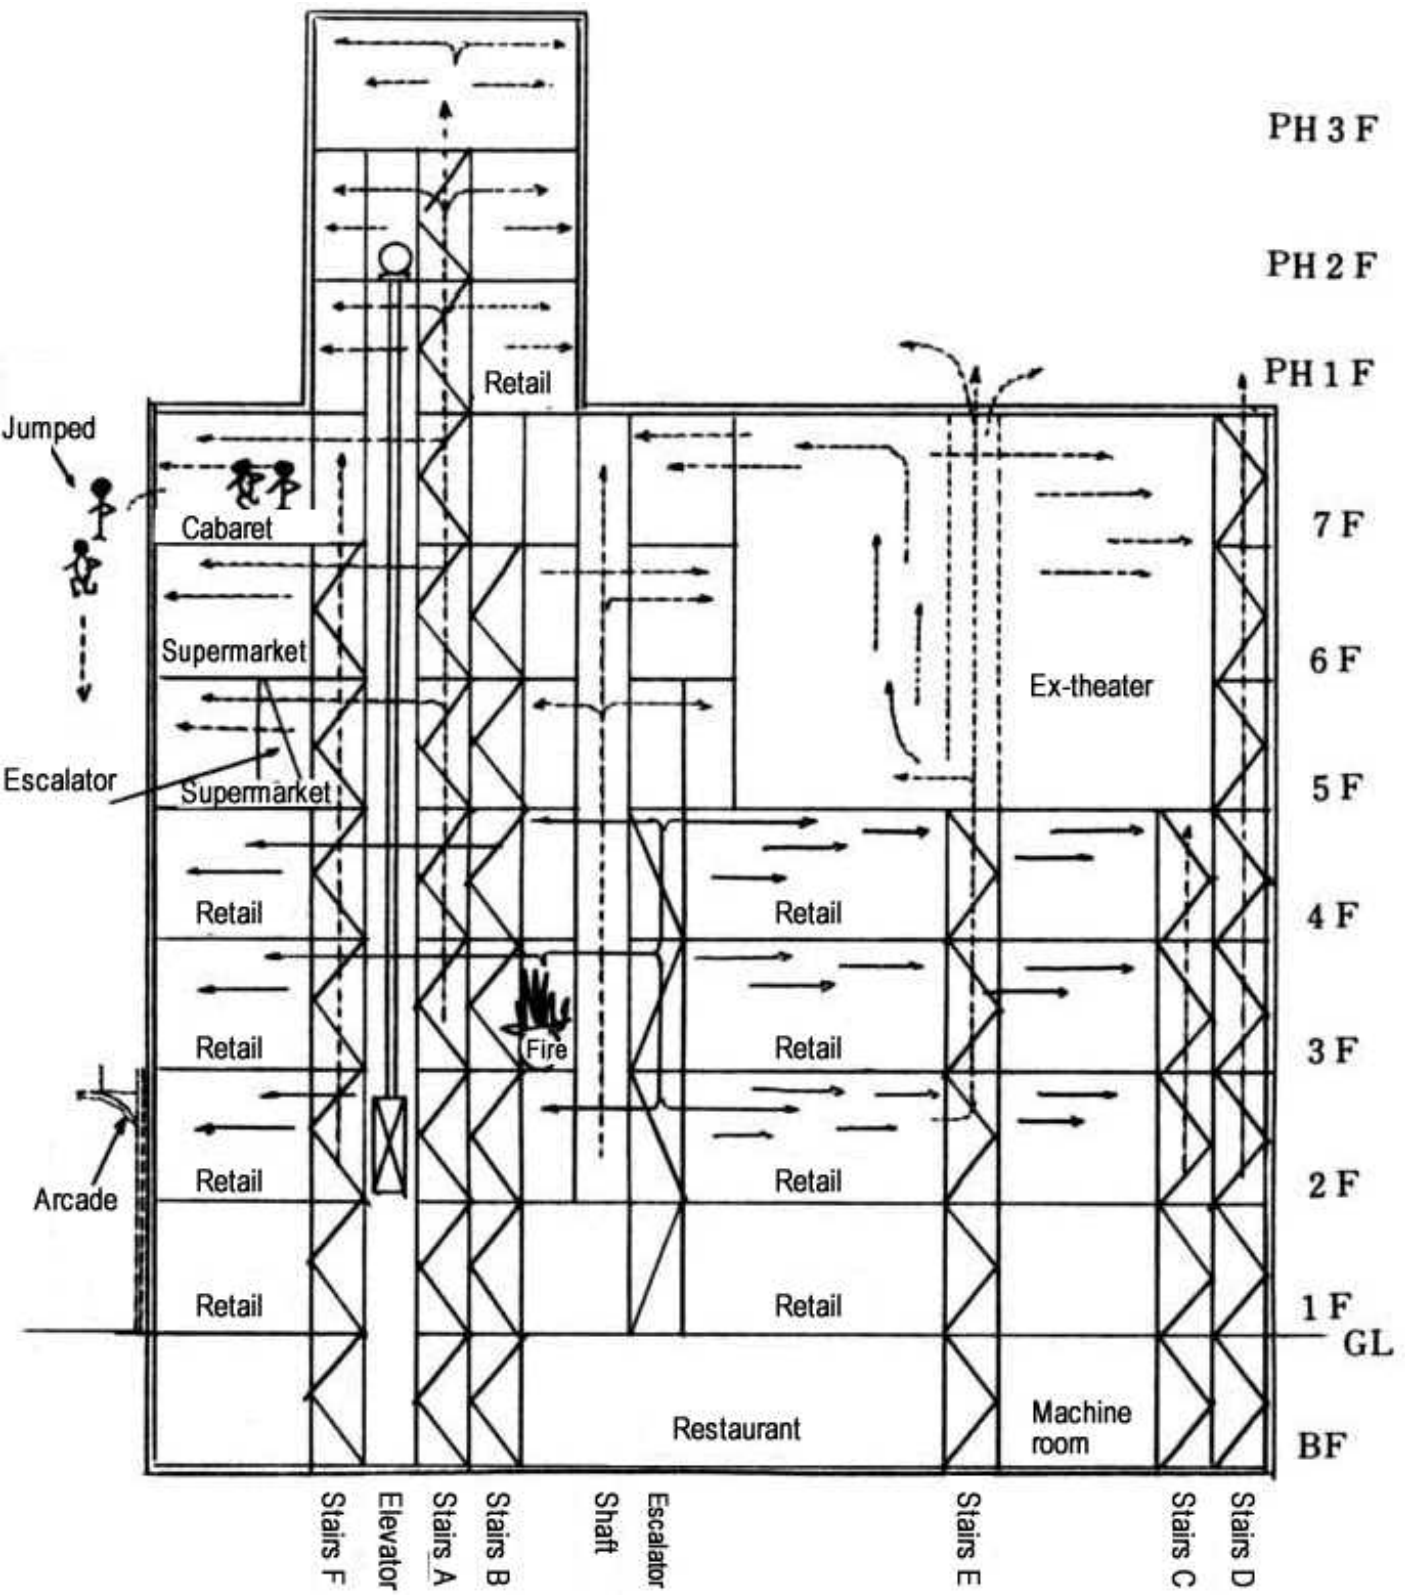
※ Refer to plane view for details of casualties

Symbol \dashrightarrow Smoke and heat \longrightarrow Propagation path

The propagation paths of the fire from the 3rd floor to the adjacent floors (2nd and 4th floors) were the unclosed fire shutters on the escalators, whereas the paths of the smoke/fumes were the exhaust air ducts running on the 3rd, 4th and 7th floors. So the smoke that was produced on the 3rd floor accumulated on the 7th floor. The smoke also traveled through the unclosed spiral stairs on the 3rd floor and the elevator shaft, and exited from 3 sections of the escape route, which created poor visibility and a closed room filled with smoke and fumes.
