Tokyo University of Science “Research Center for Fire Safety Science”

■研究成果概要報告書/ Report for Outline of Research Results

研究課題 Research Topic		Structural Fire Performance of Earthquake-Damaged Cold Formed Steel Framed Walls	実施年度 2016
研究代表者 Research Leader	所属 Affiliation	Worcester Polytechnic Institute (WPI)	
	氏名 Name	Brian Meacham	
	e-mail	bmeacham@wpi.edu	
受入担当責任者 Organization	氏名 Name	Ken Matsuyama	
<p>1. 研究の背景および目的/ Background and Aim of Research</p> <p>Post-earthquake fire performance of buildings is a concern in earthquake prone zones across the globe. In recent years, there has been an increased use of cold formed steel (CFS) framed building assemblies in many countries, including the USA. CFS is known for its strength, durability, stability, sustainability, non-combustibility and cost effectiveness over conventional light wood-framed construction. Due to its wide advantages, cold-formed steel is used as a preferred material for construction in earthquake resistant structures. However, the performance of CFS framed structures in fire remains unknown. However, multiple tests have been performed on CFS wall frames in the recent past [1-7].</p> <p>A project was successfully comp

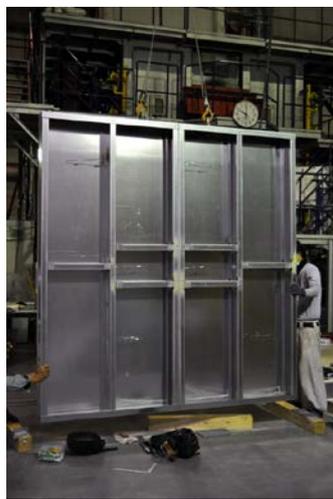
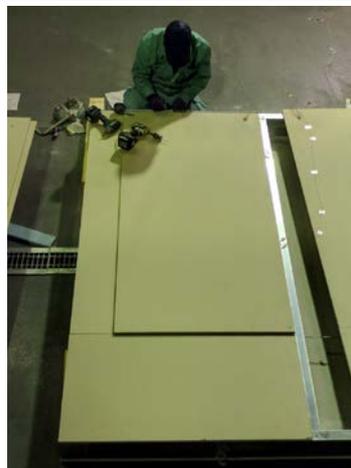
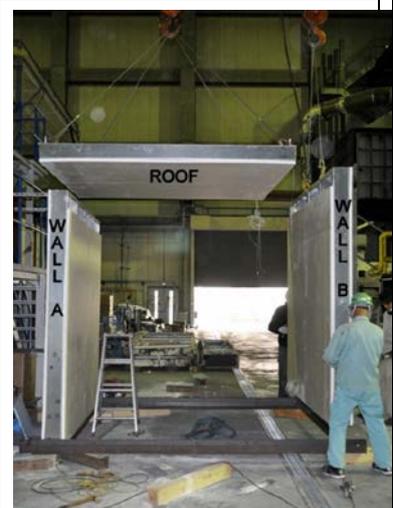
The full-scale test specimen was constructed from light-gauge cold-formed steel (CFS) frame. The assembly consisted of a CFS floor panel supported on two CFS wall panels. The assembly was provided with two cross-braces for adding structural stability and constructed over a simple platform made up of structural steel angles. This facilitated the easy lifting of specimen without compromising its verticality. Cold-formed steel framed construction represents a stud-and track system connected together using self-drilling, self-tapping sheet metal screws. The studs, tracks and joist sections were custom fabricated using locally available galvanized sheet steel bent to resemble standard US CFS sections (152.4 mm x 51 mm). It should be noted that the floor panels was fabricated using the same size tracks as studs. This is in contrast with the standard floor (or rim) track sections (254 mm x 51 mm). The CFS wall panels were built as shear walls, where one side of the sheathing consisted of a single layer of sheet steel (0.8 mm thick) adhered to 12.5 mm thick gypsum board using water-soluble adhesive. A second layer of 12.5 mm gypsum wallboard covered the base layer. 2 layers of 12.5 mm gypsum wallboard represent a 1-hour fire resistance rating.

The test specimen is comprised of two wall panels connected to a floor panel. The dimensions of the specimens are carefully chosen to fit within the internal dimensions of the furnace. The overall wall panel dimensions were 2540 mm (W) x 2400 mm (H). The roof panel was also 2540 (W) x 2400 mm (D) in dimension similar to the wall panels. Each wall panel was a combination of two separate panels, joined at the center using fasteners. The center connection represented a typical double stud connection.

arranged back to back and fastened using sheet metal screws with a spacing of 300 mm o.c..

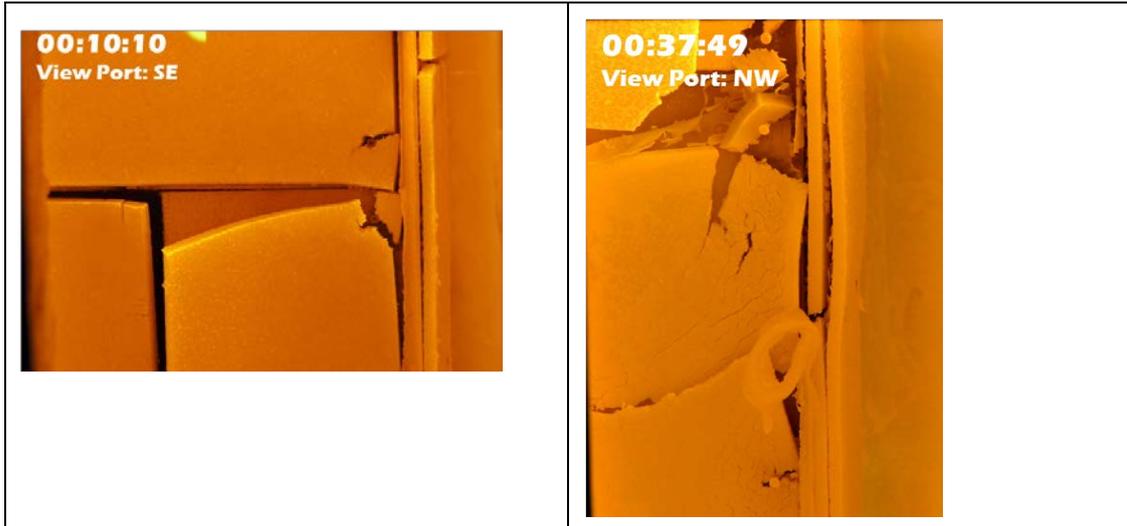
Figure below shows the views from the viewport camera, which shows the separation of gypsum wallboards as early as 10 minutes into the test. Dehydrated gypsum boards showed a shearing failure originated near the fasteners. Dehydration was evident from visually observed numerous surface micro-cracks. Also, loss of bond between the gypsum wall board and sheet steel was observed, which is consistent with the CFS tests conducted in San Diego.

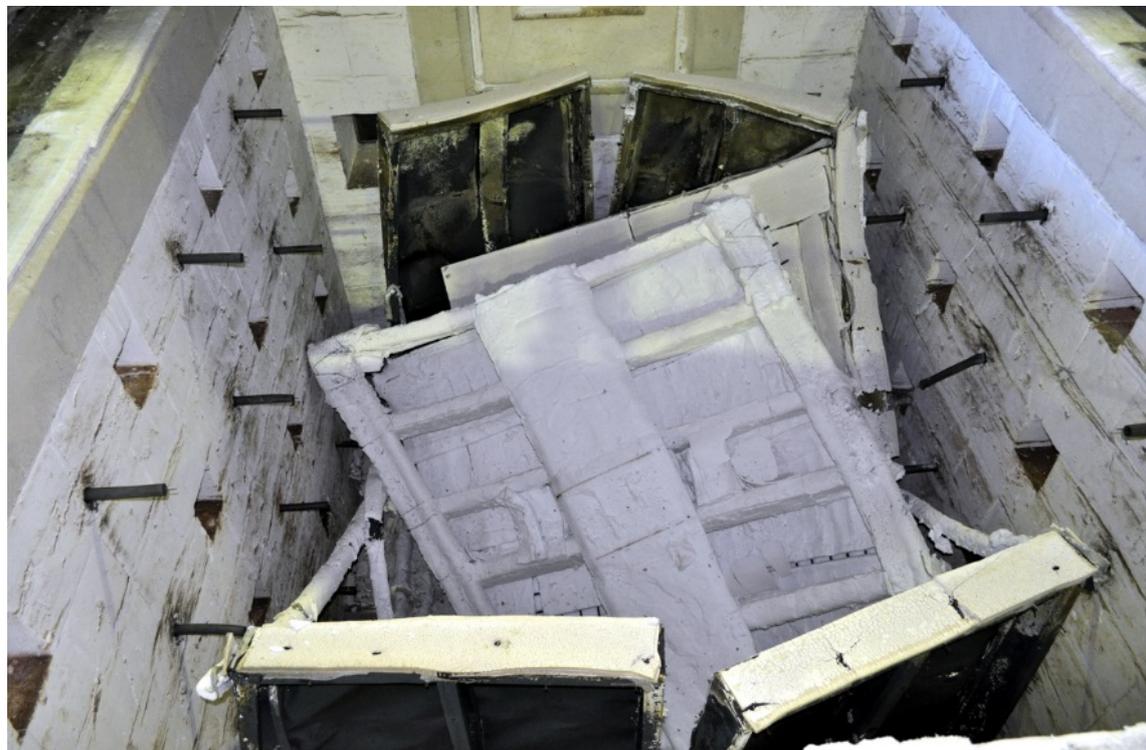
Figure below shows the collapsed roof panel and failure of the double stud connection.
