Setagaya Ward, Tokyo: NTT Underground Cable Conduit

1. Characteristics of the fire

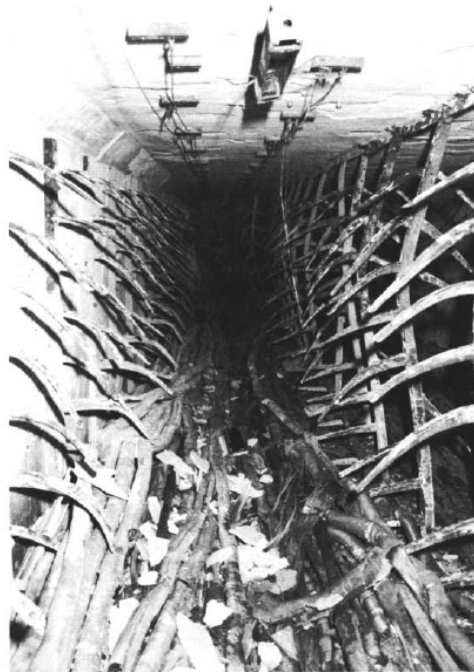
PHOTO

The fire occurred in an underground conduit (tunnel) at a point approximately 130 m from the No. 3 Setagaya Telephone Exchange. The conduit was 2.65 m wide and 2.35 m high. An aisleway of approximately 0.8 m wide ran down the center. Placed along the sides were a total of 42 telephone cables, 24 on the north side and 18 on the south side.

Employee B and Employee C of Telecommunications Construction Company A were using a blowtorch to cut open a lead pipe shielding connection points between telephone cables. Upon doing

so, they found the location of a broken wire and, to discuss how to repair it, left the tunnel. It has been determined that they did not fully extinguish the blowtorch before leaving.
