Building Name Address	Use (as per FSA Annexed Table 1)	Date and Time of Incident	Structure and Stories Area	Extent of Damage (Damaged Area/ Total Area)	No. of Casualties
Tsuruya Hotel 6-45 Higashikaigan-cho, Atami, SHIZUOKA	Hotel (5) a	Feb. 3, 1970	Fire resistive 10 stories above ground and 1 below Building area 3,208 m ² Total floor area 24,149 m ²	All, Half, Partial , Small 2,450 m ² (10%)	Fatalities 0
		Breakout at 02:00 (approx) Detected at 03:50 Notified by emergency call Extinguished by 6:00			Injured 2 (2)

I. Summary of Fire Incident

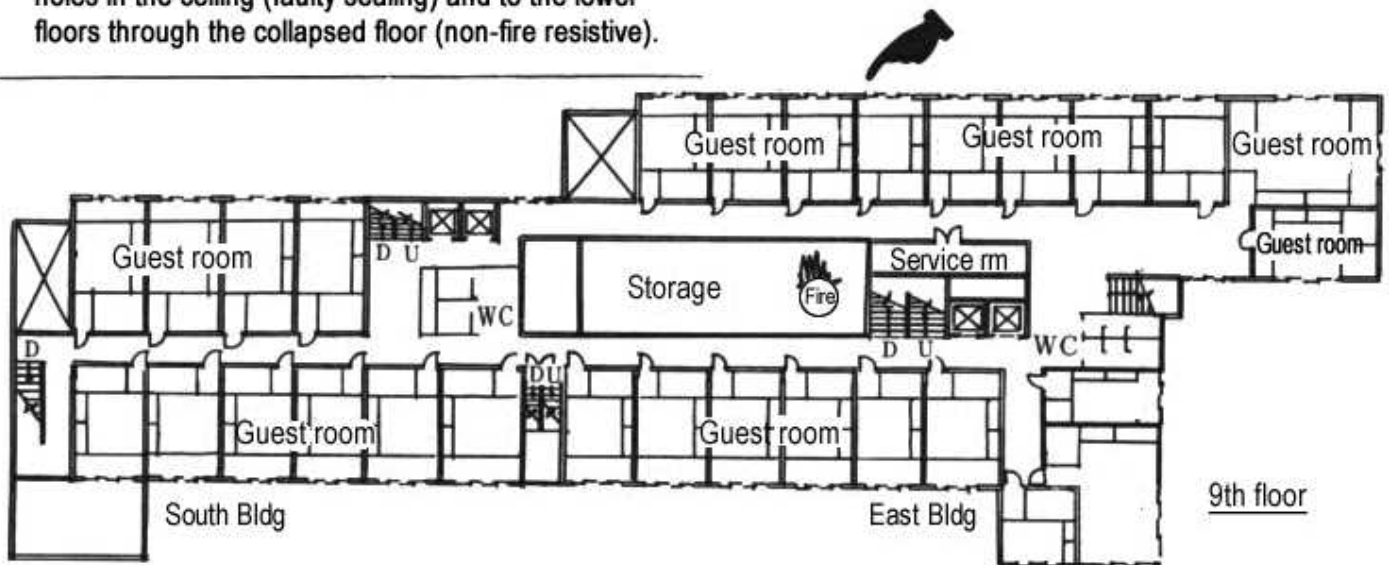
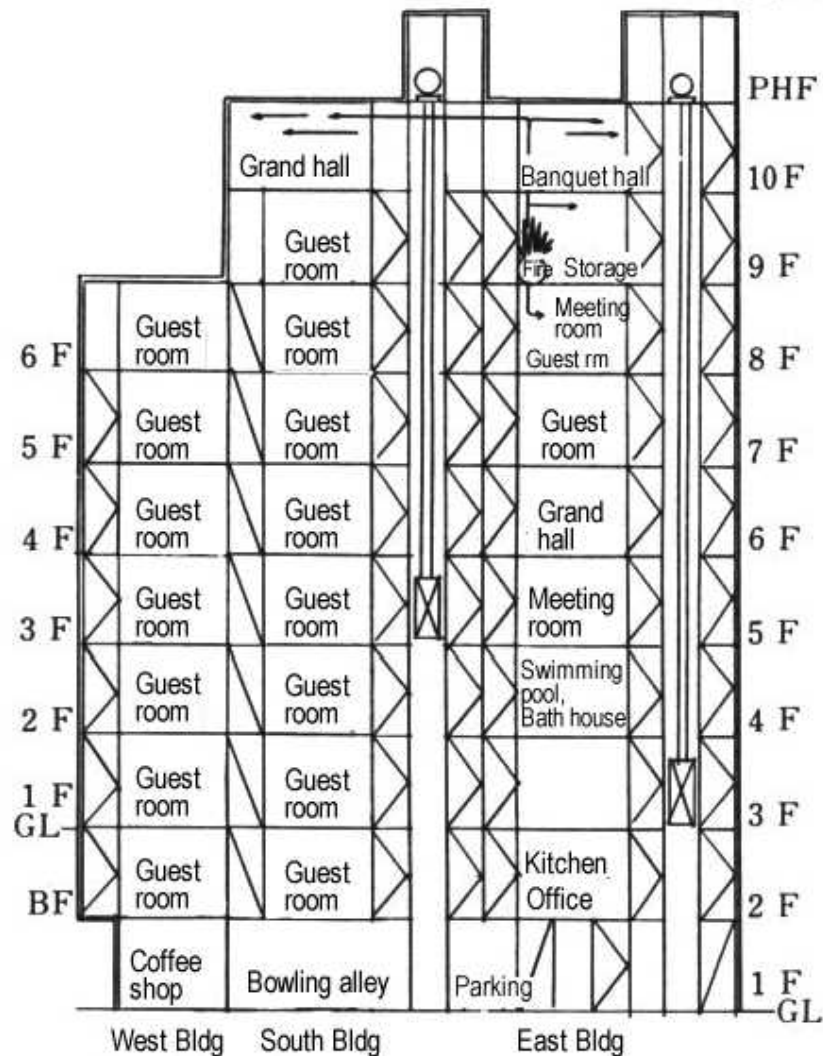
Note: Presumably, the fire spread to the upper floors through holes in the ceiling (faulty sealing) and to the lower floors through the collapsed floor (non-fire resistive).
