Hotel Zao, Yamagata city, Yamagata prefecture

### **1. Characteristics of the fire**

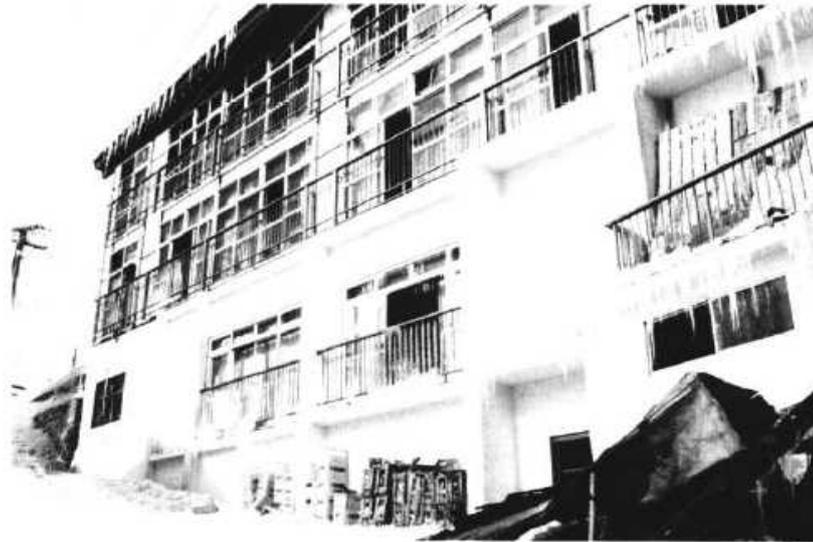
The bell of the automatic fire alarm system in this hotel was turned off as it often sounded when there was no fire. Therefore, even though the alarm system was fully operational when the fire emerged, the bell did not sound, and as a result the fire was discovered late. The fire propagated and burned 7 buildings in the vicinity of the hotel, killing 11 and injuring 2.

- (5) Fatalities
  - A total of 11 died in the building where the fire emerged (6 on the 1st floor, 4 on the 2nd floor, and 1 on the 3rd floor). They were found lying face down, and it is assumed that the cause of death was carbon monoxide poisoning.

- (8) Propagation of the fire
  - (a) The building where the fire emerged was made of timber.
  - (b) Influence of the weather conditions (snow storm with wind speed of 10–15 m/s).

- (1) Although the fire certification of this hotel had been issued, the automatic fire alarm system bell had been turned off. In addition, the evacuation guidance provided by staff members was inadequate.
- (2) It is necessary to provide instructions on how to implement fire alarm systems which sound only in the case of fire.
- (3) It is necessary to provide instructions regarding a fire prevention management system via a manual for night-time fire prevention management in hotels and inns.
