Manza Onsen Hotel, Tsumagoi town, Gunma prefecture

1. Characteristics of the fire

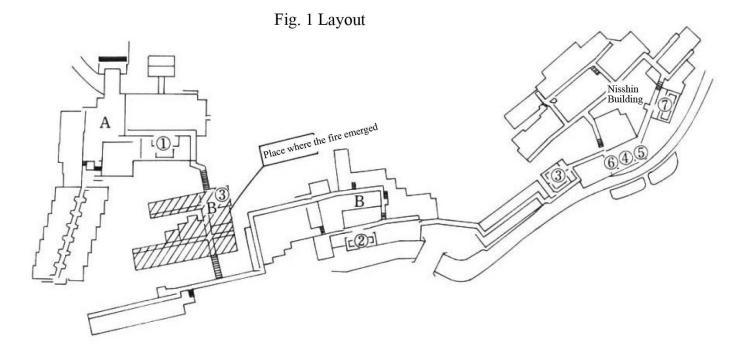
Fig. 2 Floor plans (the floor where the fire emerged; damaged floors; 1st floor; others)

(a) Number of blocks 1 (blocks 5 and 7 in Building B)

(b) Degree of burning Completely burned

② Buildings to which the fire spread Part of Building A burned

In the vicinity of the toilet roof on the 1st floor of Building B (assumed)
