Building Name Address	Use (as per FSA Annexed Table 1)	Date and Time of Incident	Structure and Stories Area	Extent of Damage (Damaged Area/ Total Area)	No. of Casualties
Kobe Department Store	Department store	Feb. 17, 1974	Fireproof structure,	All, [Half] , Partial, Small	Fatalities 1
		Breakout at 23:52 (approx.)	7 stories above ground and 1 below		
5-5-12 Udezuka, Nagata, Kobe, HYOGO		Detected at 03:59	Building area 1,861.6m ²	7,090 m ²	Injured 40 (40)
		Notified by Extinguished by 19:32	Total floor area 16,113 m ²	(44%)

I. Summary of Fire Incident

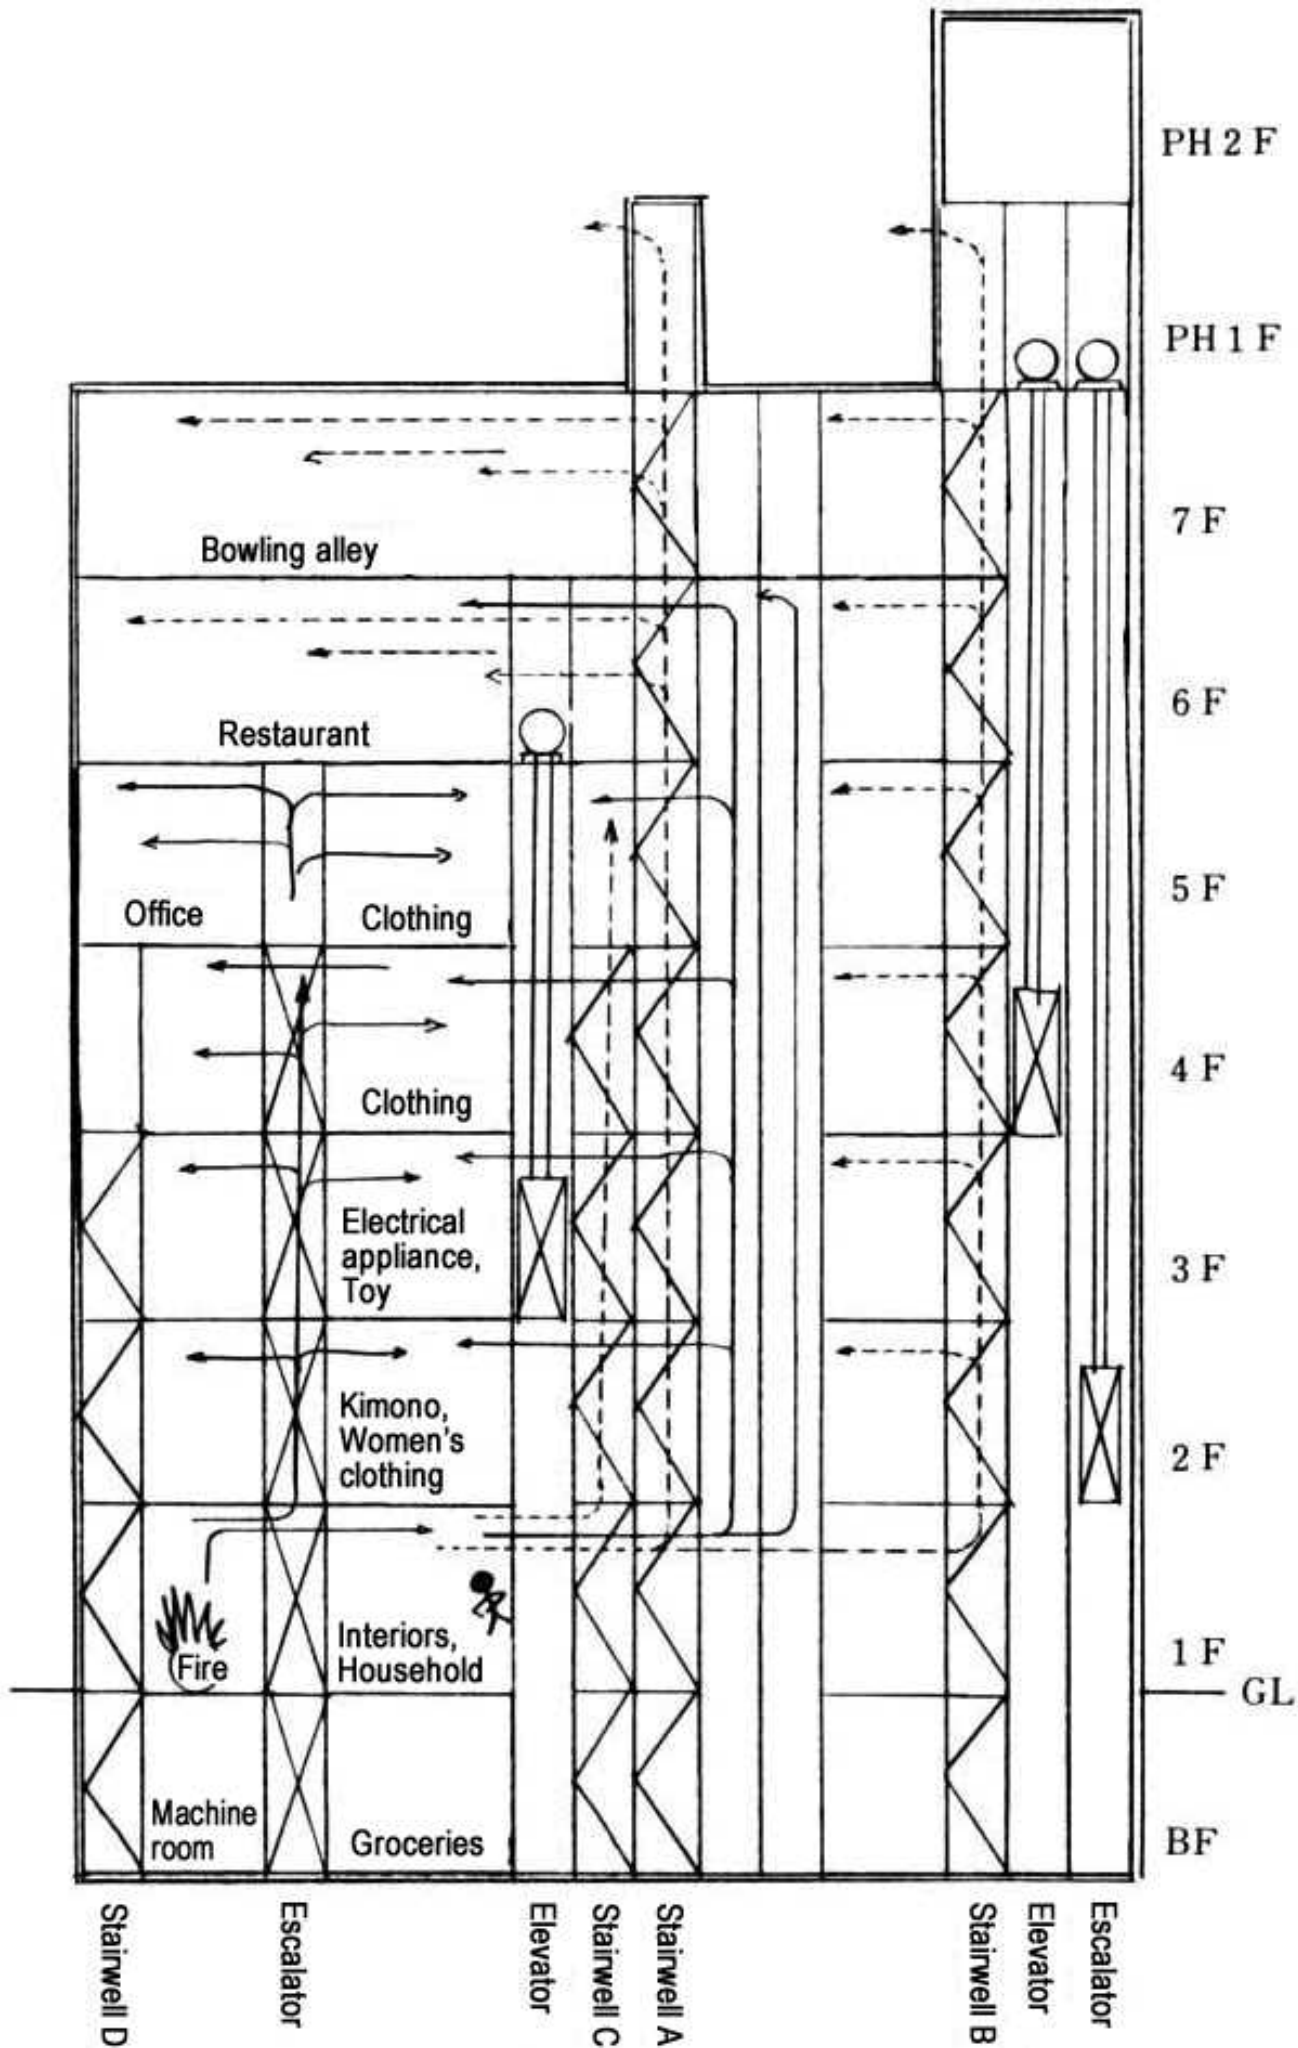
IV. Issues and Lessons Learned		
<p>1 The fire prevention manager was not aware of the faulty opening in the duct shaft above the ceiling of the sales floor, and this opening became the propagation path to the upper floors. The fire inspectors did not pay attention to this issue either because they were more focused on the fire shutters/doors. Learning from this, people who are involved in fire prevention should be more attentive to fundamental issues such as the configuration of fire compartments and be able to detect faulty portions on inspection.</p> <p>2 A centrally controlled HVAC duct system is usually accompanied by a long duct shaft that requires large clearance; however, such a shaft creates a propagation path throughout the building. Based on this, it is necessary to find alternative solutions that can reduce the duct space such as a single-zoned system or a system that can be managed per floor.</p> <p>3 Firefighting activities would be more successful if a personal oxygen mask was available for this lengthy attack under the heavy smoke.</p> <p>4 The firefighting activities were significantly challenging because all the fire shutters were closed on every floor and the large glass window above the 2nd floor was blocked by a stack of sales goods inside, which almost created an enclosed space without any opening.</p>

Symbols —→ Fire propagation path
 - - - - - Smoke propagation path
