Building Name Address	Use (as per FSA Annexed Table 1)	Date and Time of Incident	Structure and Stories Area	Extent of Damage (Damaged Area/ Total Area)	No. of Casualties
<b>Aichi Cancer Center</b>	Hospital (6) a	Feb 8, 1975	Fireproof structure	All, Half, Partial, <b>[Small]</b>	Fatalities 0
		Breakout at 22:20 (approx) Noticed at 22:24 Notified by Extinguished at 00:06 of next day	8 stories above ground and 1 below		
81-1159 Kanokaden, Chikusa-ku, Nagoya, AICHI			Building area 3,392 m <sup>2</sup>	81 m <sup>2</sup>	Injured 0 (0)
			Total floor area 16,744 m <sup>2</sup>	(0.48%)

### I. Summary of Fire Incident

The fire emerged from the machine room (81 m<sup>2</sup>) on the 1st basement floor of the hospital. The fire damaged only one room; however, the evacuation was slow and chaotic, and firefighters rescued most of the people inside. This hospital fire served to provide an opportunity to revise the evacuation plans of hospitals so that any number of physically-disabled individuals can evacuate safely.

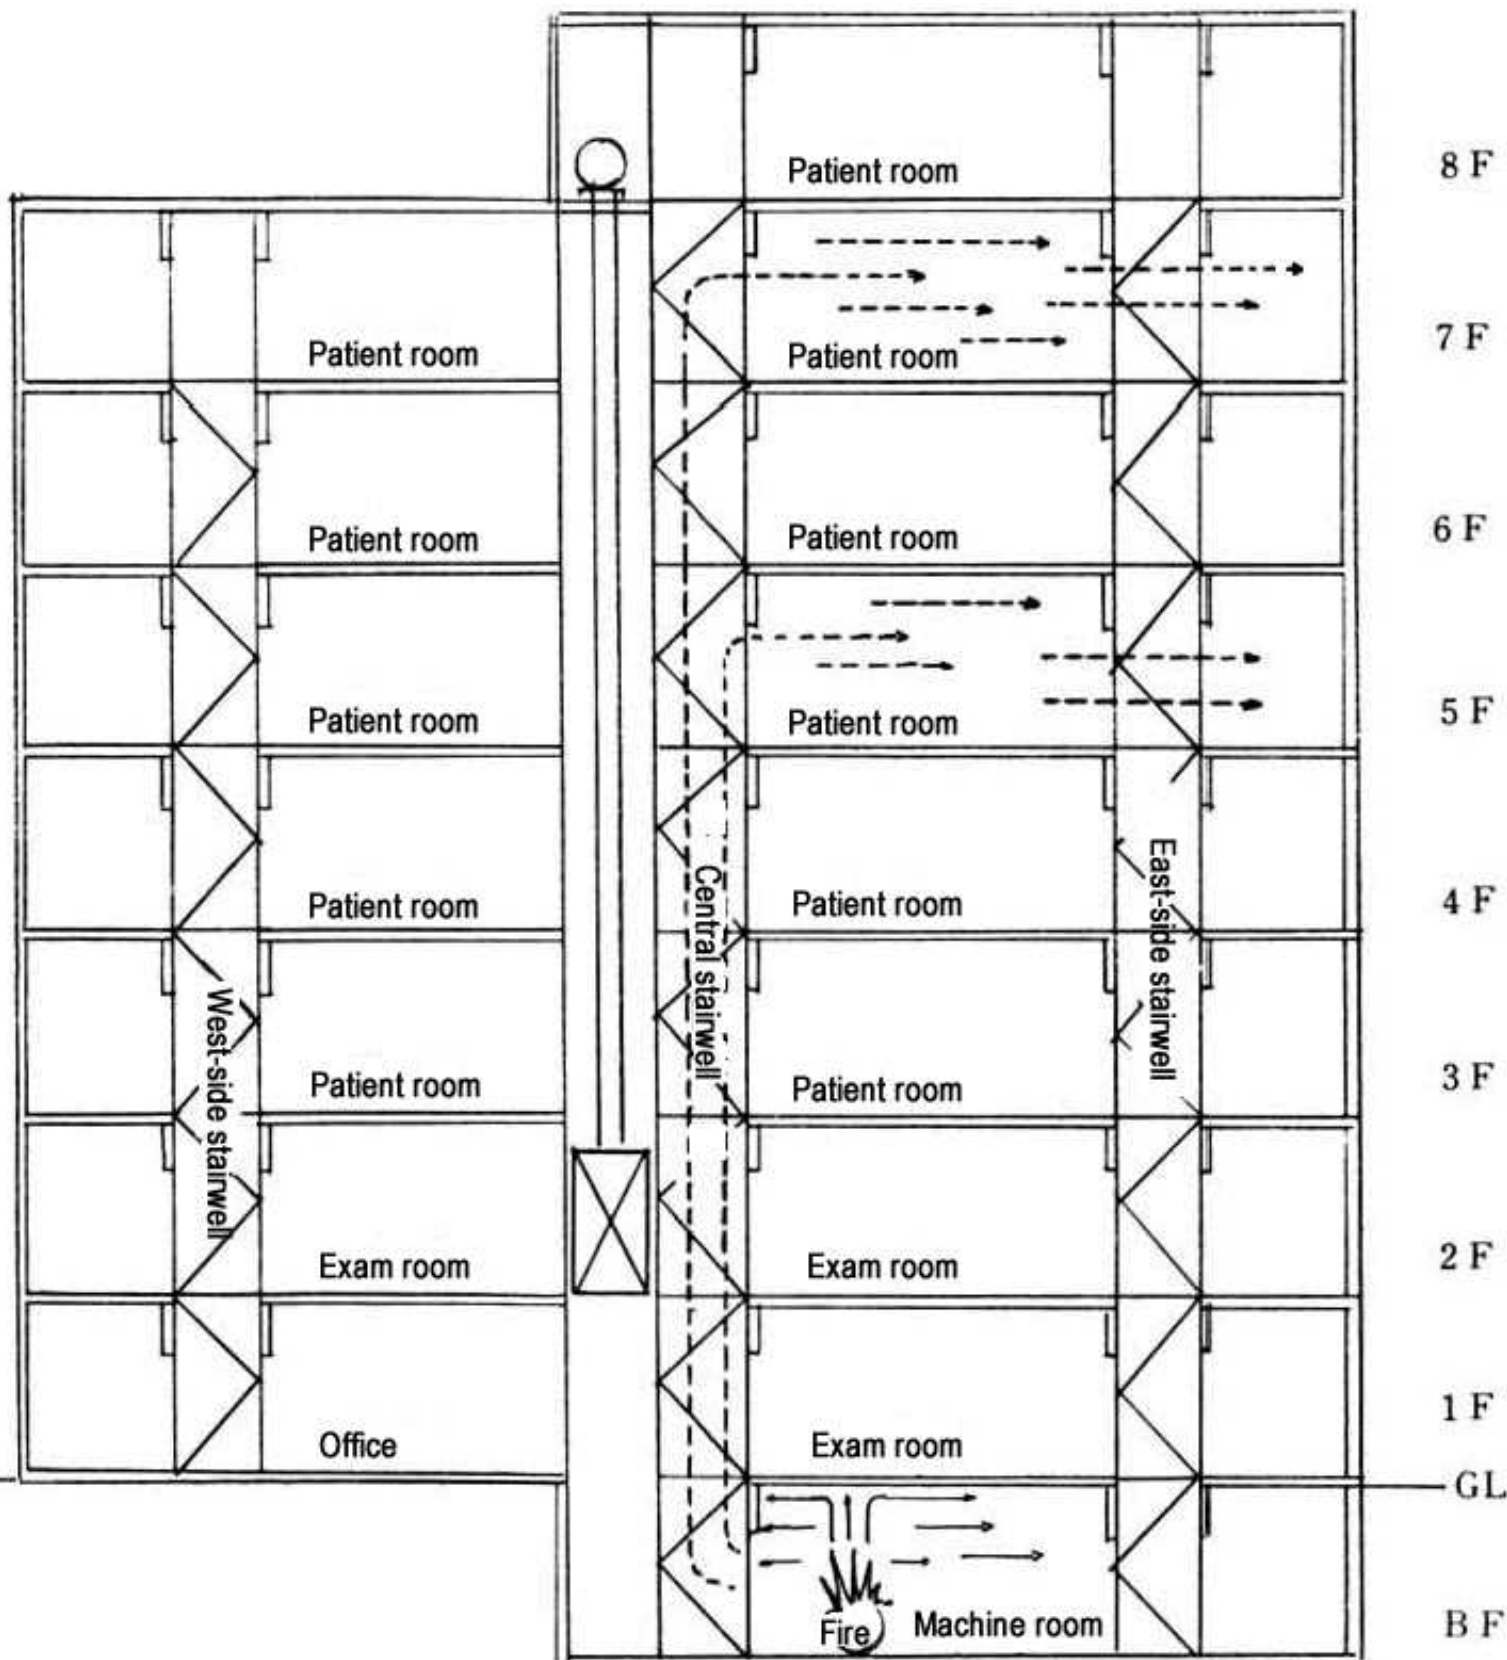
From the center of the machine room on the 1st basement floor.  
The room was constructed of exposed concrete walls but contained HVAC piping of 4.780 m total length.

From the center of the machine room on the 1st basement floor	Coverings of the HVAC piping inside the room	Central stairs and east stairs											
<p>The fire burned the coverings of the HVAC piping inside the machine room on the 1st basement floor.</p>														
<p>○ Main Reasons for Propagation of the Fire</p> <p>○ Smoke Propagation Path When the fire broke out, smoke and heated air ascended the stairwell and drifted into the 5th and 7th floors where the fire doors of the central stair were open. The smoke also drifted to the east stairs through the fire door clearance. Although the condition there was not as bad as in the central stairs, the smoke made the evacuation difficult.</p>														
<b>II. Summary of the Building</b>														
<b>(1) Built</b>	Construction, Completion, and Major Renovations													
<b>Fire Prevention Management</b>	<b>(2) Vertical Shafts</b>	<b>(3) Fire Prevention</b>
