## Fukoku Seimei Building, Chiyoda ward, Tokyo

### 1. Characteristics of the fire

The fire emerged from the electric pipe space (EPS) for cable wirings on the 3rd floor of an ultrahigh-rise building (height 120 m, 29 stories above-ground and 5 below ground).

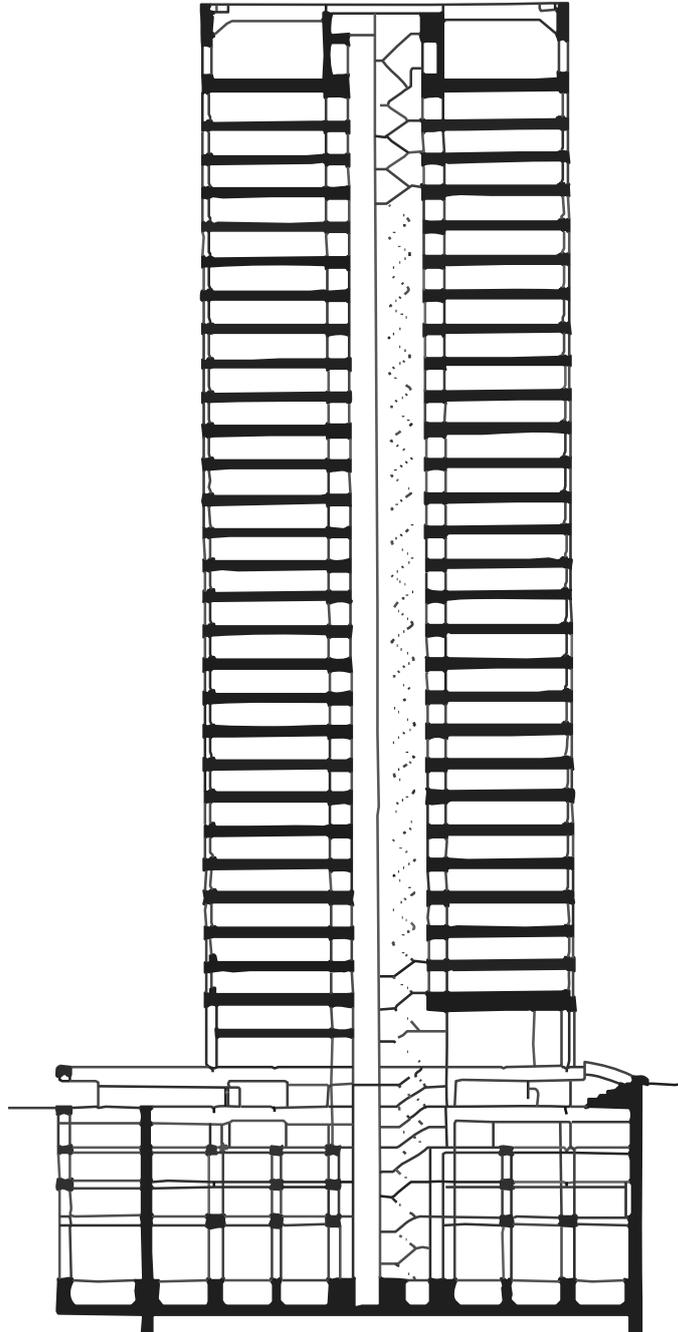
Fig. 4 Cross-section

As the shaft containing the phone cables (EPS) extended from the 3rd to the 5th floor, all cables in this space burned.
