Building Name Address	Use (as per FSA Annexed Table 1)	Date and Time of Incident	Structure and Stories Area	Extent of Damage (Damaged Area/ Total Area)	No. of Casualties
<p>Itoya Department Store, Tateyama</p> <hr/> <p>1625 Hokujo, Tateyama, CHIBA</p>	Department store (4)	Dec. 7, 1973	Fireproof structure, 4 stories above ground and 0 below	<p>All, Half, Partial, Small</p> <p>2,044.68 m²</p> <p>(100 %)</p>	<p>Fatalities 0</p> <hr/> <p>Injured 5 (5)</p>
		Breakout at 15:30 (approx.)	Partially wooden, 2 stories above ground		
		Noticed at 15:43	Building area 817.71 m ²		
		Notified by emergency call	Total floor area 2,044.68 m ²		
		Extinguished by 19:07

I. Summary of Fire Incident

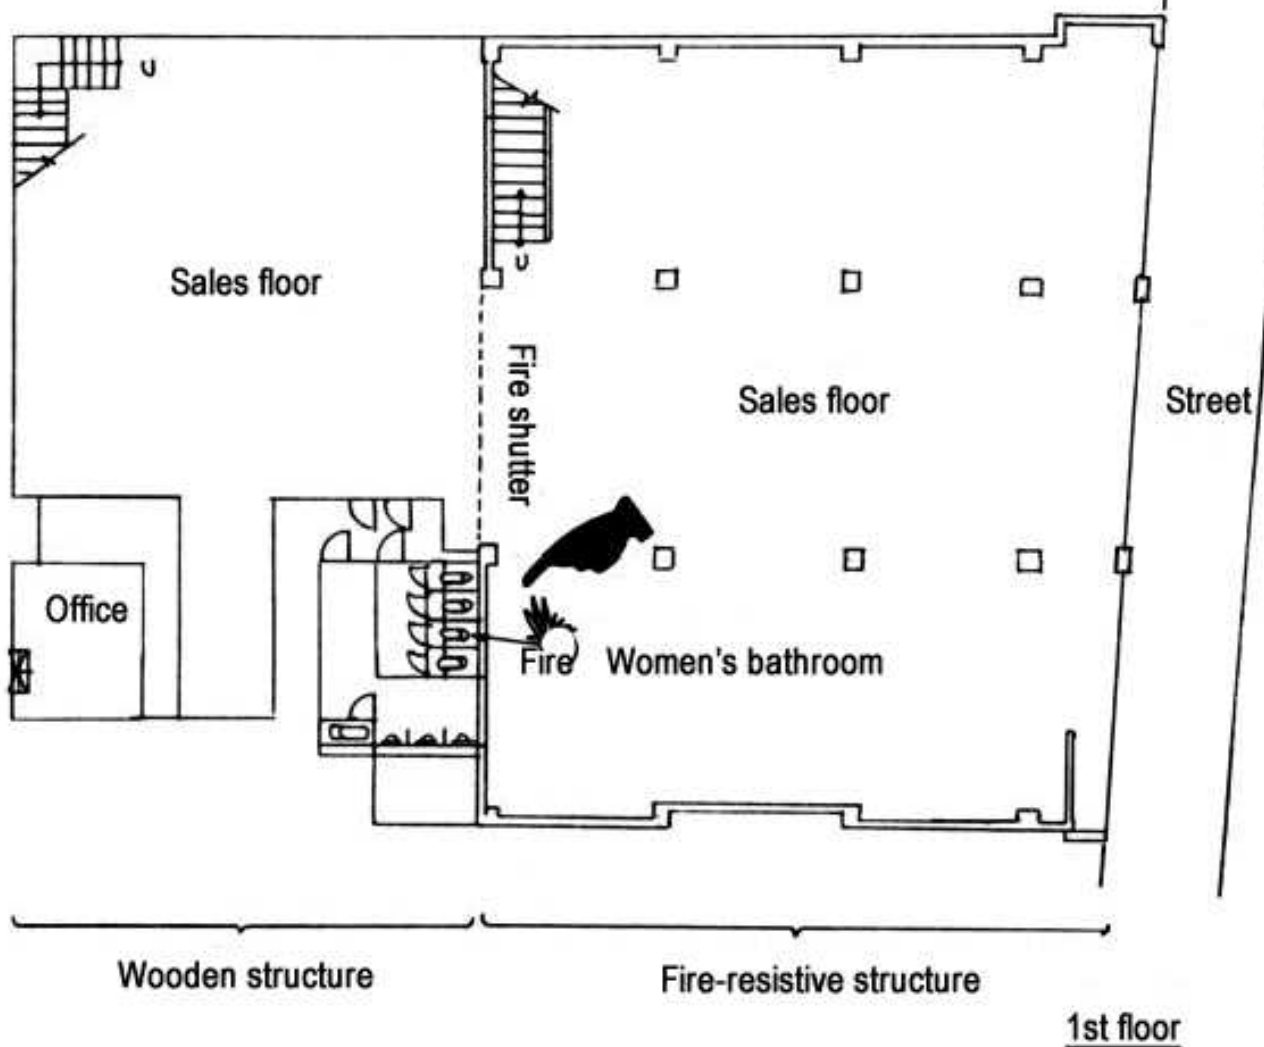
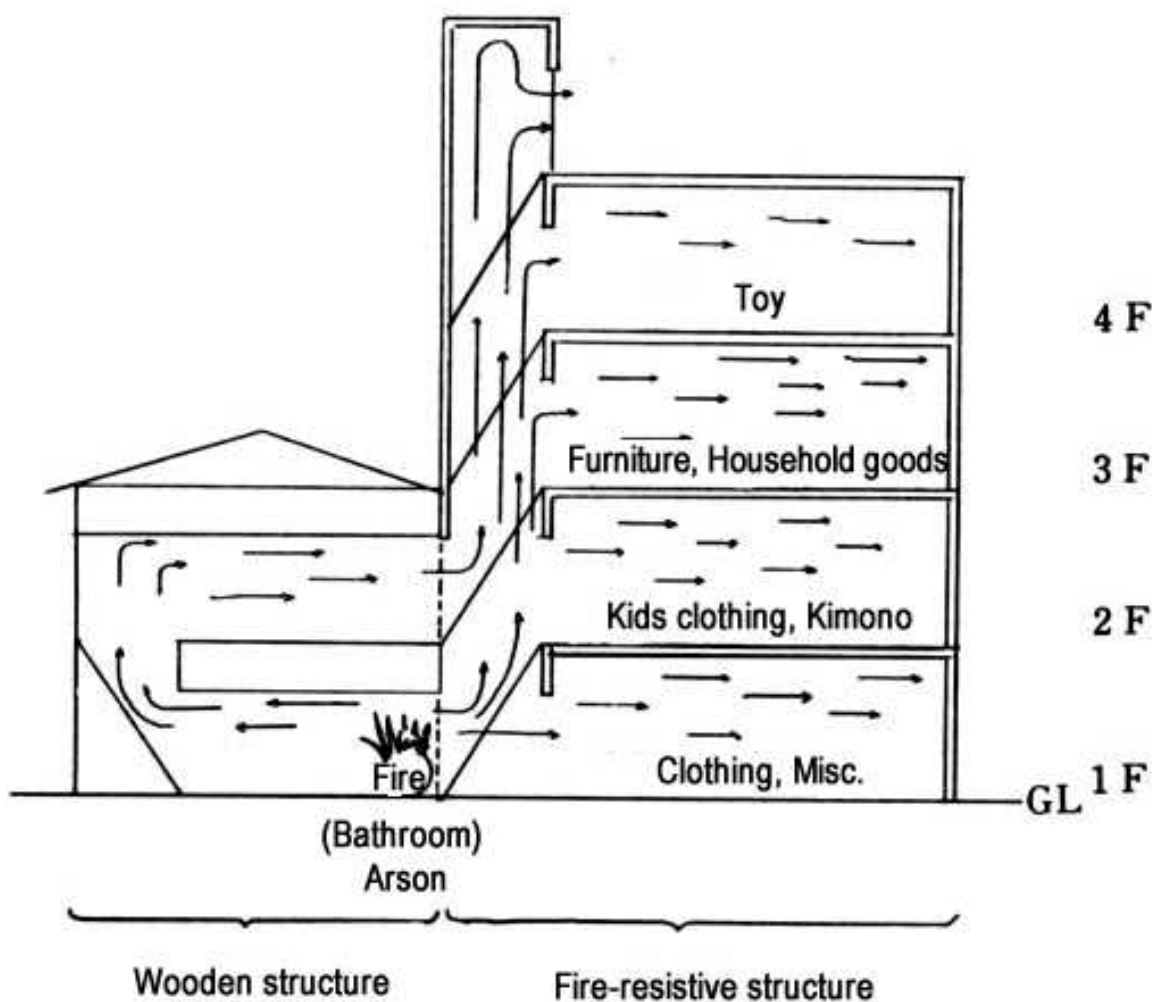
(5) Fire Propagation Path	<div><div>(Location of Fire Source)</div><div><div>Near the bathroom on the 1st floor</div><div>Windows of the 2nd-floor sales section in the wooden building</div><div>Unclosed fire shutters between old and new buildings</div><div>Inside stairs with no fire compartments</div><div>Unclosed fire shutters between the old and new buildings</div><div>Sales floors and goods</div></div></div>	
	<div><div><div><div><div>o The origin of the fire was on the windy side of the wooden building and the strong winds facilitated the fire to develop further. The fire ignited the roof of the bathroom and spread to the window (size of 3.89 m²) of the 2nd floor and then to the main building.</div><div>o From the unclosed shutters on the 1st floor, the fire propagated to the sales floor, igniting the sales goods and then spreading to the upper floors through the stairwell.</div></div></div><div><div>○ Main Reasons for Propagation of the Fire</div><div><div>o Because of the bad weather conditions, the inclined hallway on the 1st floor of the wooden building and the stairwells became a wind tunnel and strong winds blew in to facilitate the fire spreading further.</div><div>o Because of the unclosed fire shutters on the 1st floor, the fire propagated along the ceiling and ignited the sales goods.</div></div><div>○ Smoke Propagation Path</div><div><div>o The smoke propagated through the service lift that was next to the ventilation fan of the bathroom and the stairwell that was not protected by a fire compartment system.</div></div></div></div></div>

The origin of the fire is believed to be near the bathroom on the 1st floor, which was located in the wooden portion of the building.
